**Third Five-Year Review Report**

**Triumph Mine Tailings Piles Site**

**Blaine County, Idaho**

**June 5, 2014**

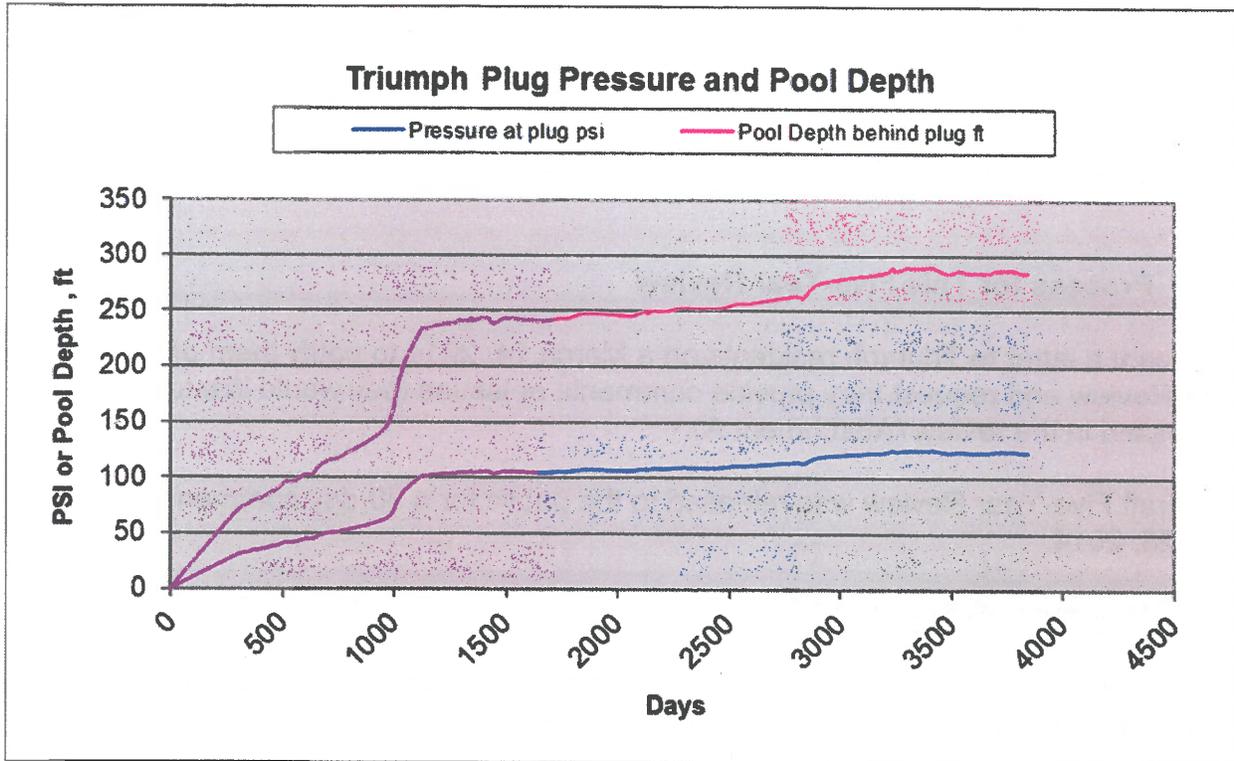
Figure 2. Triumph Mine Plug Pressure and Pool Depth Measurements.

Water pressure behind the mine plug continues to be monitored. Most recent measurements show that the mine pool has stabilized at a depth of 285 feet behind the plug (Figure 2.) This represents a pressure of 123.5 pounds per square inch (psi) behind the plug. The Mine Plug Remedial Design document identified possible seep

expression locations that correlate with four different plug pressures from 30 to 91 psi. Seep surveys were focused on these locations when the corresponding plug pressure was achieved. Two minor seeps were discovered with flow less than one gallon per minute (gpm). The next location for possible seep expression correlates with a pressure of 212 psi. It appears that the mine pool has reached or is coming close to reaching equilibrium and is not likely that the mine pool will reach the depth to create that pressure.
