Belshazzar Mine

Preliminary Assessment Report

Boise County
State of Idaho

June 2008

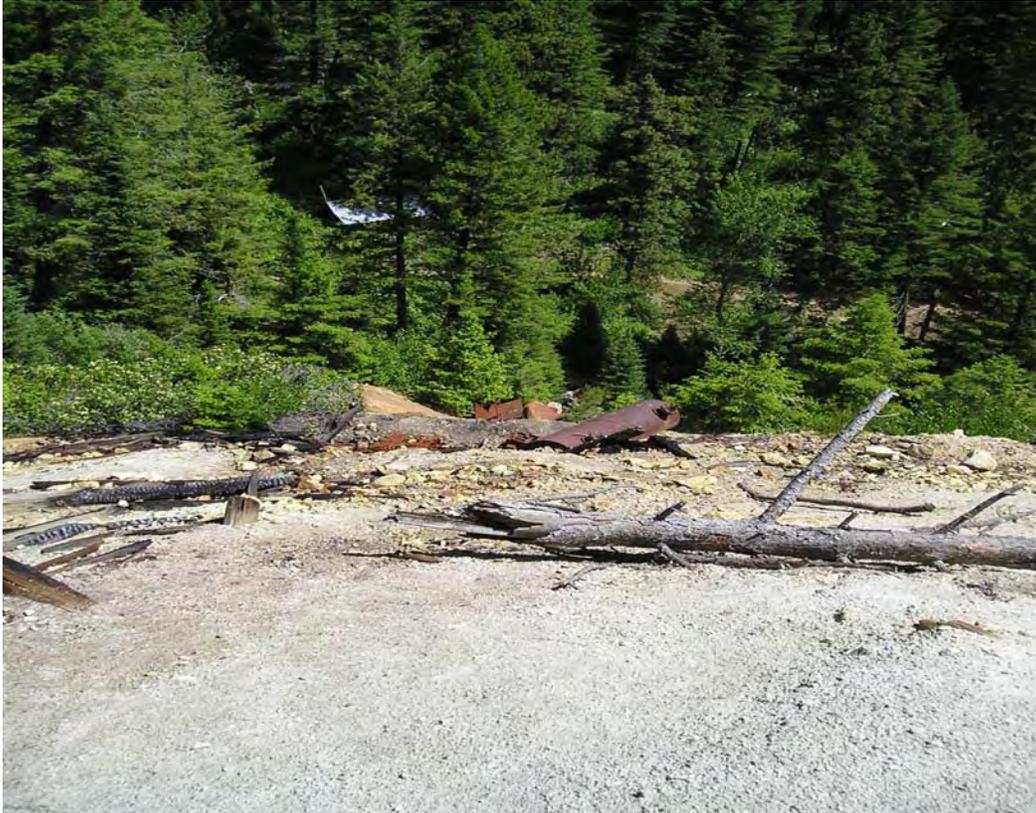
Photo 7

View to north; cabin across Fall Creek from mill ruins (lower)

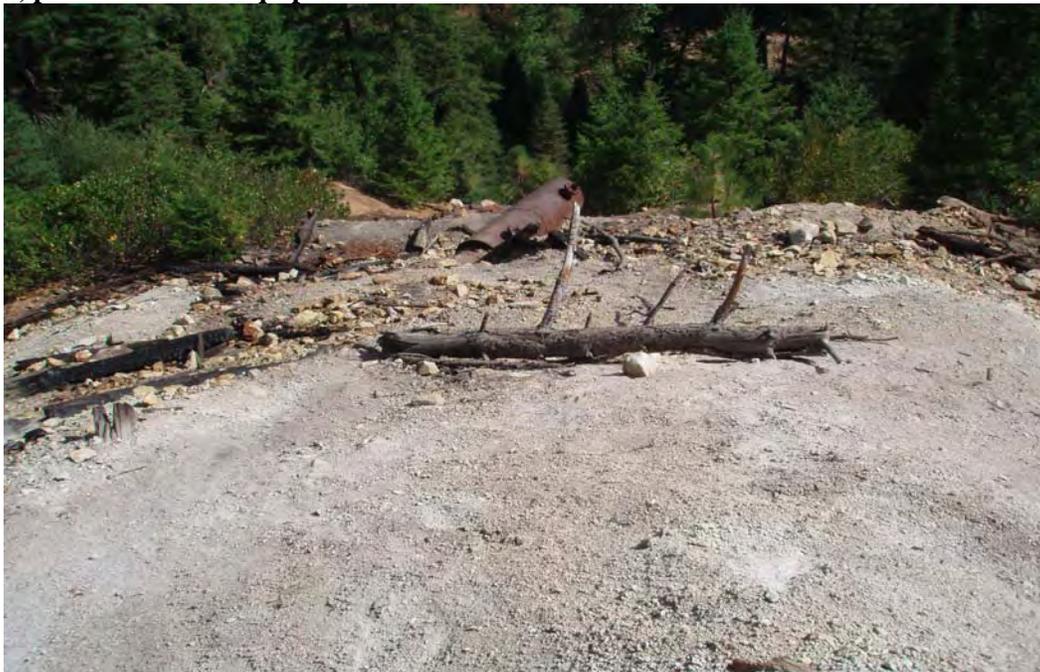
Photo 8

View to northeast (downhill); Primary Crusher – mill site

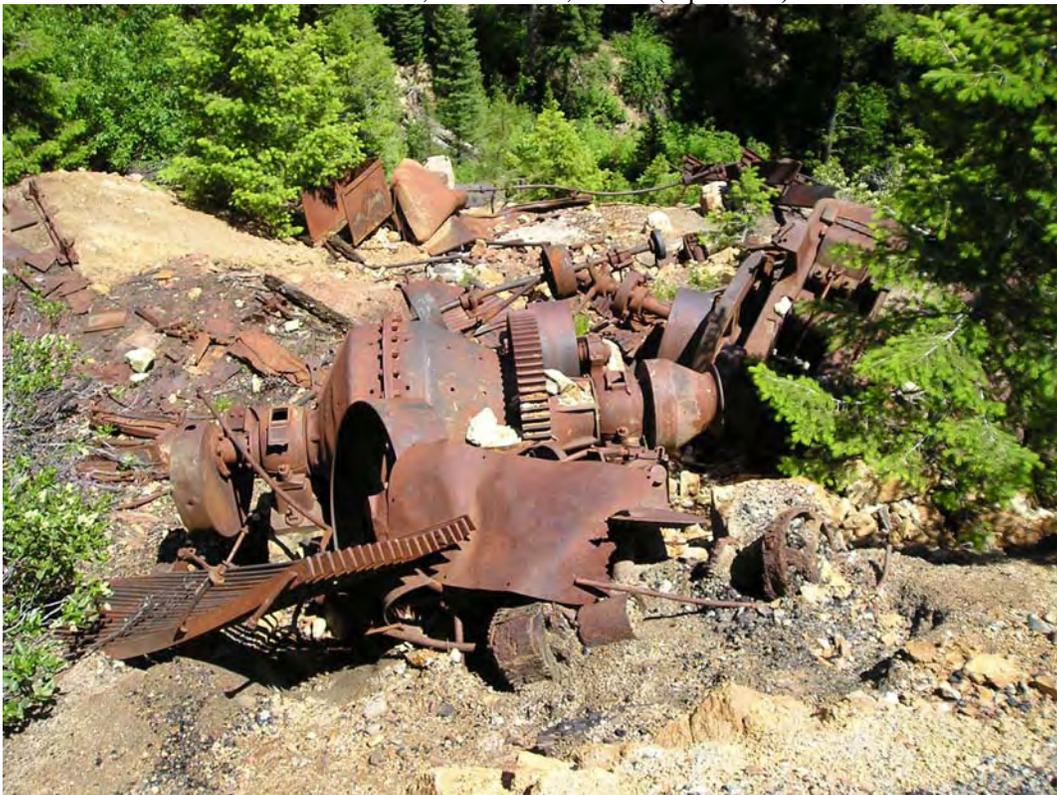
Photo 10

The mill ruins lie adjacent to and partially on top of the eastern limb of the waste dump. All that remains of the mill are its foundations and some of the abandoned milling and ancillary equipment including a ball mill, jaw crusher, electric generator and pumps were identified on the slope. The mill building apparently burned to the ground a number of years ago. Various solid wastes including scrap metal is scattered among the foundations, across the dump slope to the creek, and in the trees and brush. Figure 3.2.3 illustrates the relative location of the foundations and associated equipment. At the time of the September 15, 2007 site visit, a strong sulfide odor was detected, apparently emanating from the dump material beneath the mill.

View to northeast (downhill); Ball Mill and Jaw Crusher amid Mill foundation

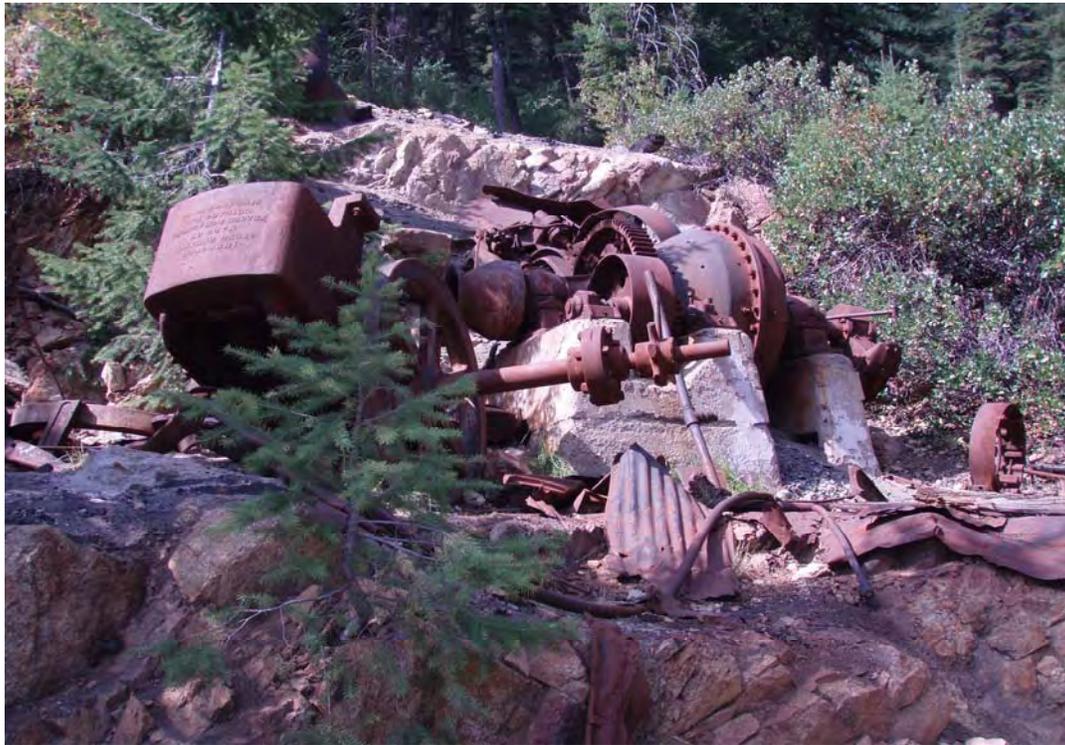
Photo 11

View to southwest (uphill); Ball Mill and Jaw Crusher amid Mill foundation

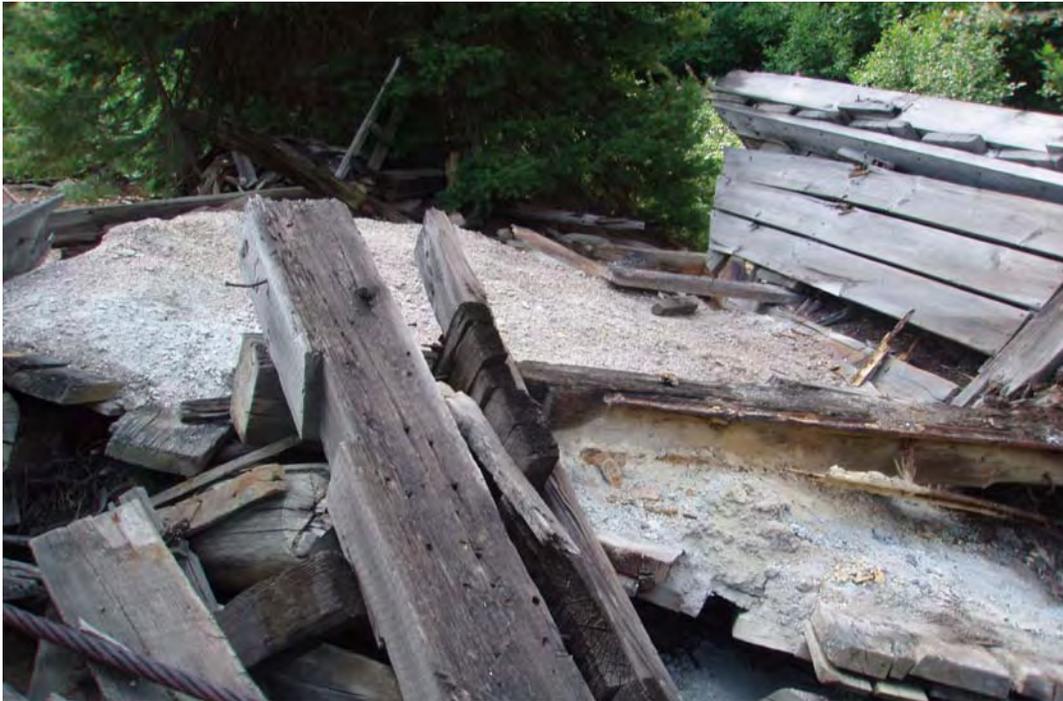
Photo 15

Close-up view; Jig Mill and tails

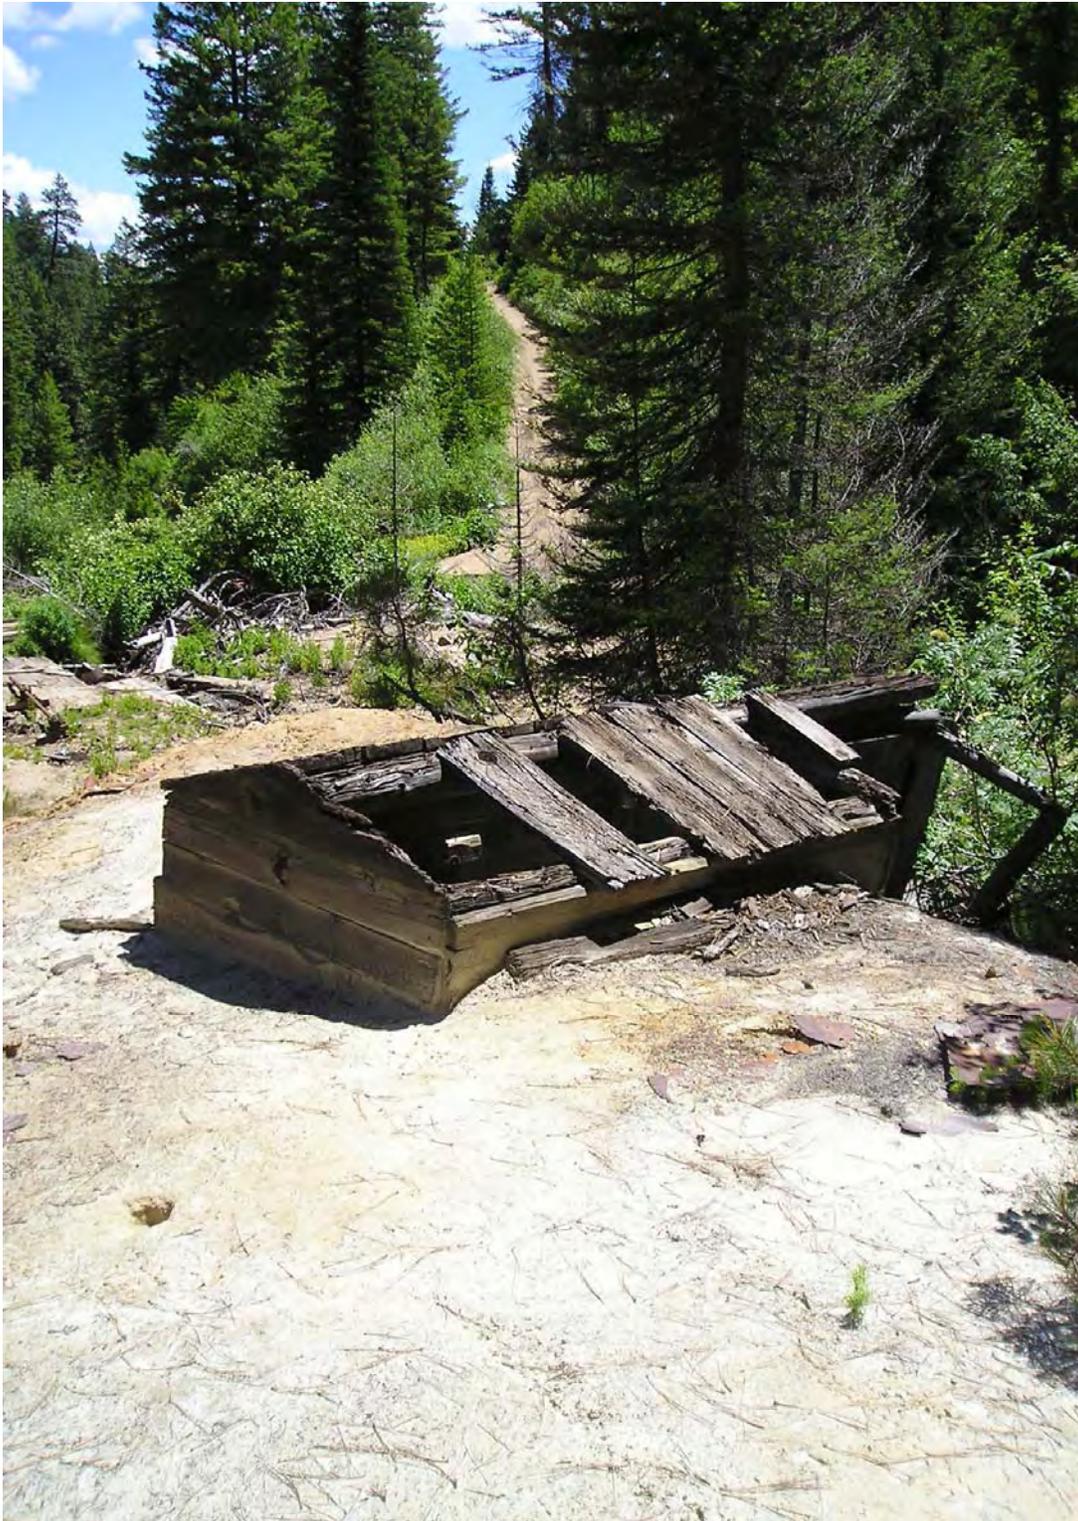
Photo 16

View to southeast; Decant Basin in upper portion of tailings pile, road (center) to millsite (not in picture)

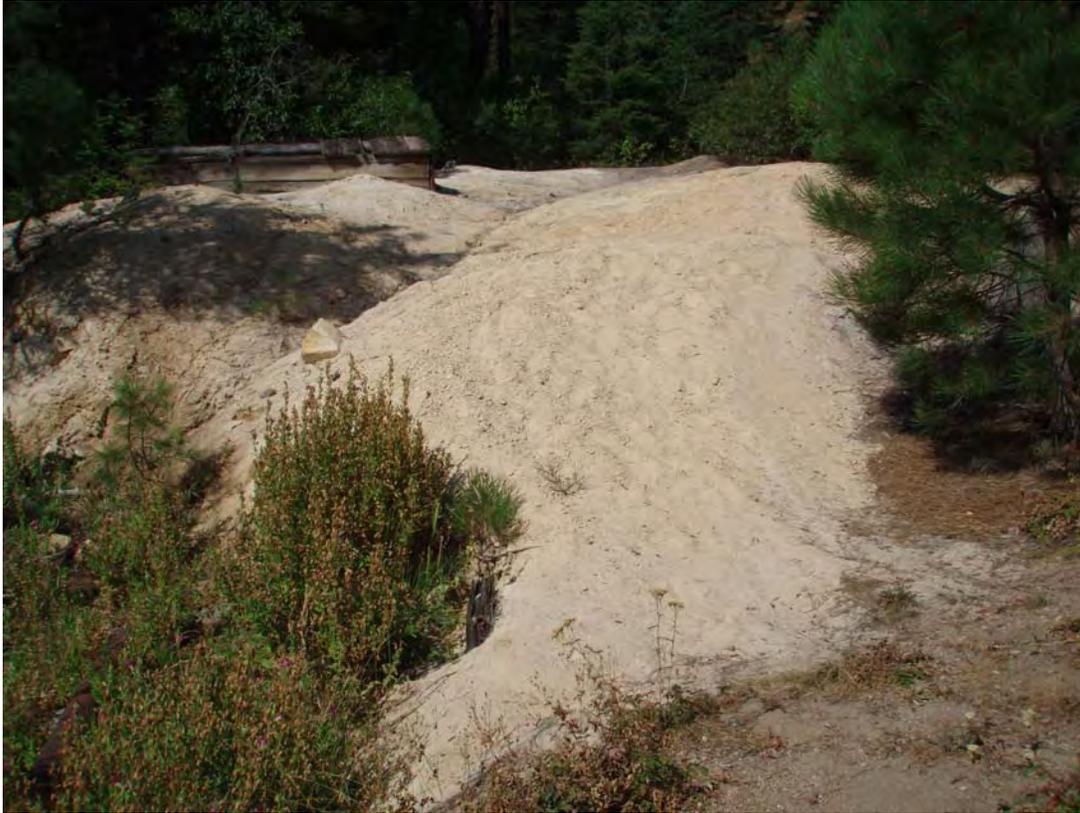
Photo 17

Sample **BS-MT-SS1** was a composite sample collected from the jig tailings pile in the Camp Area, just above Fall Creek. Concentrations of heavy metals included total arsenic, total cadmium, total lead, total mercury and total silver which exceeded IDTLs. Concentration of total arsenic exceeds HHSLs. Total concentrations of arsenic, cadmium, lead, mercury and silver significantly exceed background soils concentrations.

View to west; Jig tailings pile, Fall Creek at lower left

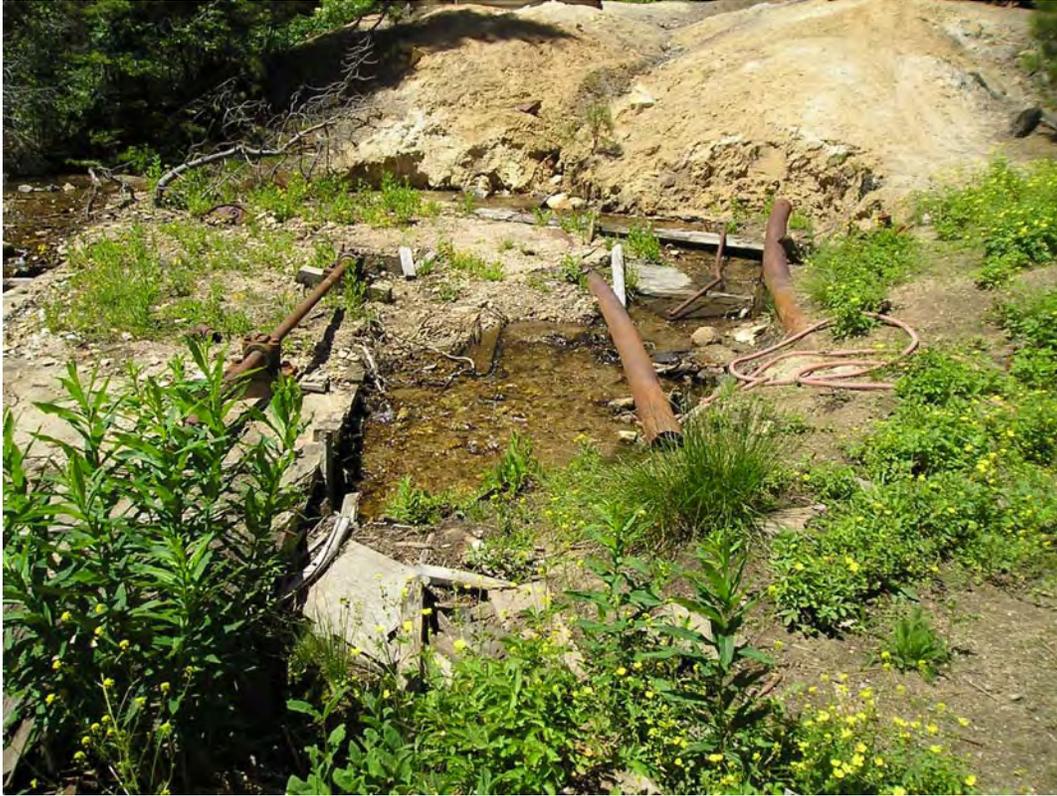
Photo 19

Mill tailings and waste dumps through which Fall Creek is incising are major sources for metals laden sediment production. Two predominant mechanisms for sediment production were noted. First the waste and tailings are subject to rapid spring runoff from both the mill site and the mine adit locations. Second, sediment is mobilized as Fall Creek incises the dumps located on its banks.

View to east; Fall Creek under-cutting Jig tailings pile, debris in stream

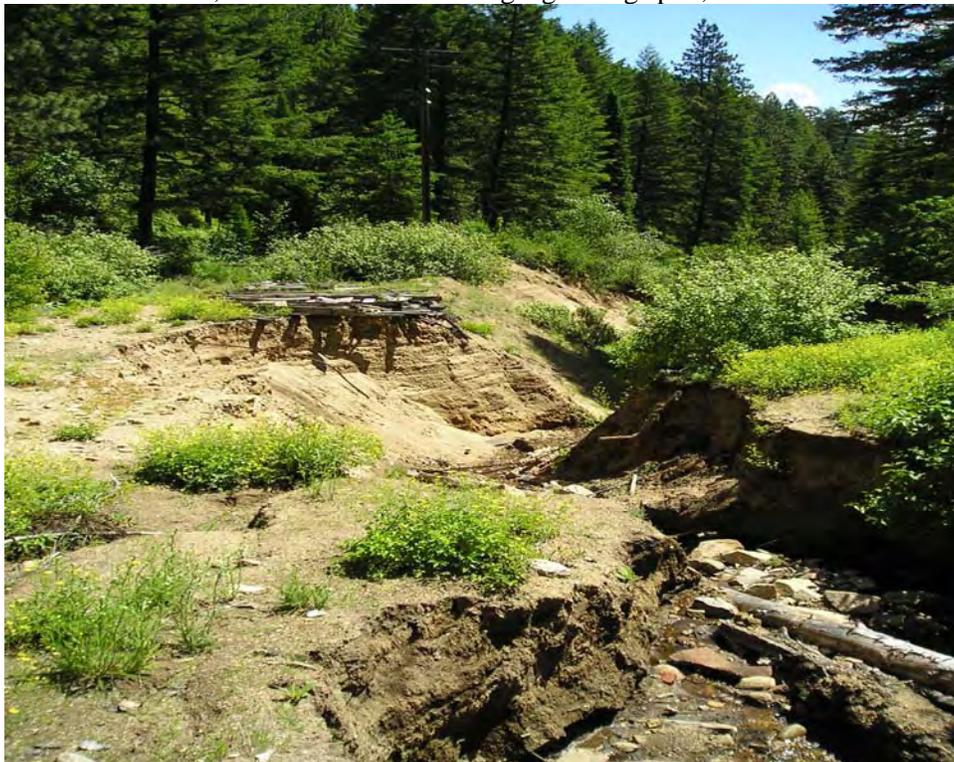
Photo 20

View to southeast, Fall Creek incising tailings and sediment

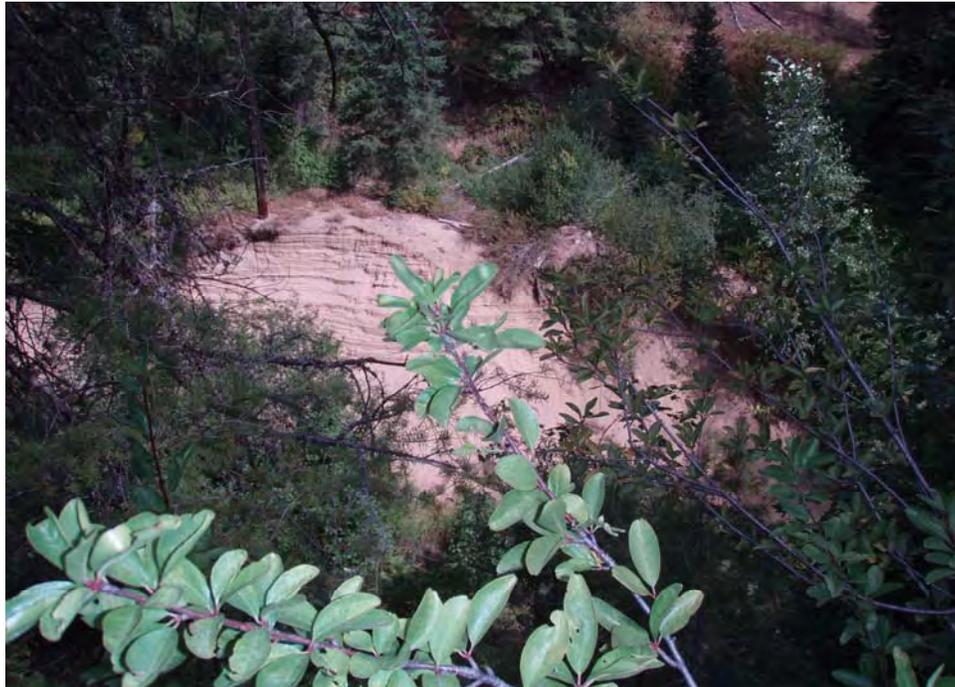
Photo 21

View to south; tailings or sediment below waste dump #1

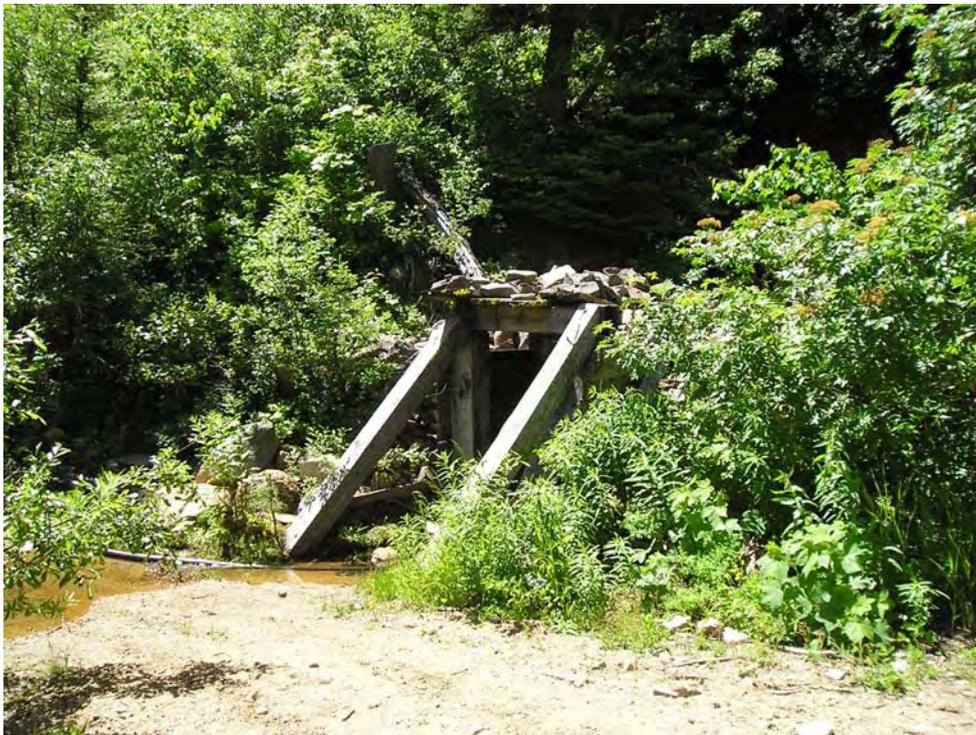
Photo 22

View to south; Adit # 1 portal, discharging to left

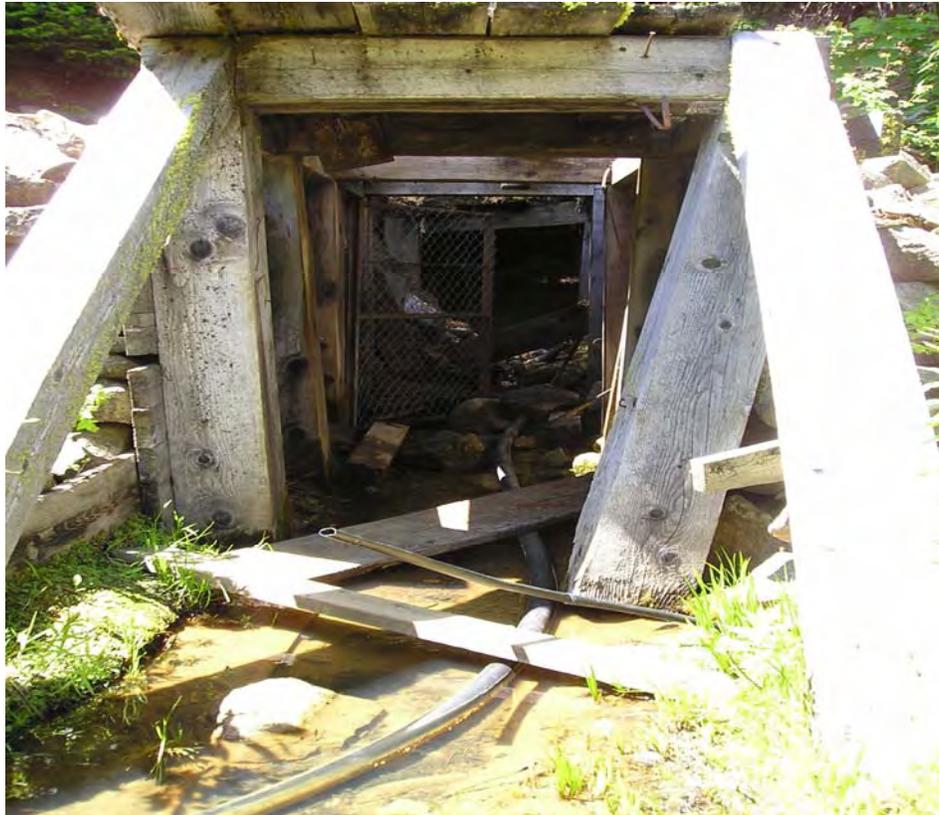
Photo 23

View to southwest; Adit # 1 portal, rock & timbers in tunnel, mostly caved

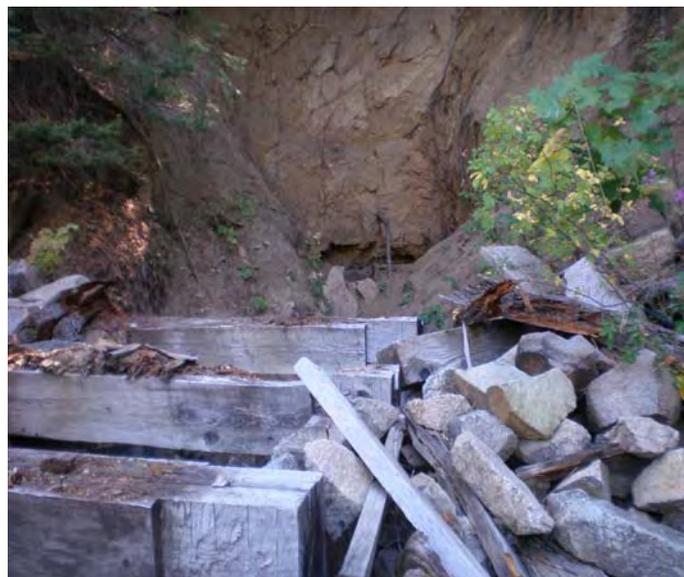
Photo 24

View to southwest; Adit # 1, caved back of portal, tunnel open at outcrop face

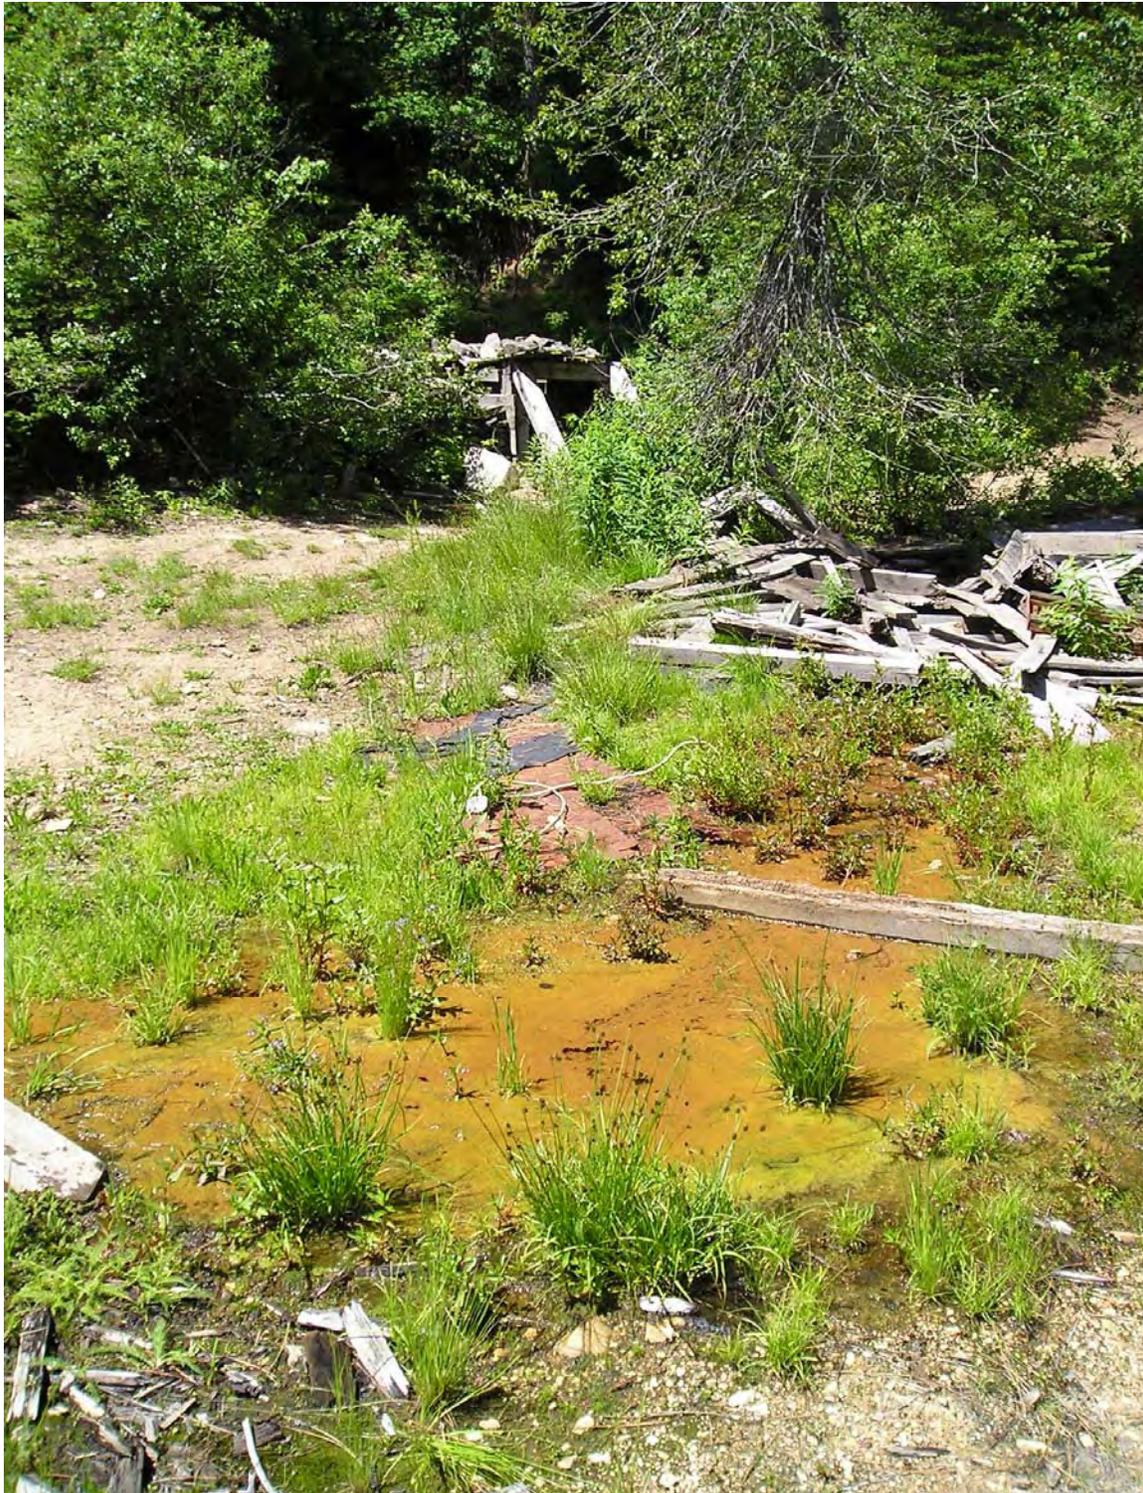
Photo 25

View to west-southwest; Adit #1 (upper center), discharge through collapsed shed (?)

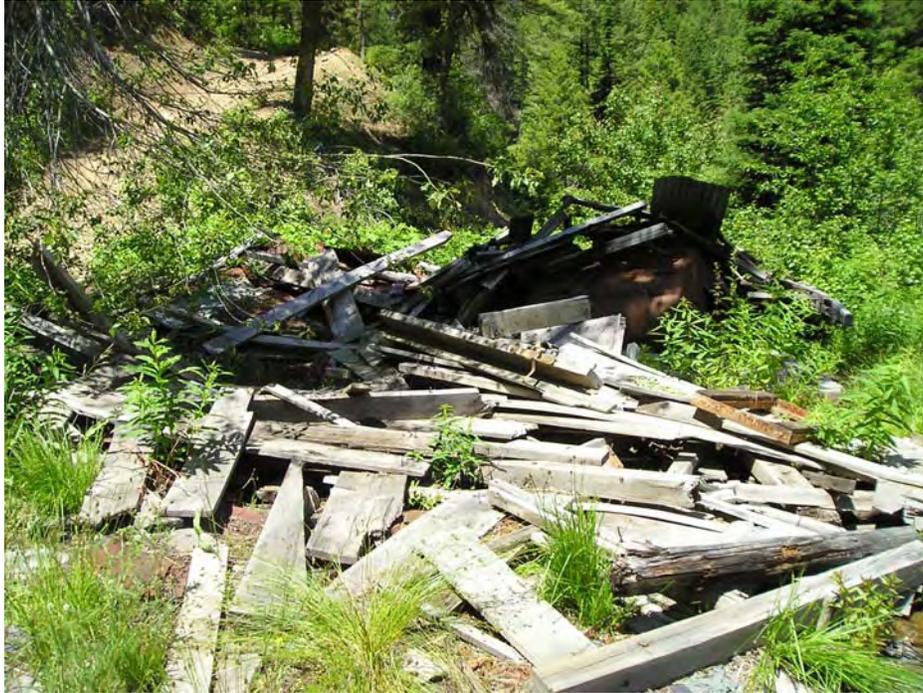
Photo 26
View to west; collapsed shed near Adit # 1

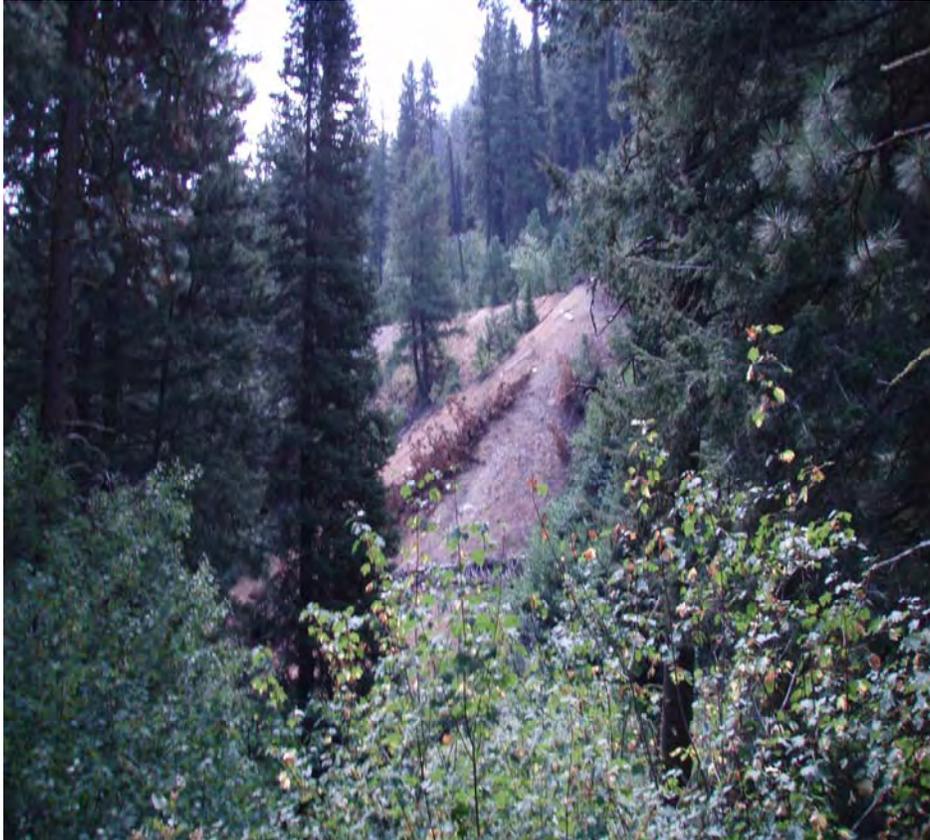
Photo 28

Waste rock provides a foundation for a bench on which there were a number of mine buildings, including the upper mill site. The waste rock is dominated by quartz monzonite porphyry, which is coarsely grained and contains minor fines. The eastern limb extends beyond the mill site to the east, though some of the waste rock may have partially supported the structure. Waste rock is evident on the north bank of the creek and may be a continuation of the dump, which at one time probably dammed up the creek. The western limb fronts the adit and trends toward the creek. The two limbs are separated by 80 meters over which a trestle ran from the portal to the mill. Scattered remains of timber supports and track along the dump slope are present. Assorted metal debris and an empty storage tank were observed near the portal. Small trees and brush are established on the landing and to a lesser extent across the dump slope. The vegetation did not appear stressed. A representative soil sample was collected from the western limb [BS-WD1-SS1].

Waste Dump # 1: Excess cancer risk for all residential and non-residential receptors is greater than the acceptable level of $1E-05$, as defined by the REM. The construction worker receptor is slightly less than the acceptable level. The non-cancer hazard is greater than the acceptable level (Hazard Index = 1) for a receptors.

View to southeast; Waste Dump # 1

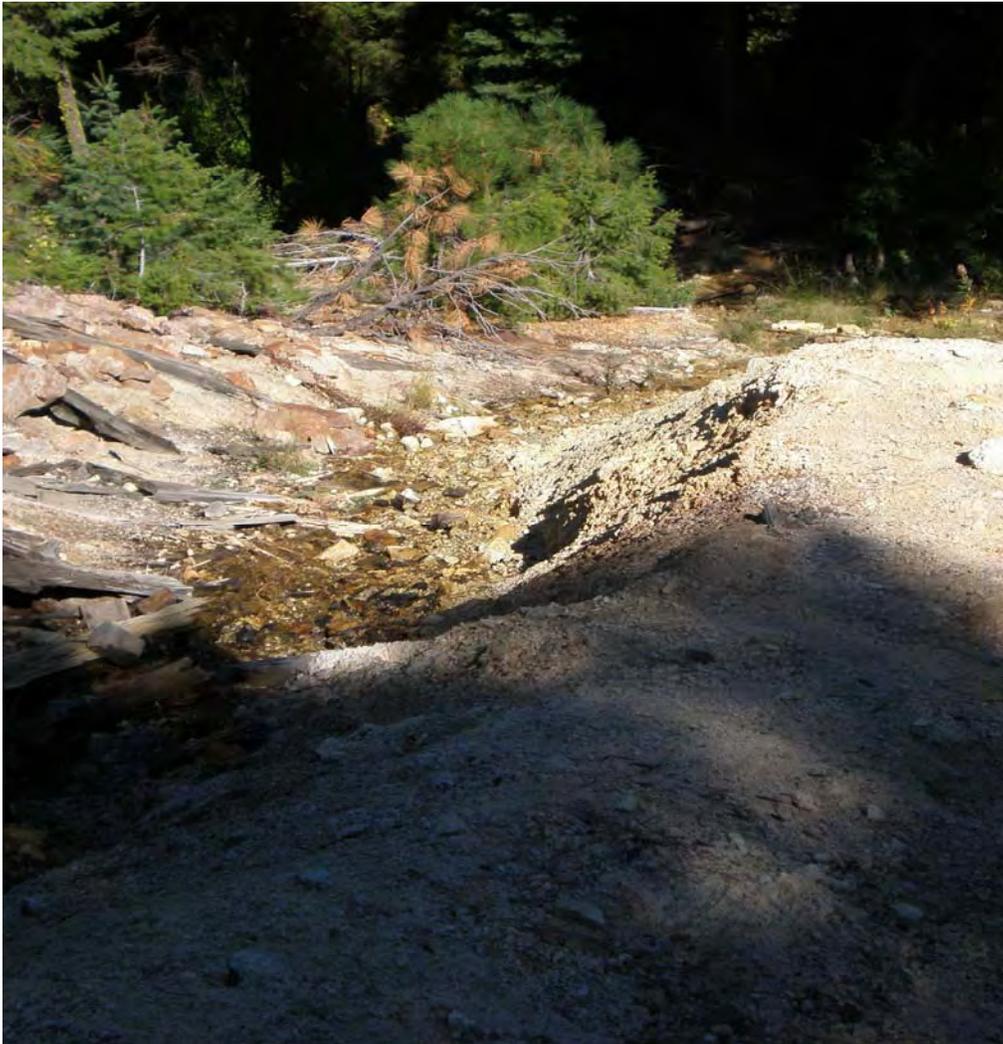
Photo 30

View to north; Adit #1 discharge incising Waste Dump # 1, Fall Creek (upper)

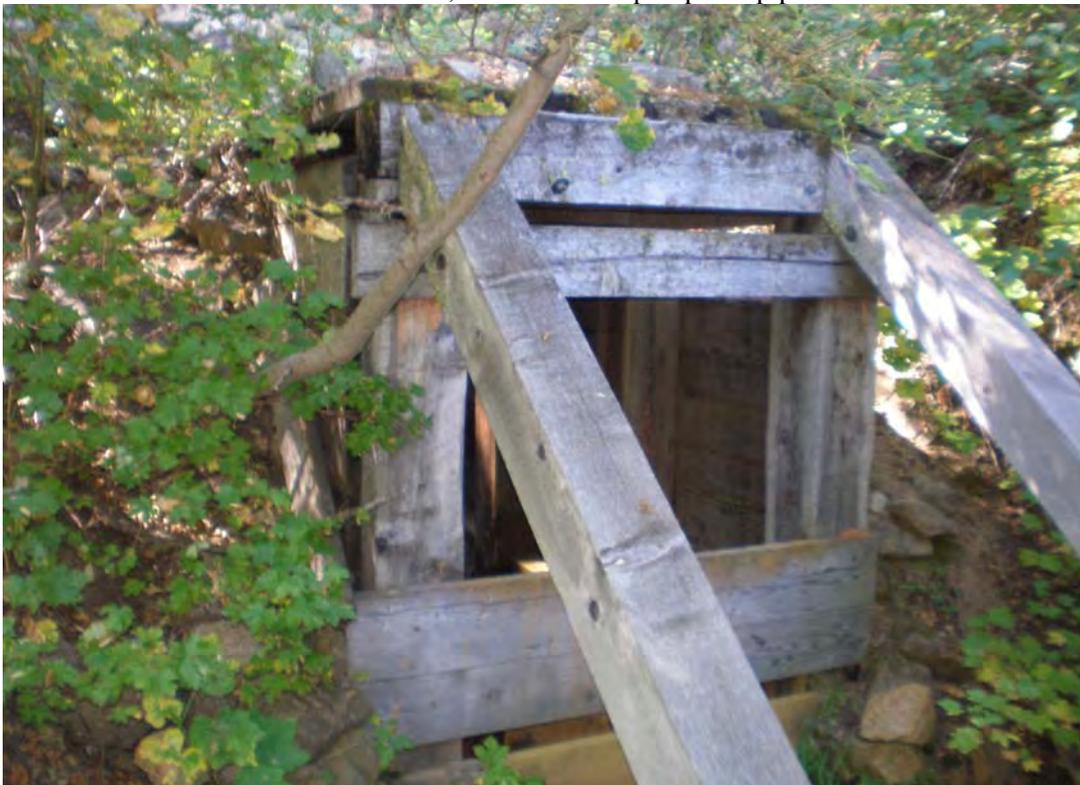
The timbered portal is in fair condition, a few boards partially bar entrance to the tunnel. When viewed from the portal, some of the cribbing in the tunnel had fallen from the back and ribs. Pyrite was observed in the muck at the portal. Approximately 10 gpm of water was discharging onto the landing. Iron-stained precipitate borders the water's course across the landing and road into the south side of the dump, where it apparently infiltrates. Thick vegetation is supported and does not appear stressed. A surface water sample was collected at the portal [BS-PPE-SW2]. The adit water was not observed to resurface, either along the toe of the dump or from the adjacent ground.

Photo 36
View to west, Adit # 2 portal

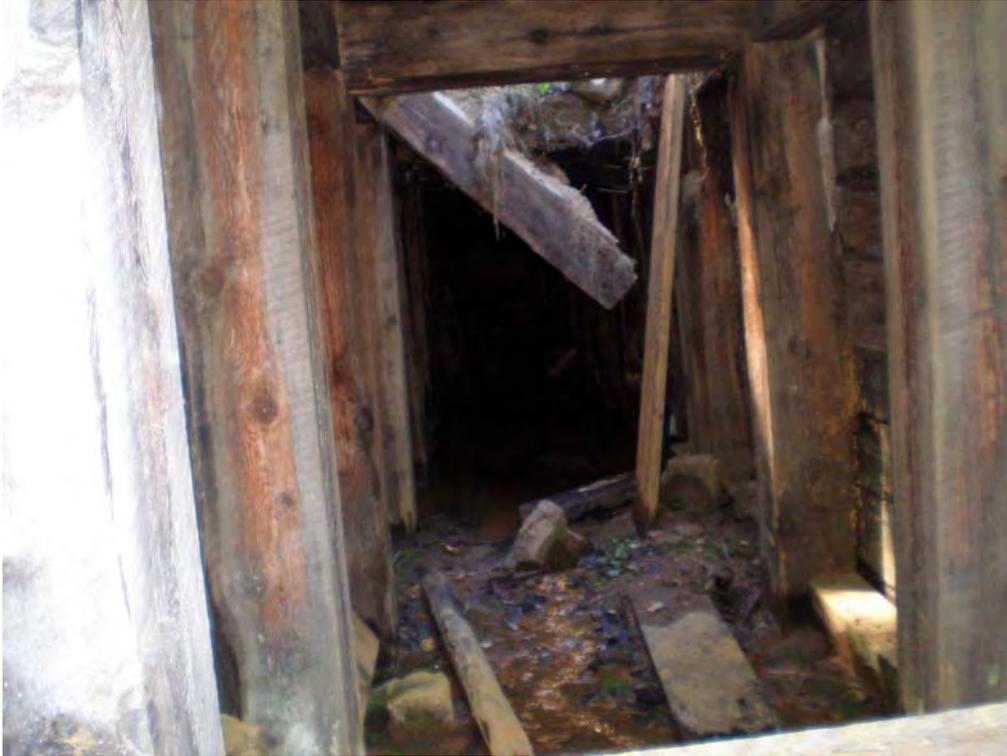
Photo 37

Close-up into Adit # 2 portal, discharge (lower center), abundant pyrite in muck

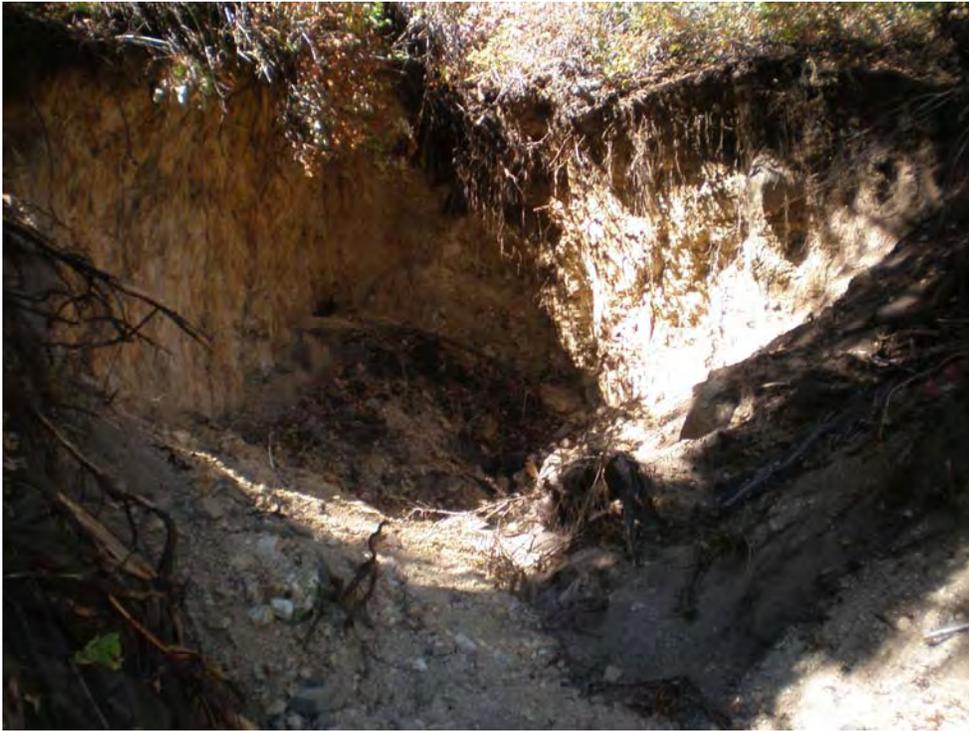
Photo 39

The adit is caved, and waste rock was dumped immediately outside of the portal. The waste dump is small, estimated to contain <150 cubic yards of material. The dump is dominated by quartz monzonite porphyry with disseminated pyrite. Remnant tracks protrude from the collapsed adit onto the dump, minor solid waste was noted. A red wheelbarrow seemingly in perfect condition was observed near the toe of the dump. Because there was no surface water or direct connection between this dump and the perennial stream, and because the dump was so small Waste Dump #3 was not sampled.

View to northwest; caved Adit # 3, waste rock piled in front of adit
