**SKYLARK MINE
PRELIMINARY ASSESSMENT REPORT
CUSTER COUNTY, IDAHO**

**STATE OF IDAHO
DEPARTMENT OF ENVIRONMENTAL QUALITY**

October 2003

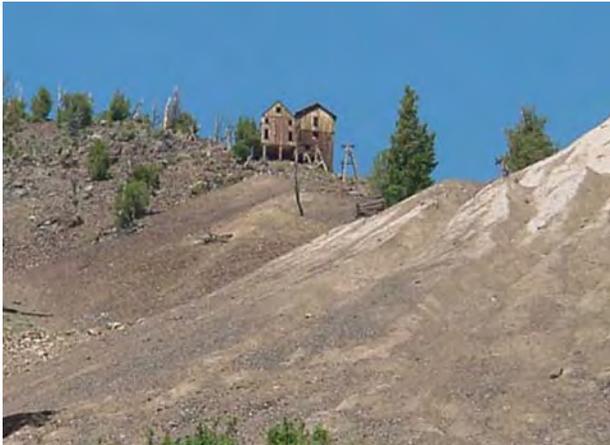
Bunkhouse, tramway loading shed (top center)

- Photo 1 View to north uphill from Ramshorn Mine, bunkhouse, tram head-station and loading shed (top center).
- Photo 2 View to east, Skylark structures (top left). Note: steep slope.

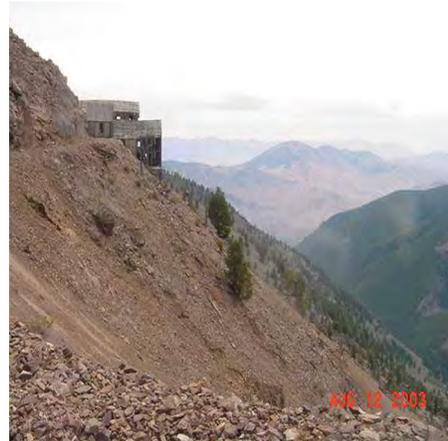
Photo 2

View to east, bunkhouse (top left).

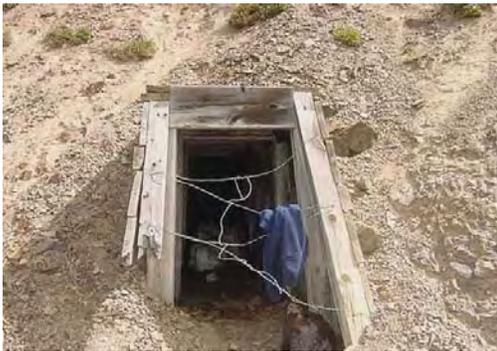
View to north, middle adit, wire barrier

- Photo 3 View to north, middle adit portal, wire barrier.
- Photo 4 View to north, portal interior, open door to tunnel, remnant snow (center).
- Photo 5 View to northwest from upper adit's waste rock dump, shed debris (foreground), collapsed adit (lower left), prospects and minor waste rock dumps (upper left near trees).

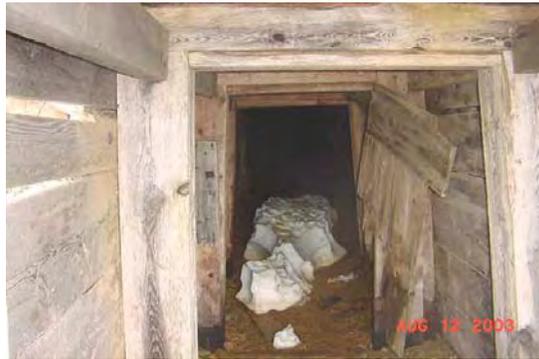
Photo 4

Portal interior, open door, remnant snow

Soil survey data was compiled by the USGS for the site is unavailable, but direct observation indicates medium to fine-grained silty-sand exists in shallow horizons across the slopes. The slopes are otherwise covered with slate rock talus. Based upon direct observation of snowmelt within the middle adit and the absence of adit drainage, a moderate to high infiltration rate is expected.

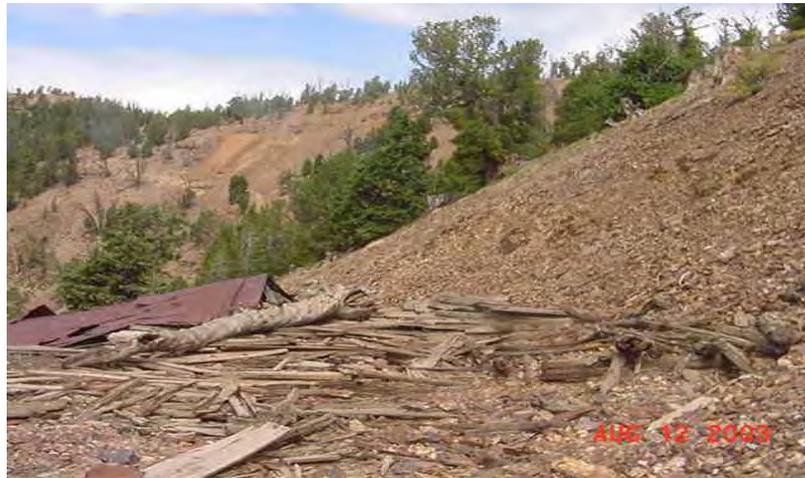
Photo 5

Approximately 200 feet east, another collapsed adit was identified. This adit is referred to as the “upper adit”. A waste rock dump, measuring approximately 400 cubic yards, held the remains of a portal shed. The road switched back at this point, continuing uphill where three prospects were identified. Two of the prospects were collapsed while the third was open. The westernmost prospect appeared the largest with a waste rock dump measuring approximately 50 cubic yards. The road continued beyond the prospects toward Keystone Mountain. Although other prospects may be located above these prospects, DEQ did not investigate the upper reaches, further.

Collapsed adit at lower right, shed debris at center, prospects at upper left

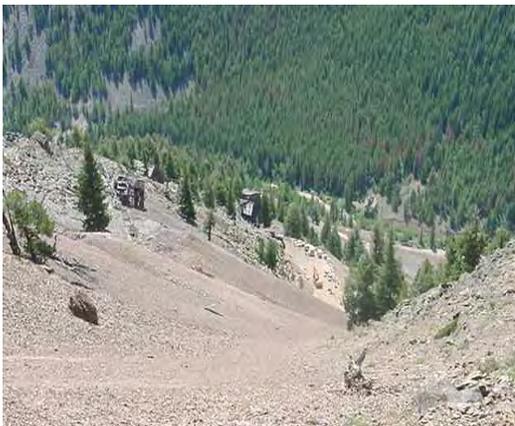
Photo 6

View of Ramshorn Mine - upper adit

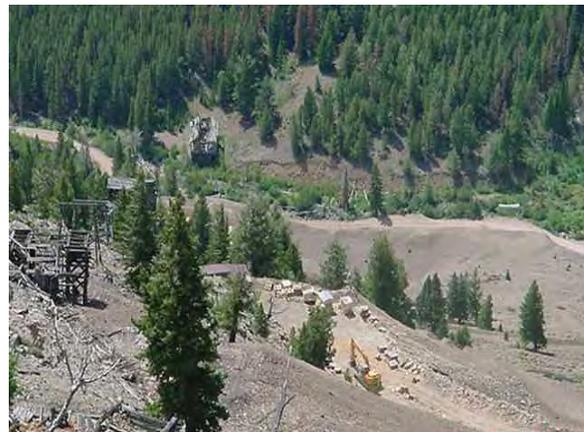
Photo 7

Close-up view of The Rock Works' operation

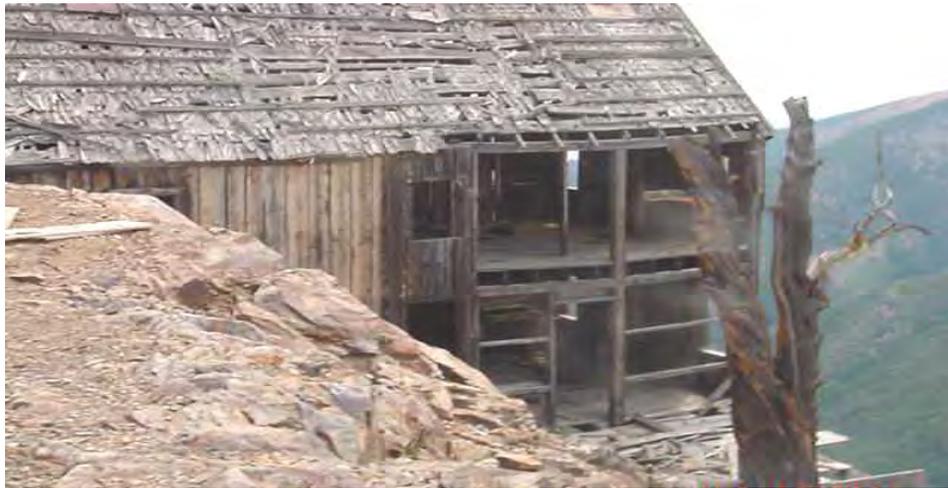
Photo 8

The bunkhouse and tramway loading shed were constructed on outcrops of Ramshorn Slate and were buttressed by pilings. One room that appears to have been the kitchen is still equipped with a wood-cooking stove.

Close-up of bunkhouse, kitchen on lower level at right

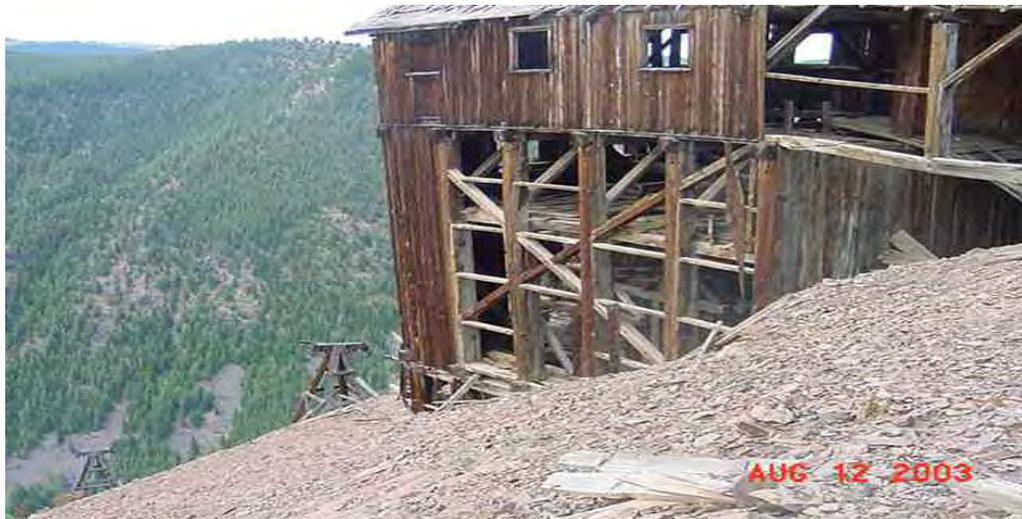
Photo 9

The tram head-station and ore loading shed are located adjacent to the bunkhouse. The tramway, which also connects to the Ramshorn Mine, terminates at the Skylark. The head-station’s gears were visible, though most of the rigging appeared in poor condition.

View to southwest, tram head-station (lower level), ore sorting and loading areas (upper level), tramway cable supports at lower left
