**HANSY MINE  
PRELIMINARY ASSESSMENT REPORT  
SHOSHONE COUNTY, IDAHO**

**STATE OF IDAHO  
DEPARTMENT OF ENVIRONMENTAL QUALITY**

**December 2004**

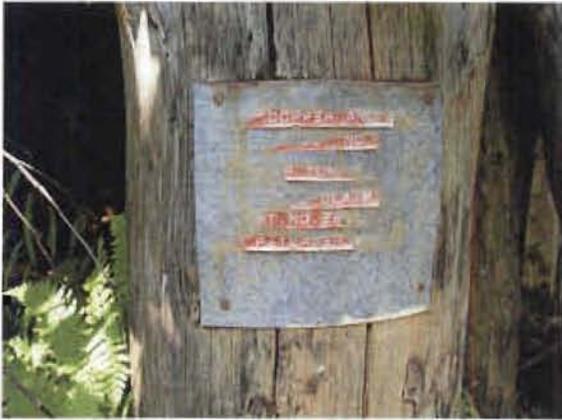
**Photo 1**  
Close-up of identification marker outside Adit No. 1.

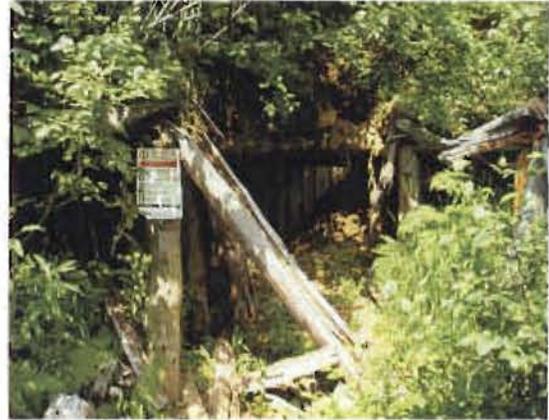
Arriving on site at 10:45 a.m., DEQ first came to Adit No. 1 which had a partial collapse of its portal. A heavy wooden and locked gate blocked the entrance. A claim notice/location marker and warning signs were posted and clearly visible. The marker was heavily weathered and appeared to read: “HANSY COPPER AND GOLD / MINES, INC. / \_\_\_\_R TUNNEL \_\_\_\_ / \_\_\_\_ CLAIM / PAT. NO. 26 \_\_\_\_ / SAM PETERSON, \_\_\_\_.” Across (east) from the adit and on the western bank of the Olentangee Creek was the waste rock dump and the remains of an ore bin. A small amount of water discharge was coming from the adit and pooling on the road. The flow was insufficient enough to reach the creek and appeared to be subsiding into the waste rock dump. The discharge rate was estimated to be at or less than 2 gallons per minute. The waste rock dump was estimated to be approximately 100’ long x 50’ wide x 15’ high. The exposed portion of the dump, adjacent to the creek, appeared to have weathered to red ferrous staining. A total of six (6) samples were collected from the adit discharge, the waste rock dump, and from Olentangee Creek above – at and below the waste rock dump (Figure 2-4).

**Photo 2**  
Opening to Adit No.1 with warning sign and identification marker.

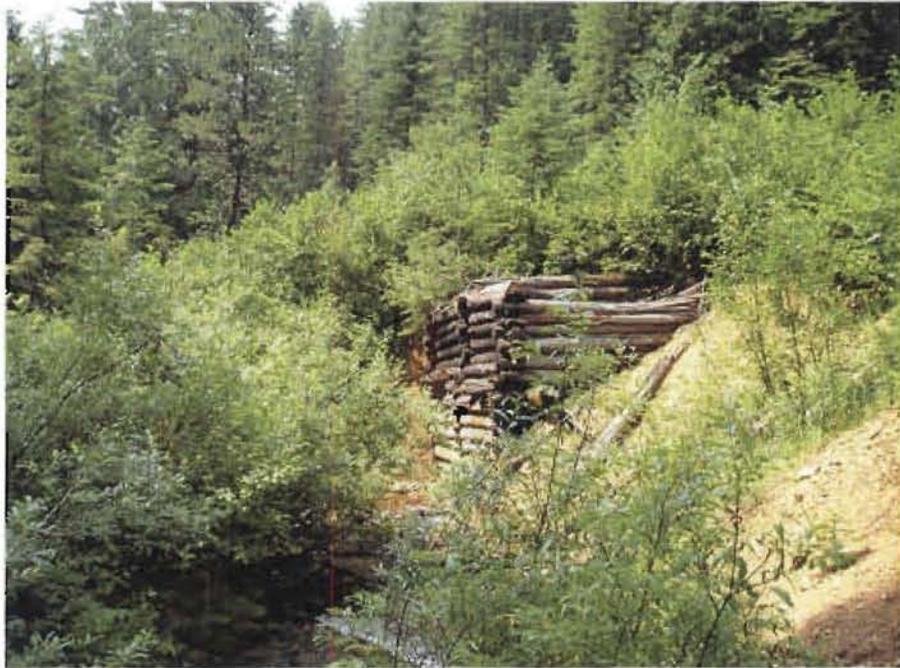
**Photo 3**  
Looking south down Olentange Creek along the eastern edge of the Adit No.1 waste dump, with the log ore bin in center of photograph. Sample H-5 was collected from the creek approximately 15 feet downstream from the ore bin. Sample No. H-6 collected from the waste pile to the adjacent to the ore bin, next to the rotting log.

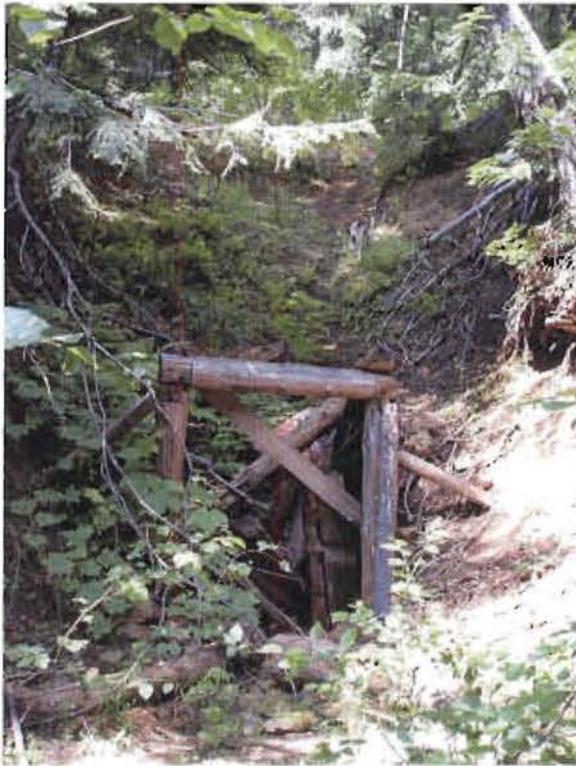
**Photo 4**

Looking west at the portal to Adit No.2. This tunnel is completely collapsed.

Hansy4	Looking west at the portal to Adit No.2 – This tunnel is completely collapsed. No discharge noted from this adit.
Hansy5	Close-up of the collapsed entrance to Adit No. 2 – Drum is empty.
Hansy6	Looking west at the sloughed slope caused by the collapse of Adit No. 3 – View is from the main road (below Adit No. 3) and looking uphill.
Hansy7	Looking southwest from the end of Prospect Cut #4.
Hansy8	Looking northwest at the opening of Adit No. 6.
Hansy9	Looking down at the opening to Adit No. 6 – A 4” rock dropped into the opening and was heard rolling and traveling for a long period of time suggesting a downward sloped tunnel.
Hansy10	Looking south from the opening to Adit No. 6 – This is Prospect Cut #2.
Hansy11	Looking down from the opening to Adit No. 6 – Prospect Cut #2 in background.

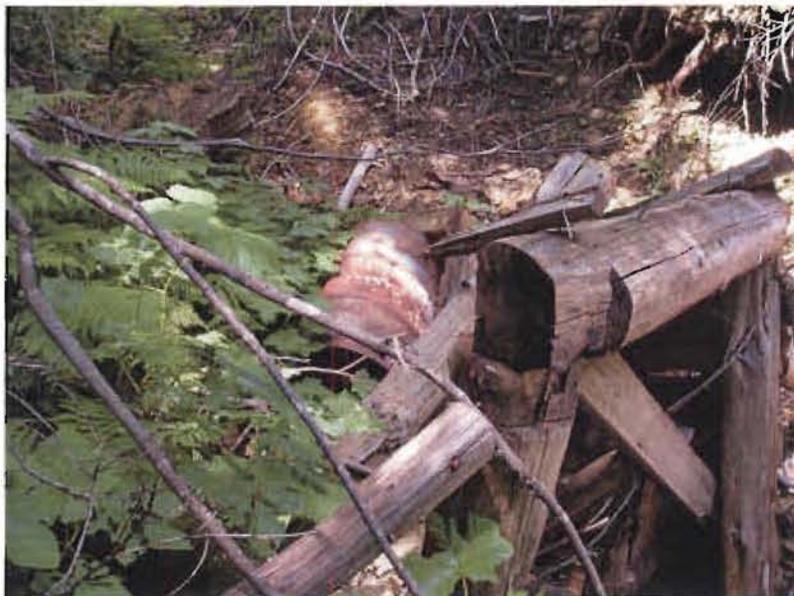
**Photo 5**

Close-up of the collapsed entrance to Adit No. 2. Drum is empty.

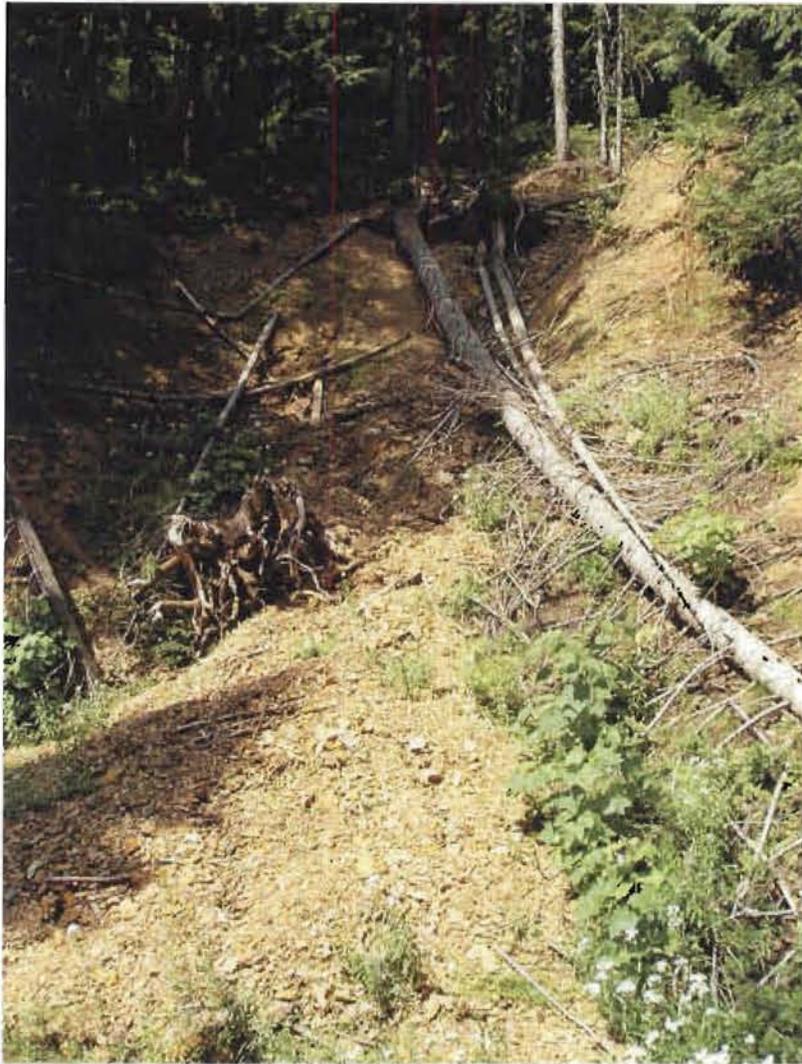
**Photo 6**

Looking west at the sloughed slope caused by the collapse of Adit No. 3. View is from the main road (below Adit No. 3) and looking uphill.

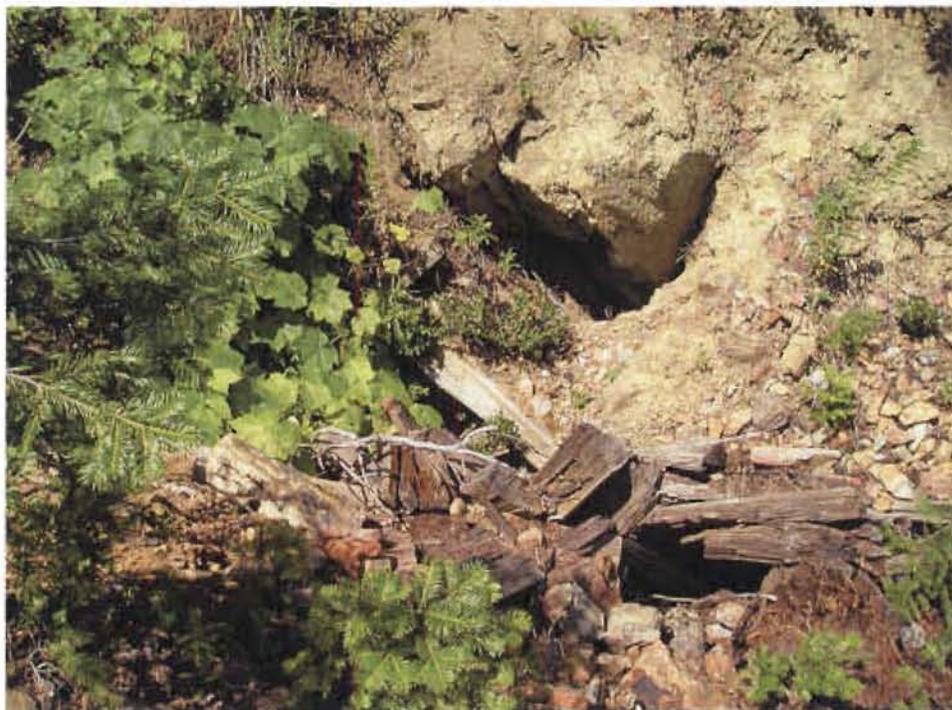
**Photo 8**

Looking northwest at the opening of Adit No. 6, just above the pile of timbers.

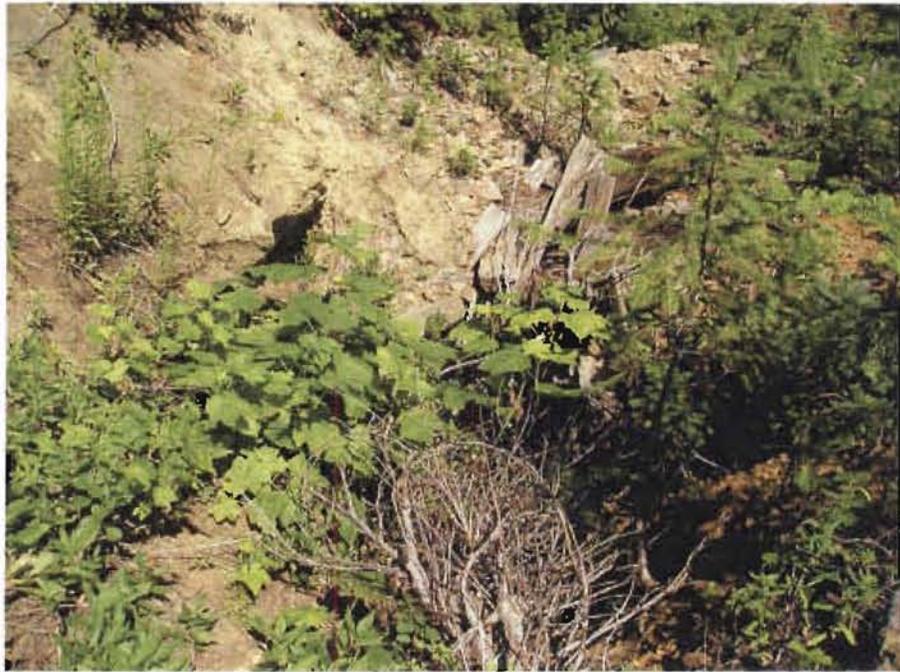
**Photo 9**

Looking down at the opening to Adit No. 6. A 4-inch rock dropped into the opening was heard rolling and traveling for an extended length of time suggesting a downward sloped tunnel.

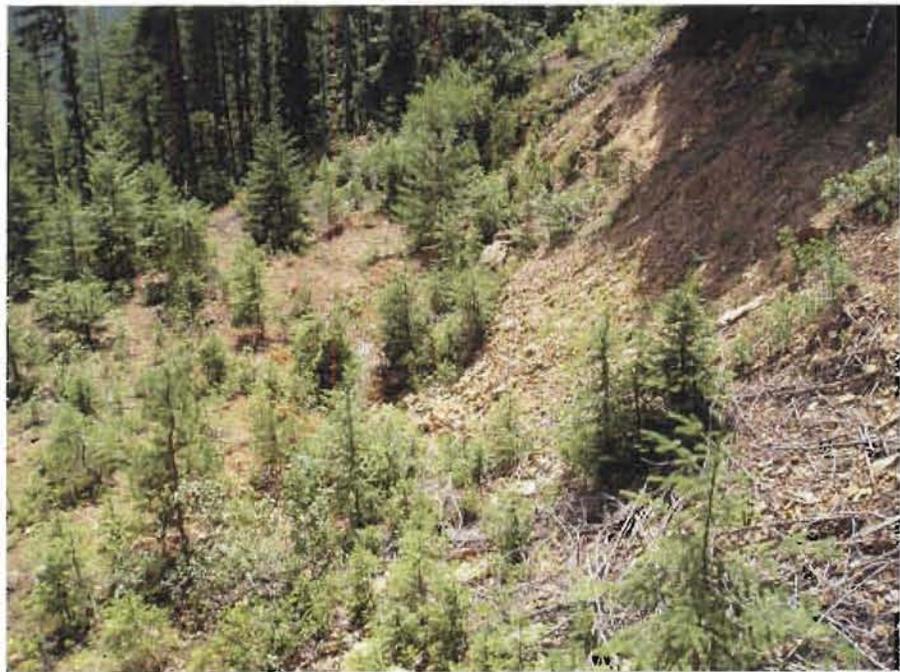
**Photo 10**

Looking south from the opening to Adit No. 6. Area identified as Prospect Cut No. 2.

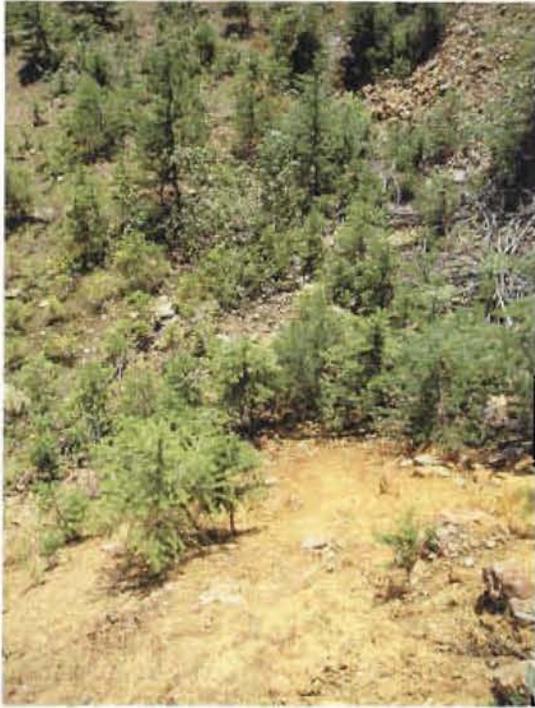
**Photo 11**  
Looking down from opening to Adit No. 6.  
Prospect Cut No. 2 in background.

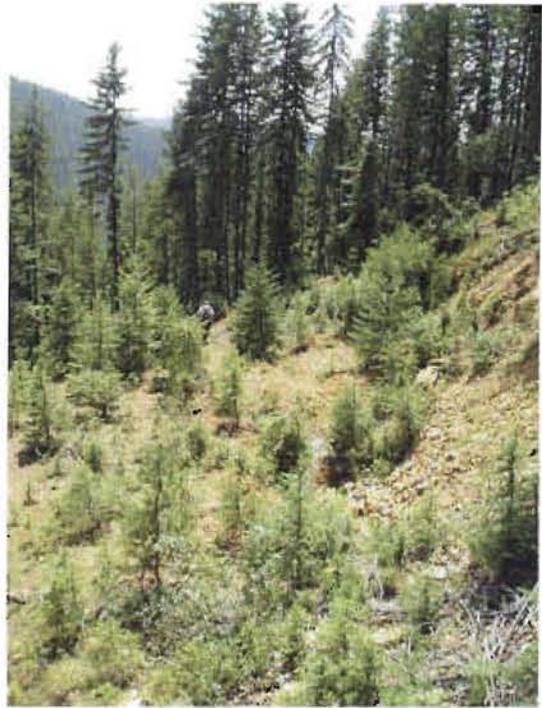
**Photo 12**  
Looking south. Long view of Prospect Cut  
No. 2

- Hansy12 Looking south – Long view of Prospect Cut #2.
- Hansy13 Close-up of Adit No. 5 entrance – Opening is large enough for human entrance. Note the piled debris at the entrance with fallen timbers on the inside.

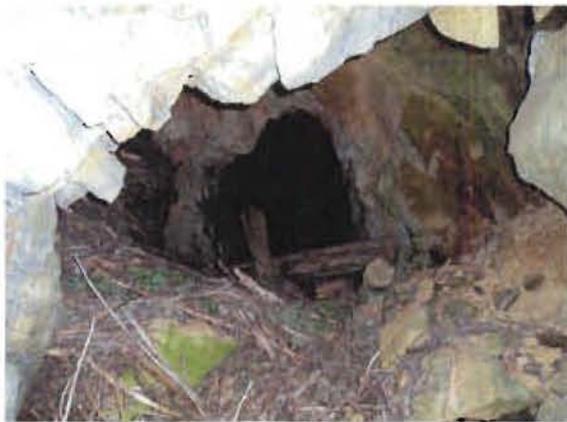
**Photo 13**  
These photos are of the Adit No. 5 portal. Opening is large enough for human entrance. Note piled debris at the entrance, with fallen timbers on the inside. Mine access warning poster to the left of the opening had been vandalized, and discarded away from the adit.

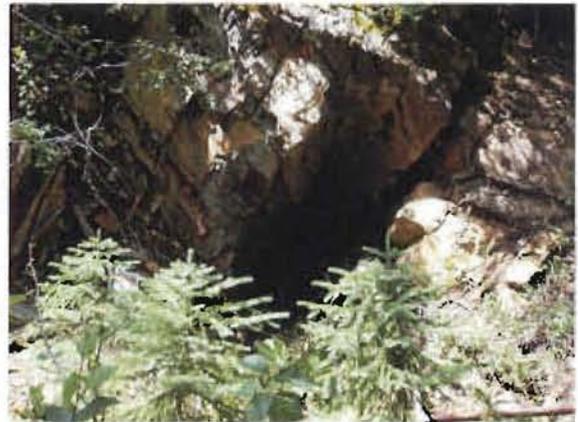
**Photo 14**

- Hansy14 Looking northwest at Adit No. 5 entrance – Mine access warning poster to the left of the opening had been vandalized and discarded away from the adit.

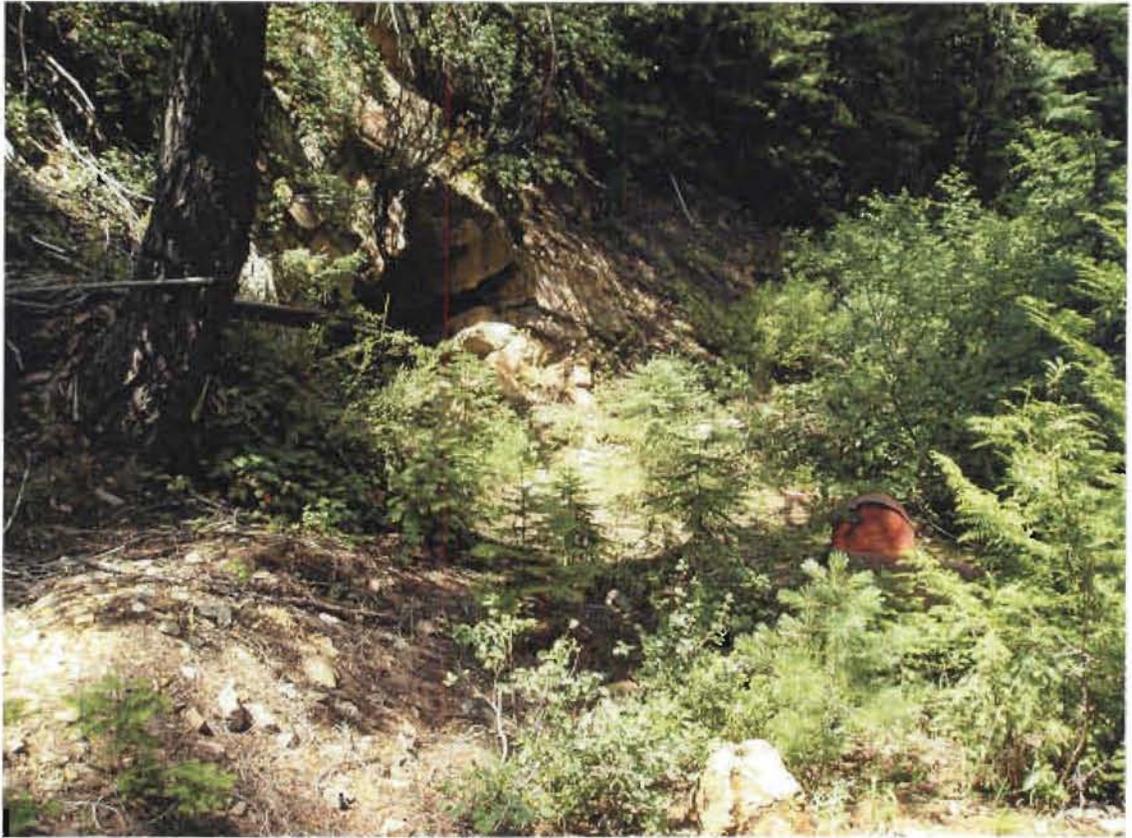
**Photo 15**

Looking north across waste rock dump from Adit No. 5 (in the center-left of photograph). The red, 55-gallon drum and rust-brown, 55-gallon drum in front of it are empty.

- Hansy15 Looking north across waste rock dump from Adit No. 5 (in the center-left of photograph) – The red, 55-gallon drum and rust-brown, 55-gallon drum in front of it are empty.

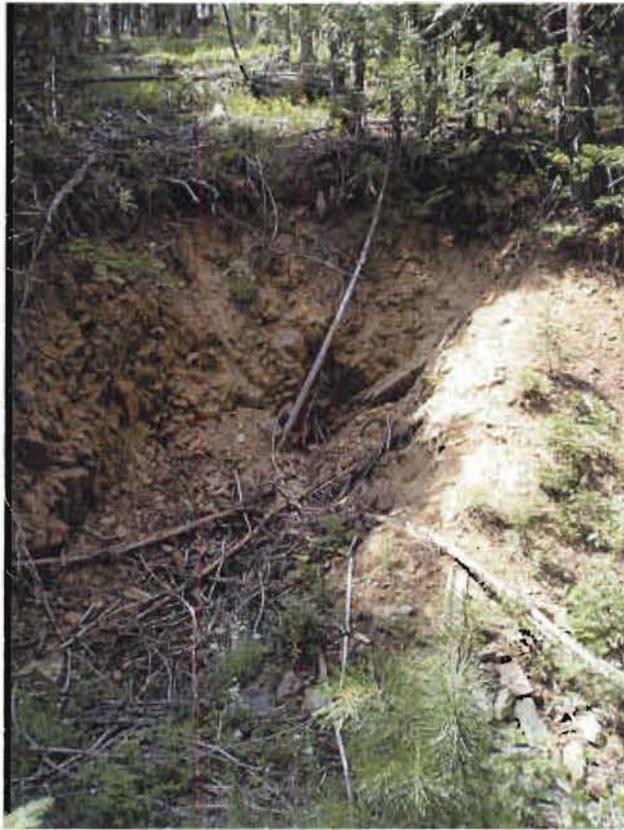
**Photo 16**

Looking northwest at Adit No. 4. Note slumped materials. Adit opening is in center.

- Hansy16 Looking northwest at Adit No. 4 – Note slumped materials. Adit opening is in center of photograph.
- Hansy17 Looking south at the deck of railroad ties (center of photograph) located at Adit No. 4 – Note the section of rails beyond the stacked ties. The rails extended from Adit No. 4, across the landing and out over the waste rock dump (see photos Hansy19 and Hansy20).

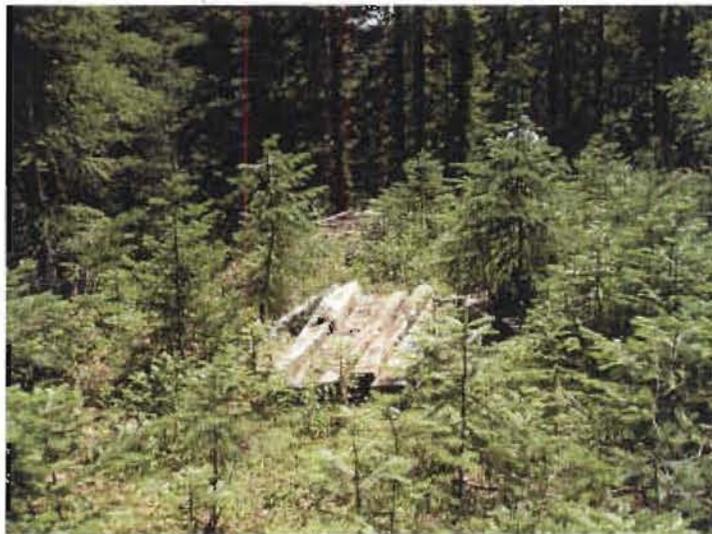
**Photo 17**

Looking south at the deck of railroad ties (center of photograph) located at Adit No. 4. Note the section of rails beyond the stacked ties. The rails extended from Adit No. 4, across the landing, and out over the waste rock dump.

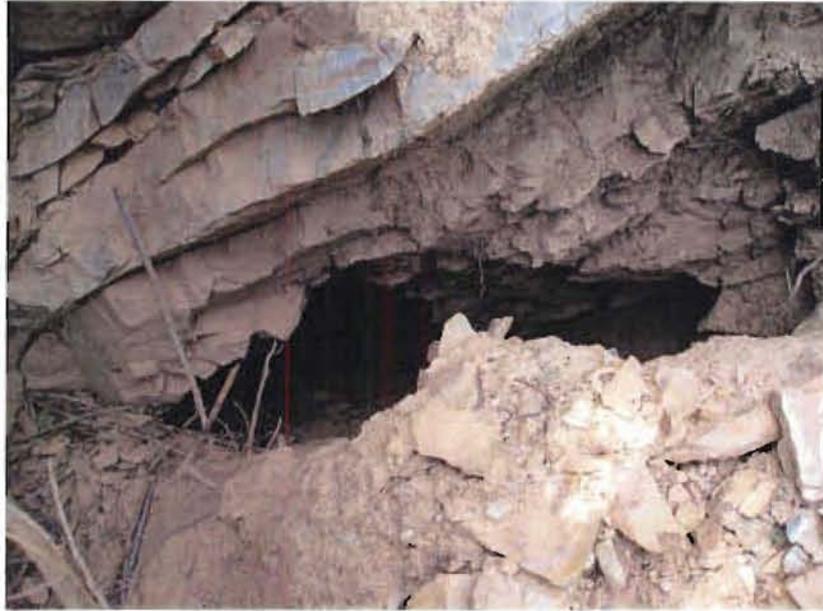
**Photo 18**

Close-up of the opening to Adit No. 4. Note slumped/collapsed debris at the entrance. There appeared to be less material obstructing the entrance than noted by IGS.

- Hansy18 Close-up of the opening to Adit No. 4 – Note the slumped/collapsed debris at the entrance. There appeared to be less material obstructing the entrance than the 1998 inspection by J. Kauffman.

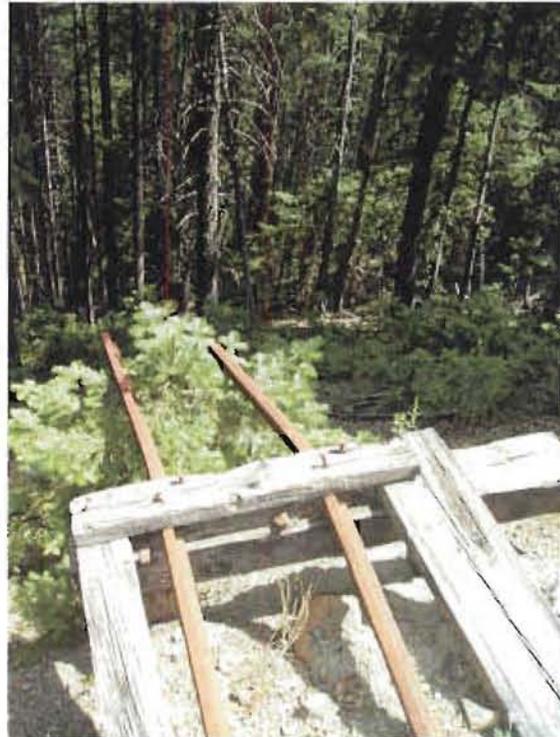
**Photo 19**

Close-up of the rails extending out over the edge of the waste rock dump.

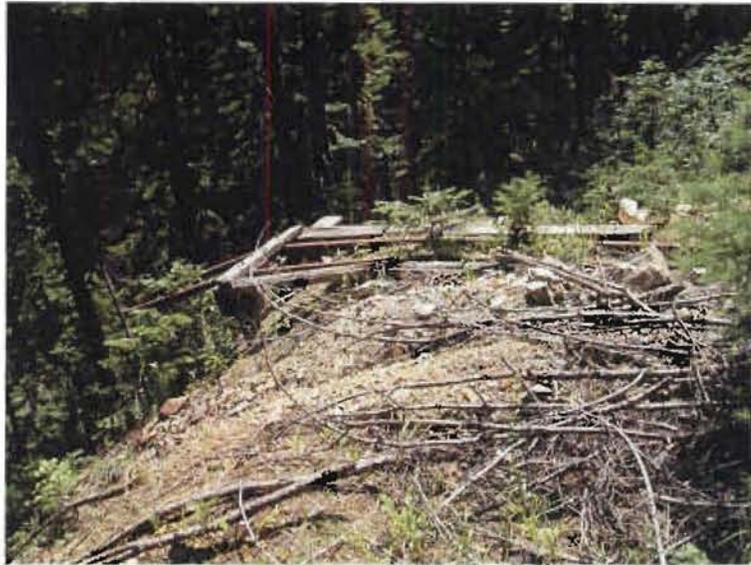
**Photo 20**

Wider view of the rails extending out over the edge of the Adit No. 4 waste rock dump.

- Hansy19 Close-up of the rails extending out over the edge of the waste rock dump – Looking east.
- Hansy20 Wider close-up of the rails extending out over the edge of the waste rock dump – Looking south.

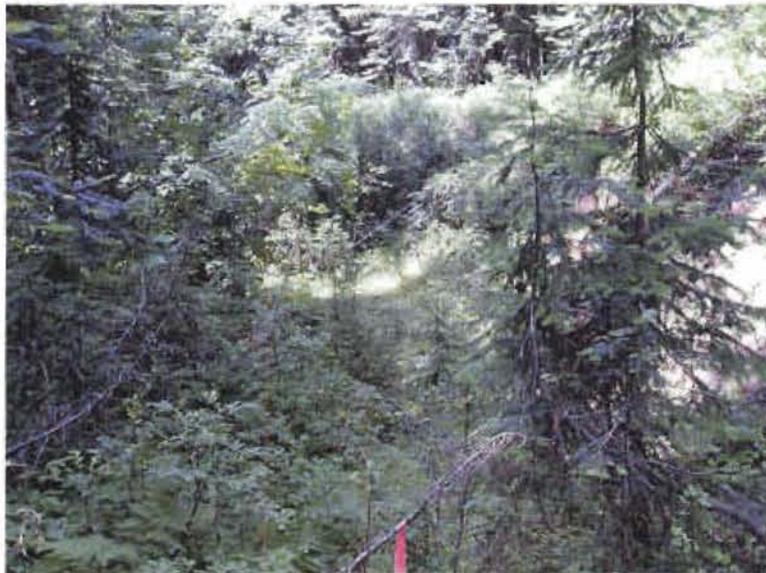
**Photo 7**

Looking southwest from the end of Prospect Cut #4.
