Subject: Abbreviated Preliminary Assessment for Hayfork Mine, Boise County, Idaho

**Abbreviated
Preliminary Assessment for
Hayfork Mine
(aka Humming Bird, Gold Bug Group, Switzerland,
Hercules, Black Eagle Group)**

September 2016

Date of Site Inspection: 6/2/2016

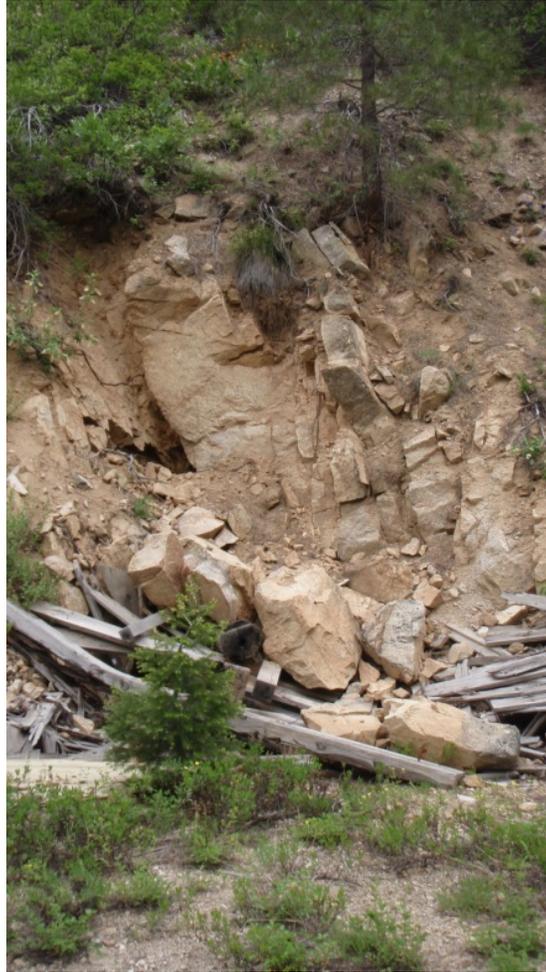
An adit at Site A (Figure 2) was partially collapsed with rock and wood. At the time of the site visit, no water or waste rock piles were present and the adit was accessible (Photos 1-2).

Photo 1. Partially collapsed adit surrounded by rock and wood debris.

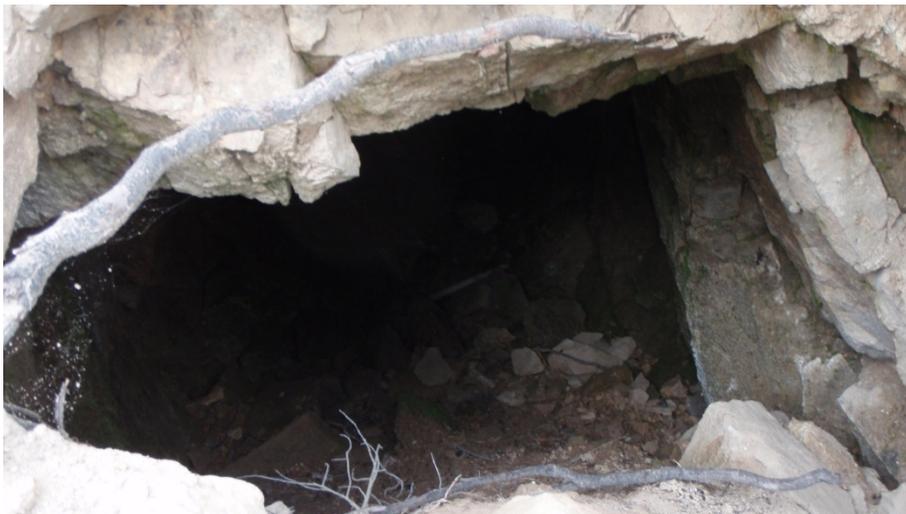
Photo 2. Close-up of the adit.

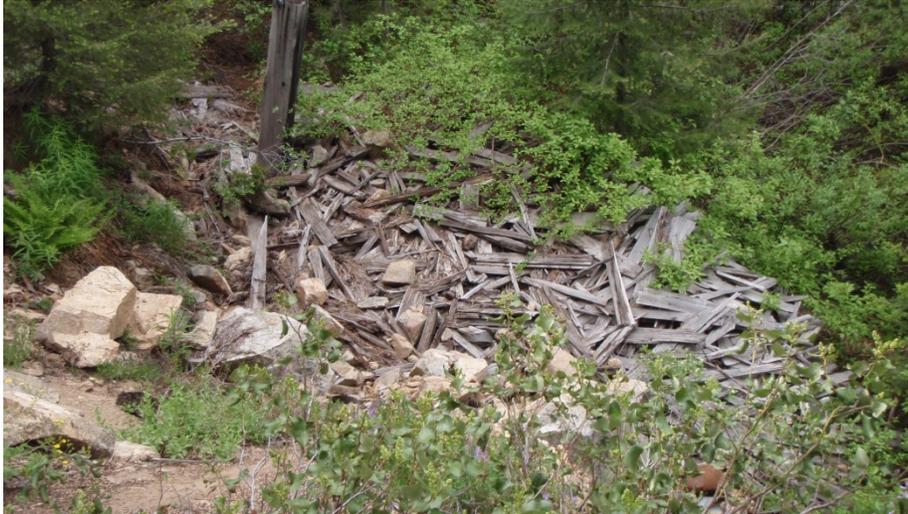
At the location of the former old mill site (Figure 2), no waste rock piles were observed. Remnants of the former mill include wood, rock, and rusty parts (Photo 3).

Photo 3. Location and remains of old mill site.

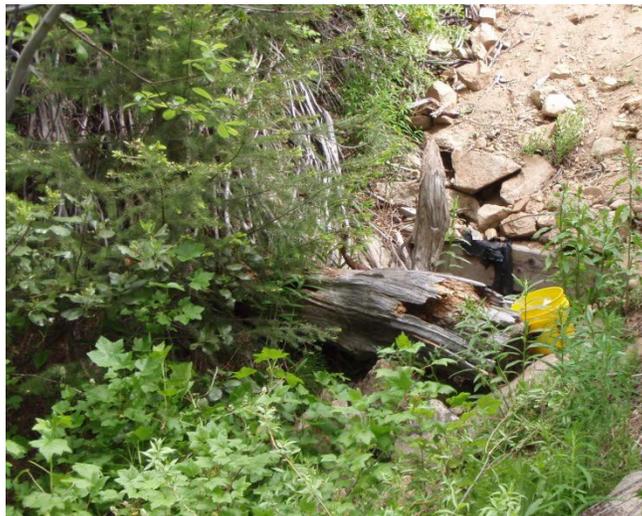
An adit located on the Gold Bug claim, just north of the former mill site (Figure 2), was mostly collapsed with a small amount of water originating from the adit opening. The surrounding area was covered with dense healthy vegetation (Photos 4-5).

Photo 4. Mostly collapsed adit located on the Gold Bug claim.

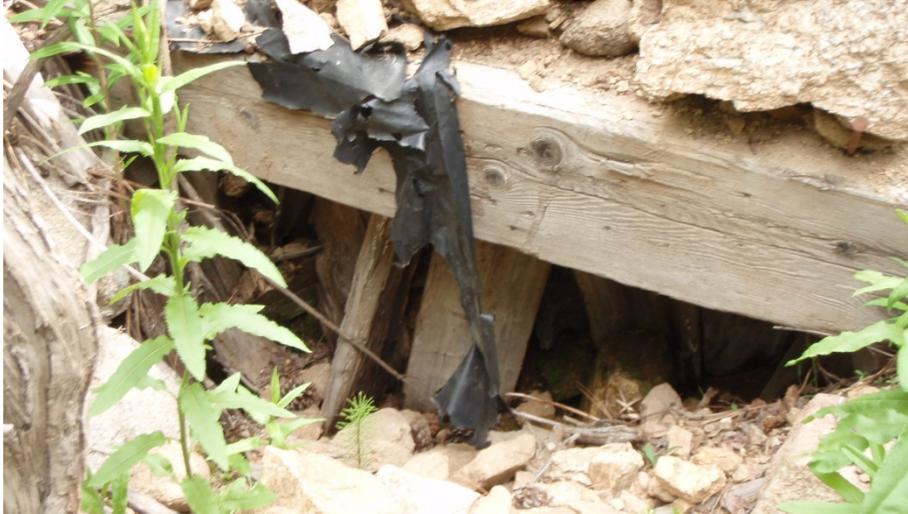
Photo 5. Close-up of adit.

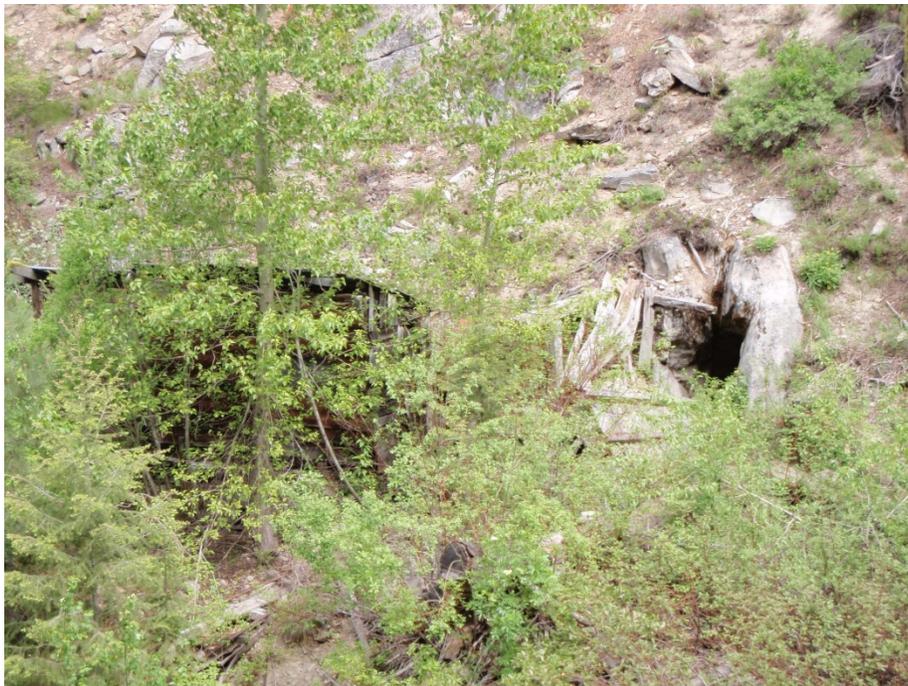
As identified in the IGS 1995 report, an old structure was observed on the Switzerland claim. Access to this structure and an open adit is limited because they are located on the other side of a creek (Photos 6-8) from the road with no bridges present in the area. A small waste rock pile is located to the east of the adit (Photo 9). No erosion from the waste rock pile was observed.

Photo 6. Old structure (left) and Switzerland adit (right).

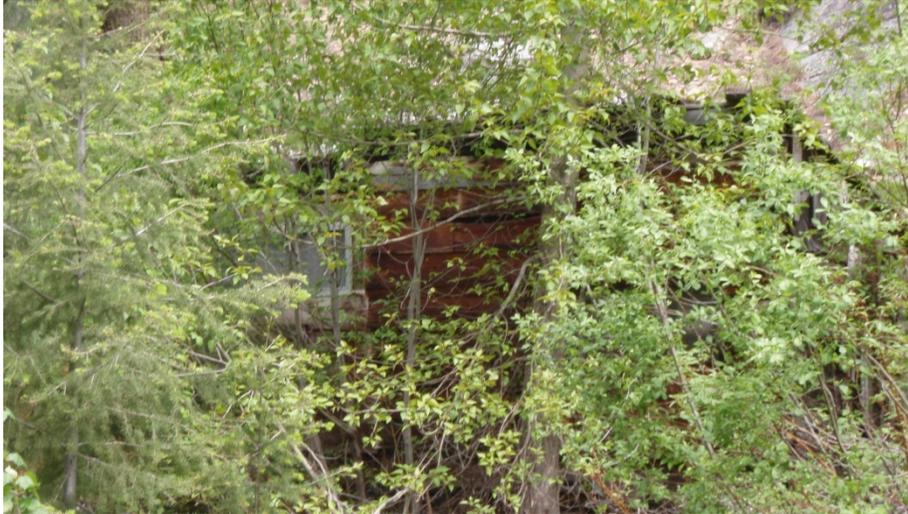
Photo 7. Close-up of old structure at Switzerland adit site.

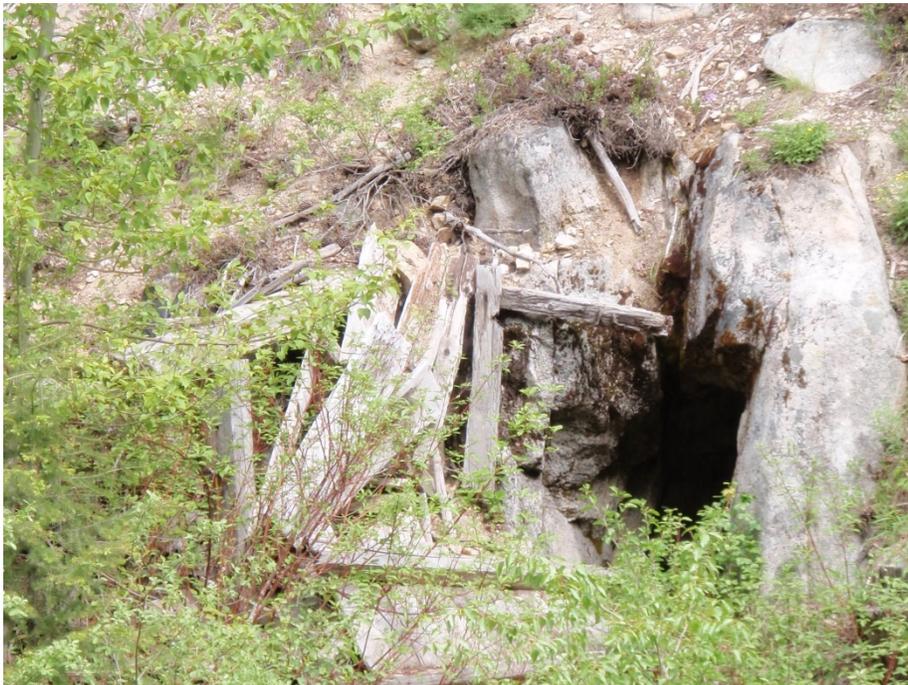
Photo 8. Close-up of Switzerland adit.

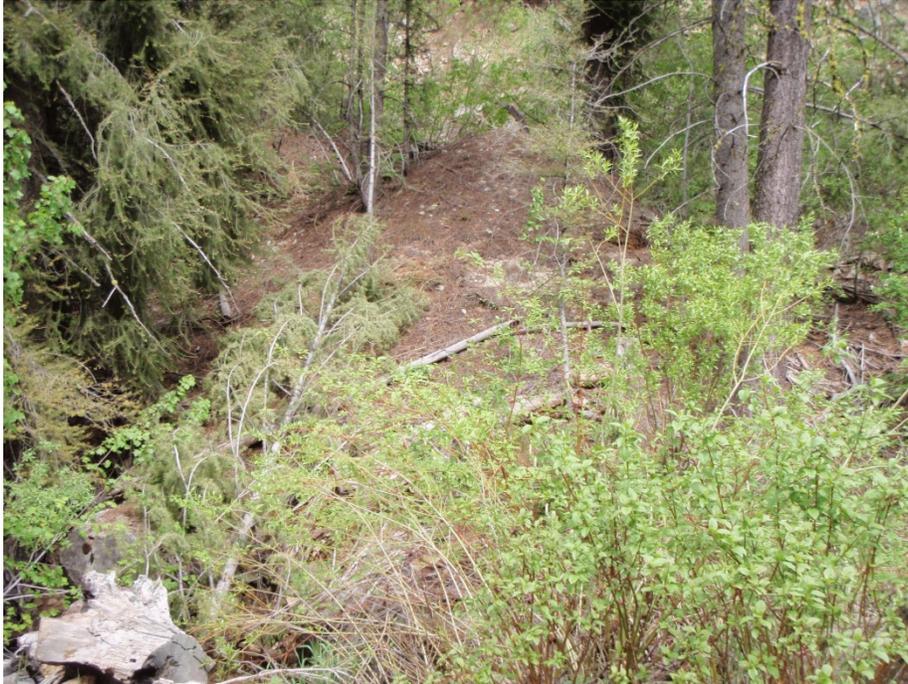
Photo 9. Small waste rock pile east of Switzerland adit.

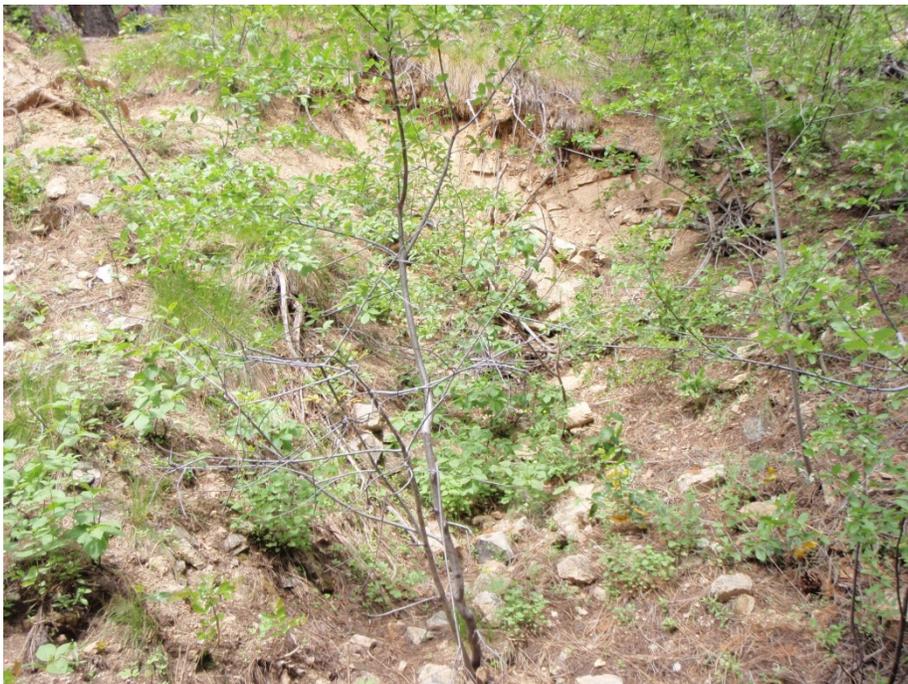
A well vegetated waste rock pile downhill from a collapsed hole/tunnel was visited on the Humming Bird claim. No openings were observed (Photos 10-11).

Photo 10. Location of old waste rock pile on Humming Bird claim.

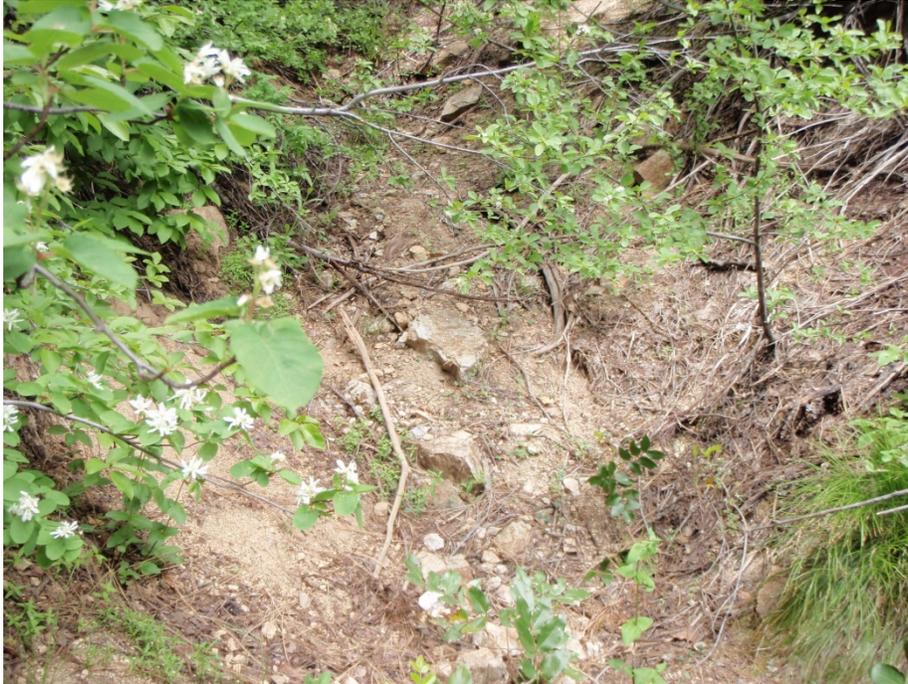
Photo 11. Collapsed hole or tunnel (no openings).

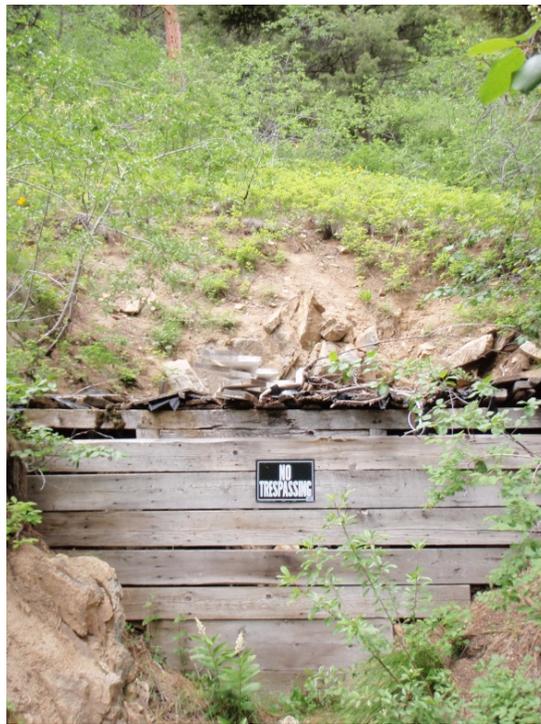
The Black Eagle site included a boarded up adit (Photo 12). No water originated from this adit. Approximately 30 feet in front of the adit is an old work shack remodeled into a cabin for summer time use; however, according to the landowner this cabin has not been used in recent years. It is built on a vegetated waste rock pile and tracks exiting the adit have been removed.

Photo 12. Boarded up Black Eagle adit.

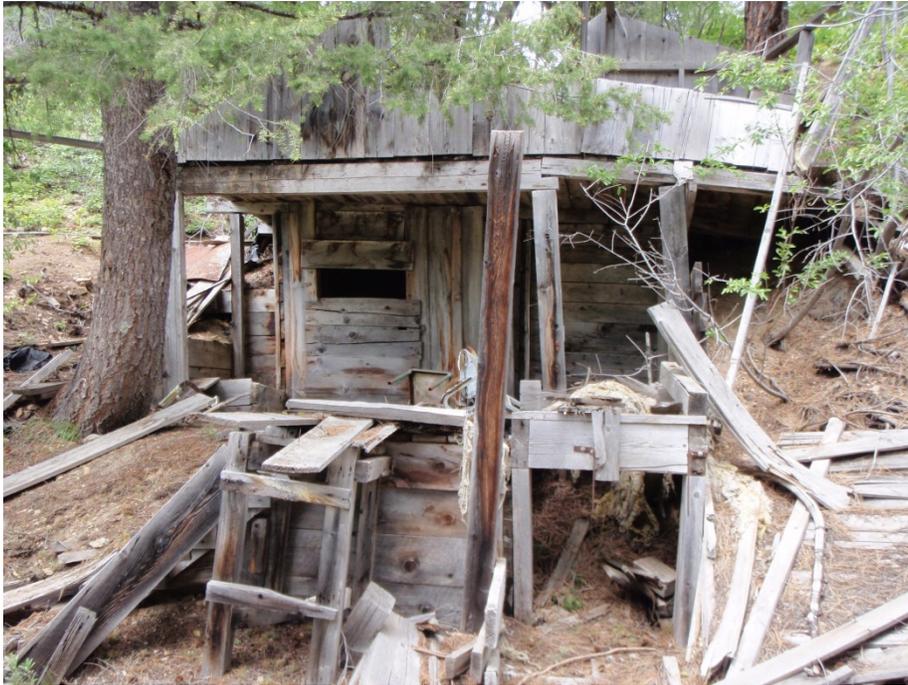
Based on information from the landowner, the Black Eagle site also includes a structure built in the 1980s to support prospecting. A tunnel located inside the old structure has caved in (Photos 13-14).

Photo 13. Structure at Black Eagle site.

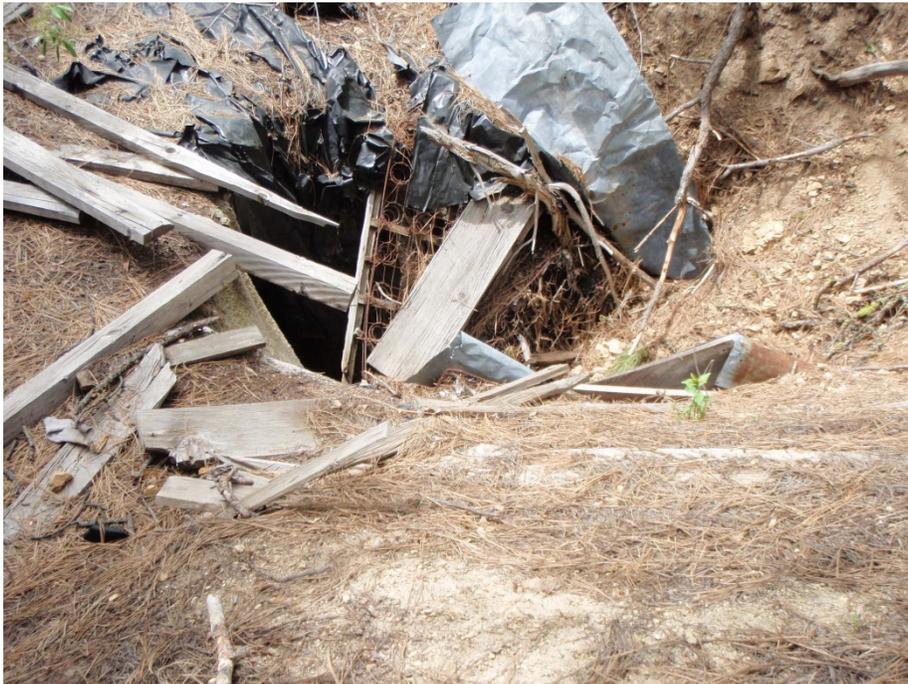
Photo 14. Collapsed tunnel on the back side of old structure.
