Preliminary Assessment and Site Inspection Report for the Gilmore Townsite Common Use Areas and Surrounding Lands

Lemhi County

**State of Idaho
Department of Environmental Quality**

February 2017

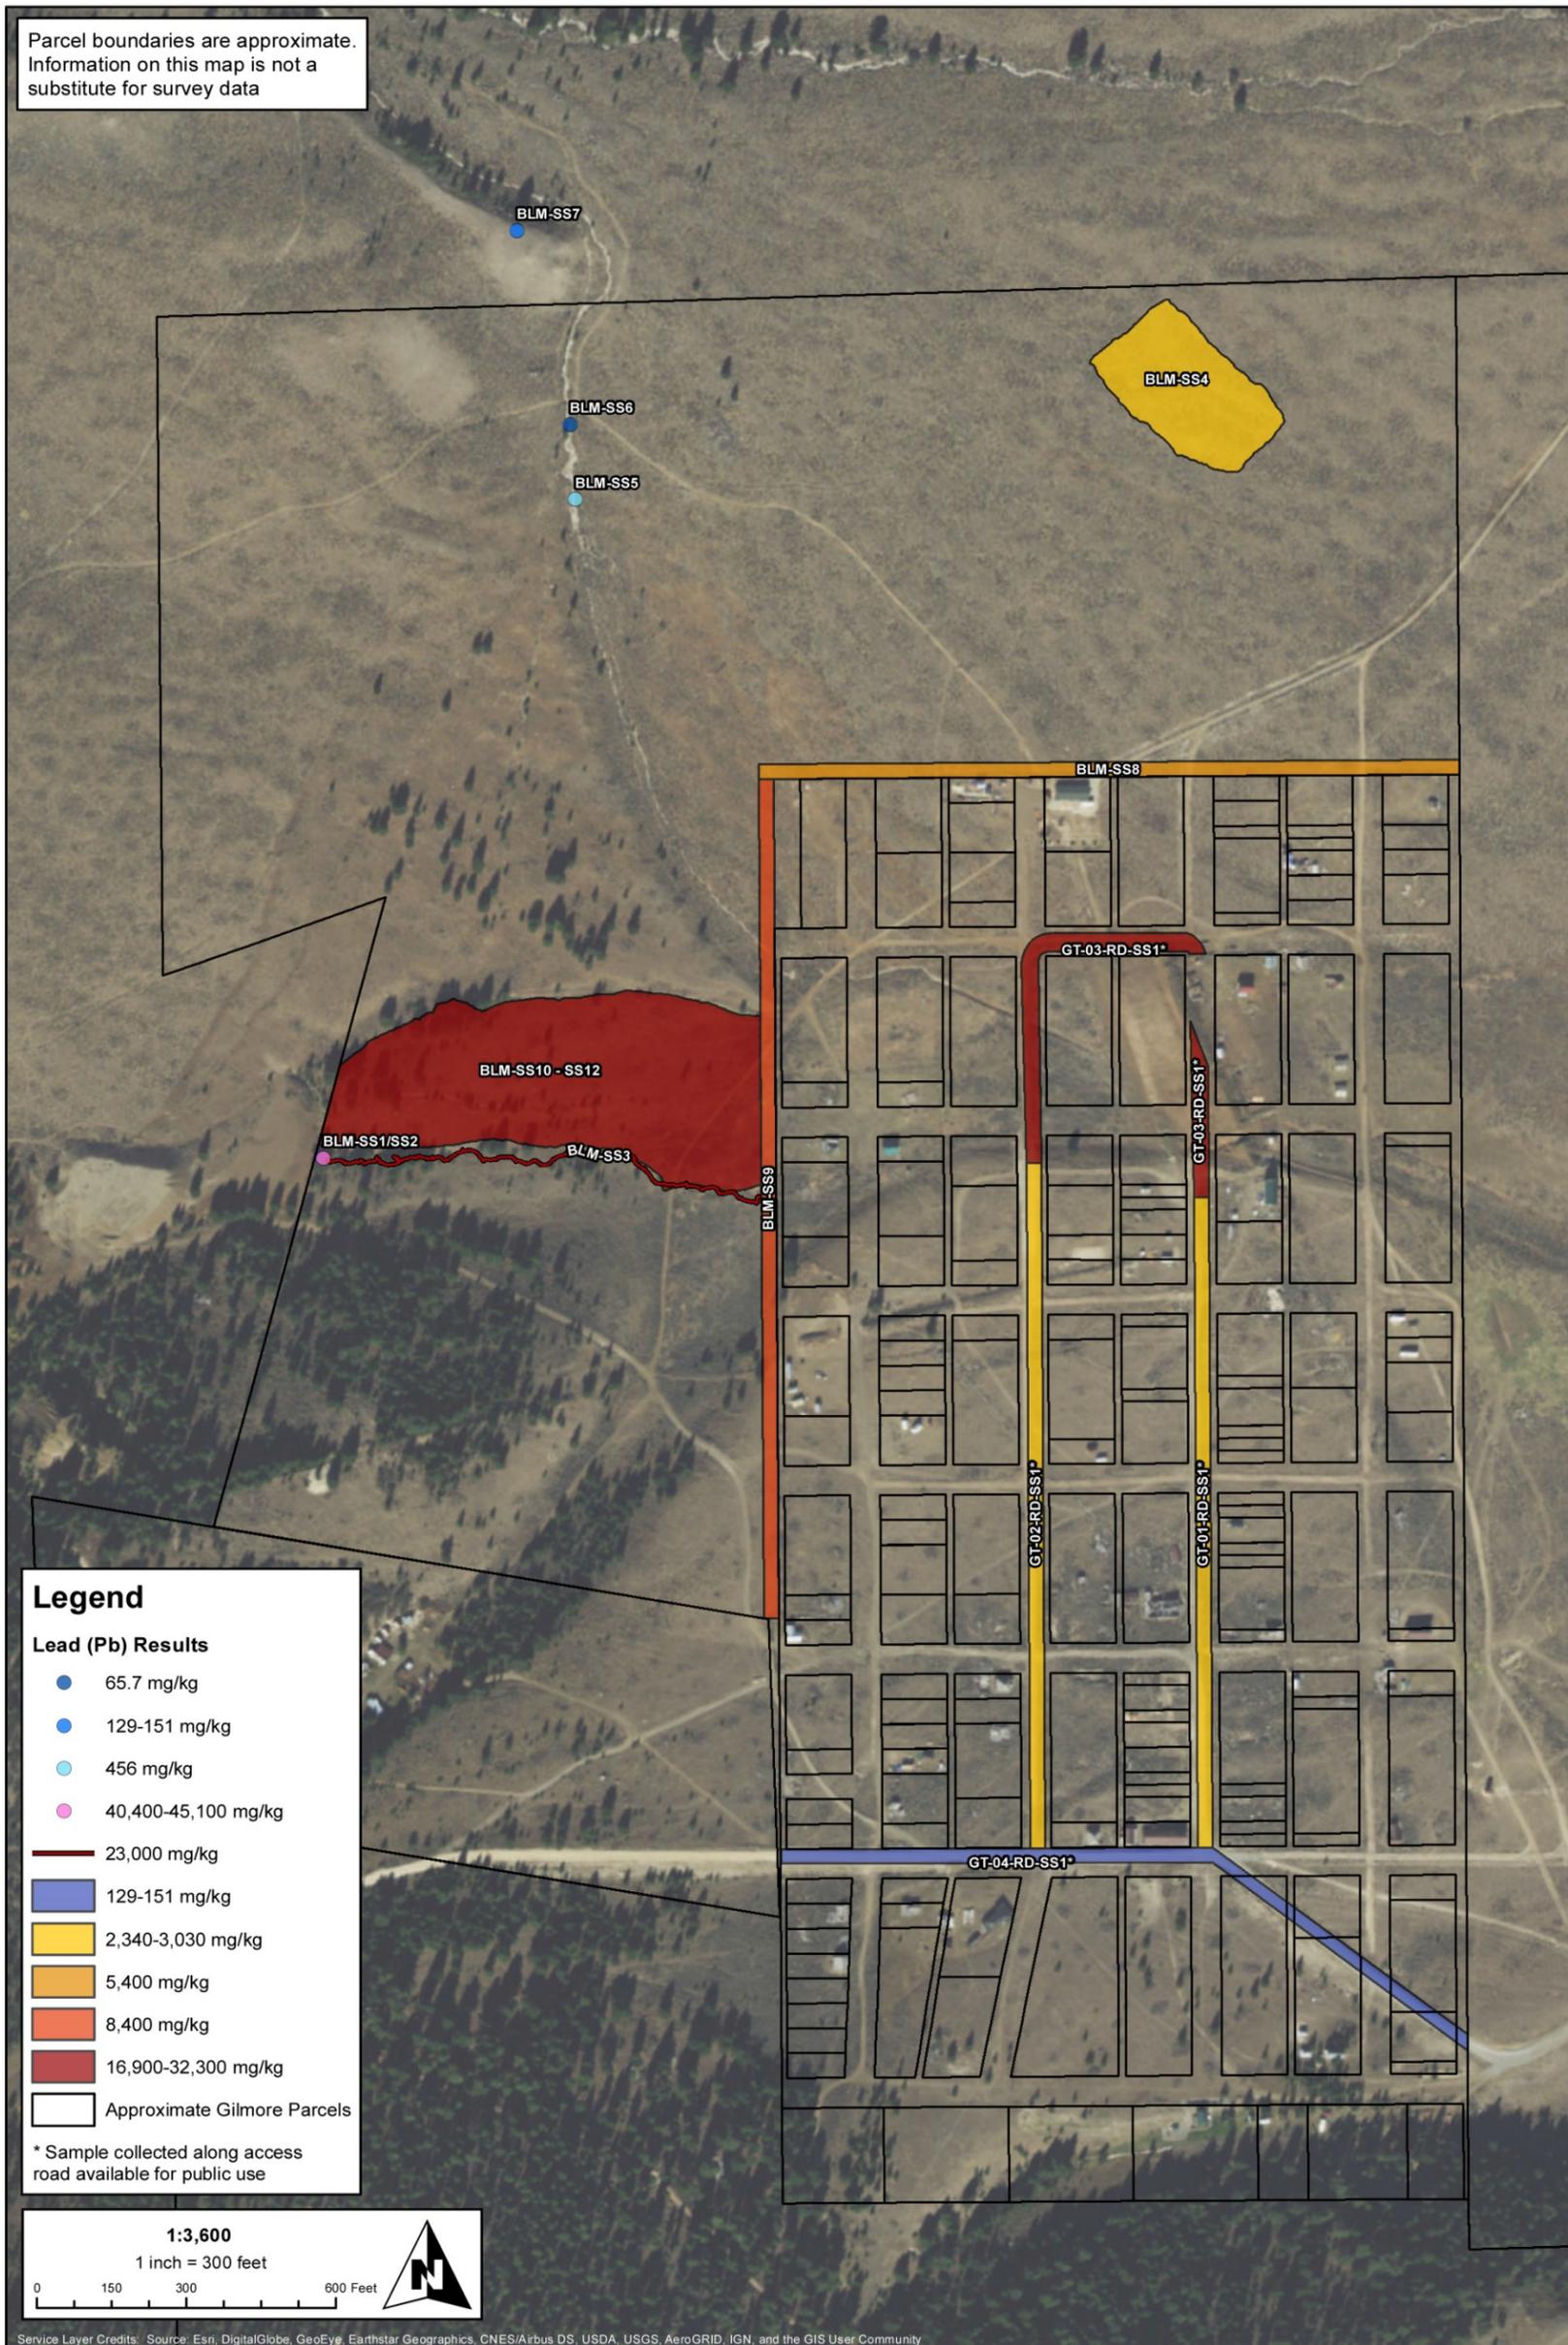
Figure 4. Sample locations and results map.

- Highest lead detections are observed: 1) where tailings material has eroded onto BLM property (40,400 and 45,100 mg/kg) and 2) where drainage and erosion pathways have likely resulted in migration of tailings materials across BLM property and to the northern area of the Gilmore townsite (lead concentrations range from 16,900 to 42,900 mg/kg in these areas).

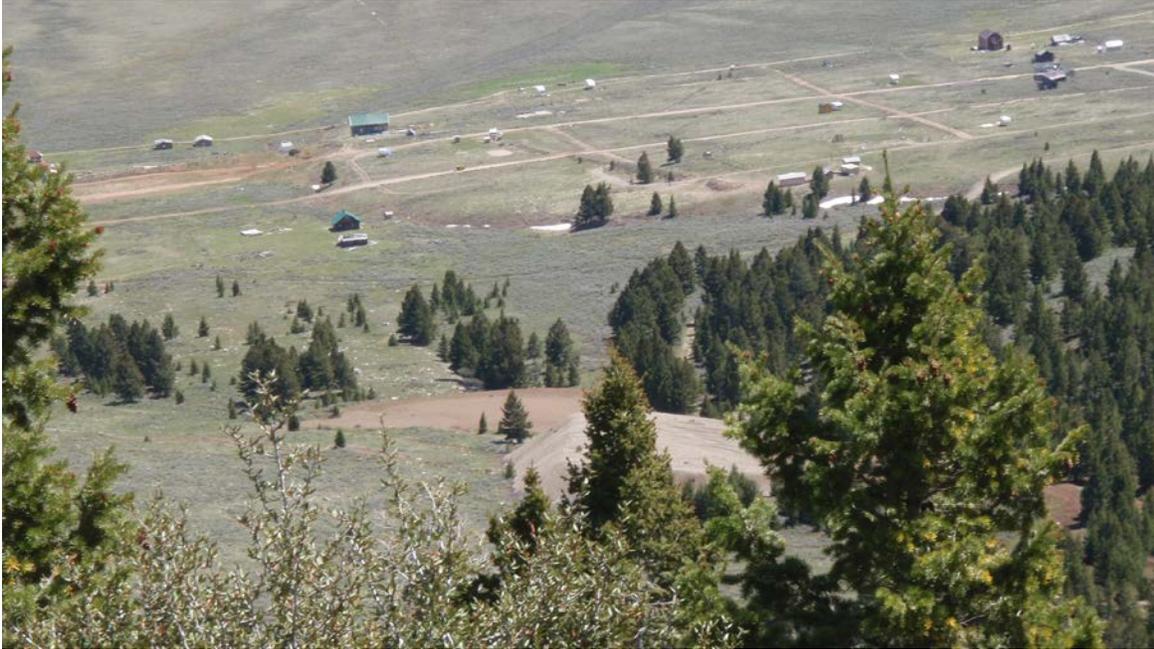
Photo 1: Overview of Gilmore townsite. Photo taken from hillside to the west of the townsite, looking to the southeast. Picture shows two main north-south running roads (samples GT-01-RD-SS1 and GT-02-RD-SS1); depressed area with dark brown soils at north end of townsite where horseshoe shaped road was sampled (GT-03-RD-SS1; left side of picture).

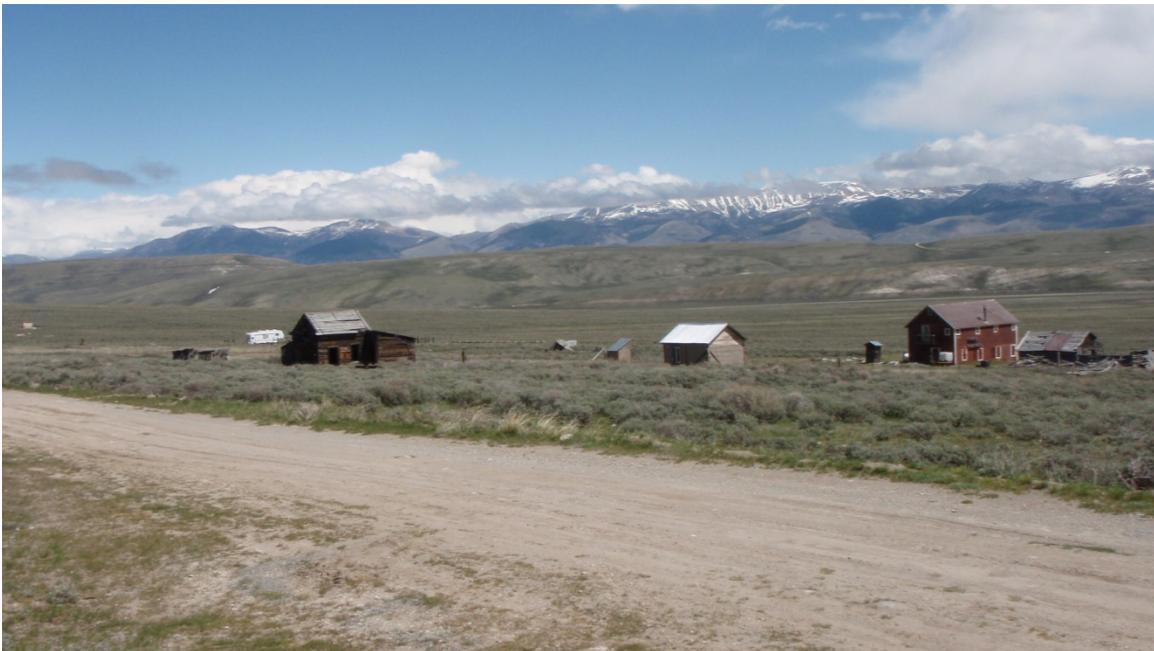
Photo 2: North-south road on east side of townsite (looking northeast, sample GT-01-RD-SS1 collected along this road).

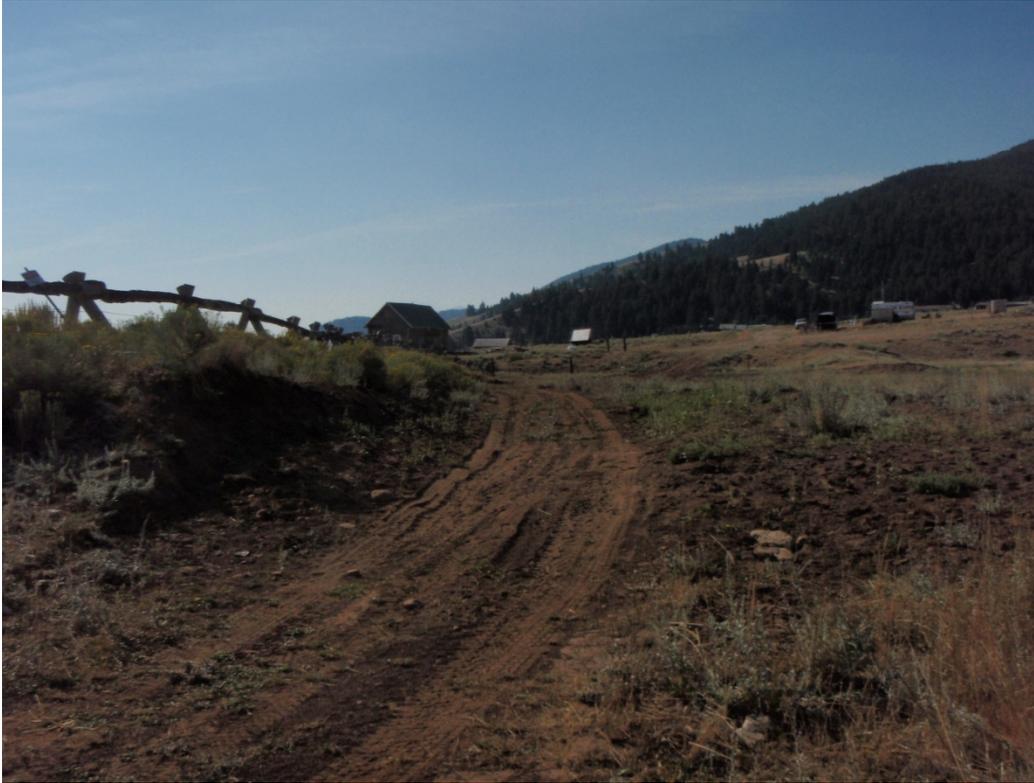
Photo 3: Part of the northern loop of roads (looking south). Depth samples (GT-03-RD-SS3/SS4) collected within this area.

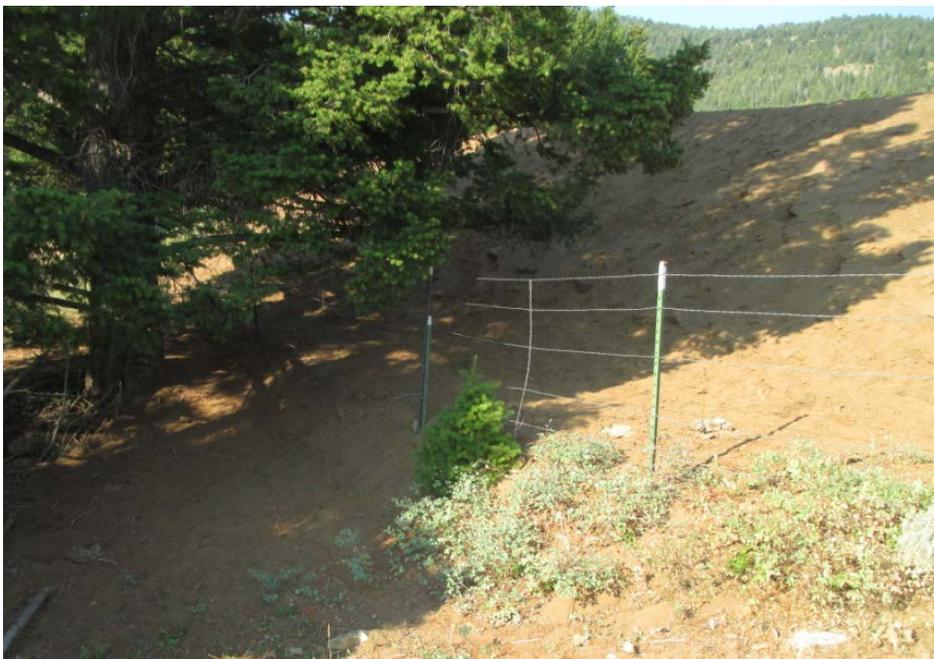
Photo 4: Area where tailings material has eroded onto BLM property; site of samples BLM-SS1/SS2.

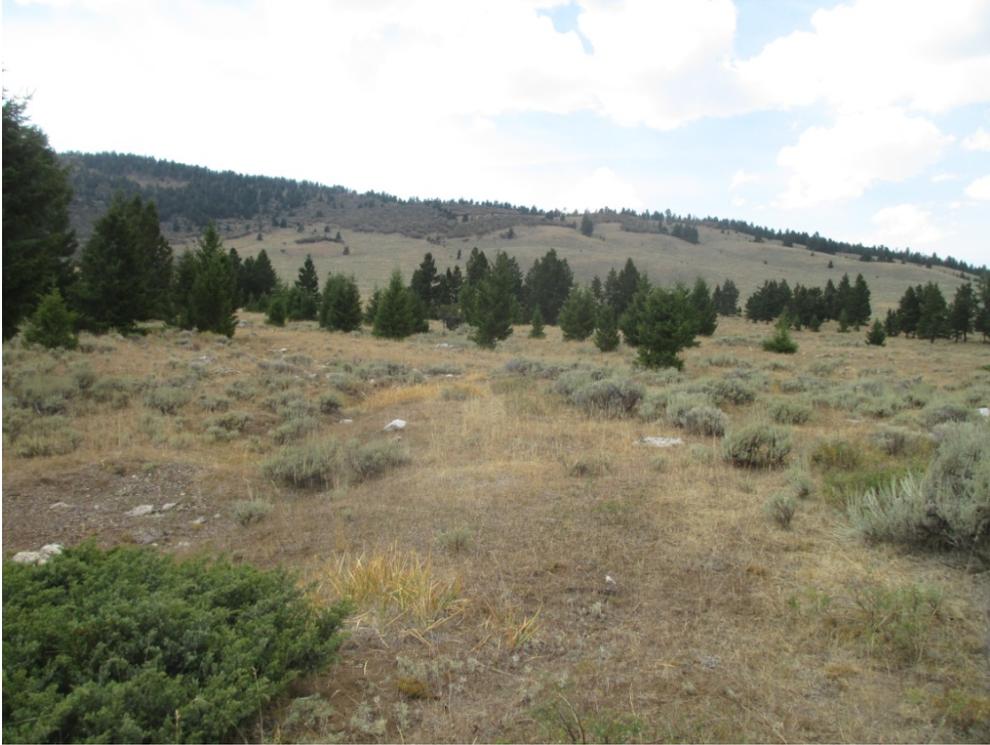
Photo 5: Wedge shaped area sampled (looking west); site of samples BLM-SS10, BLM-SS11, and BLM-SS12.

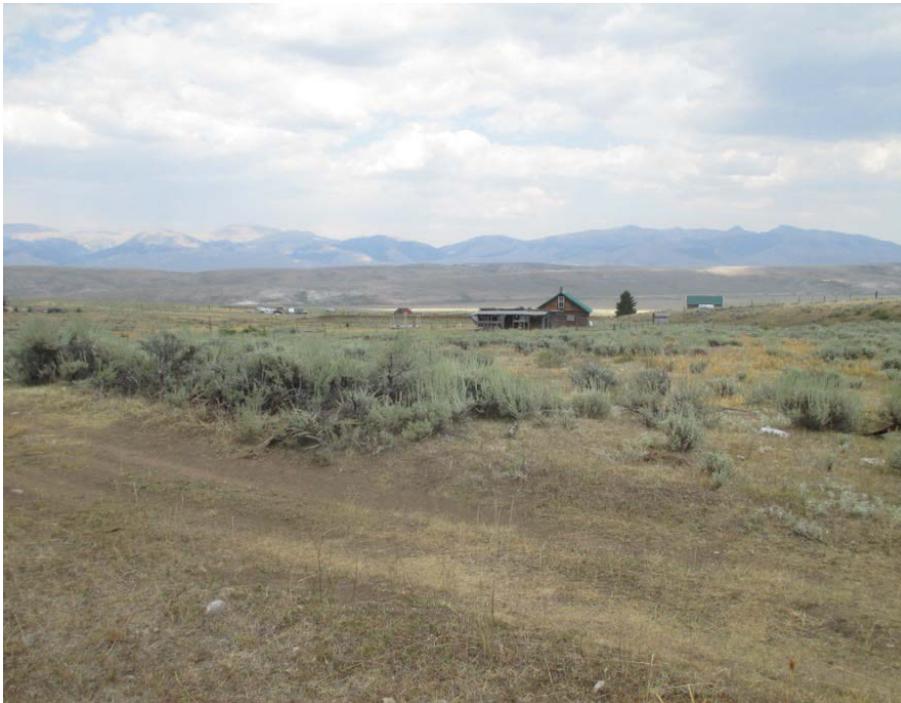
Photo 6: Wedge shaped area sampled (looking east); site of samples BLM-SS10, BLM-SS11, and BLM-SS12.

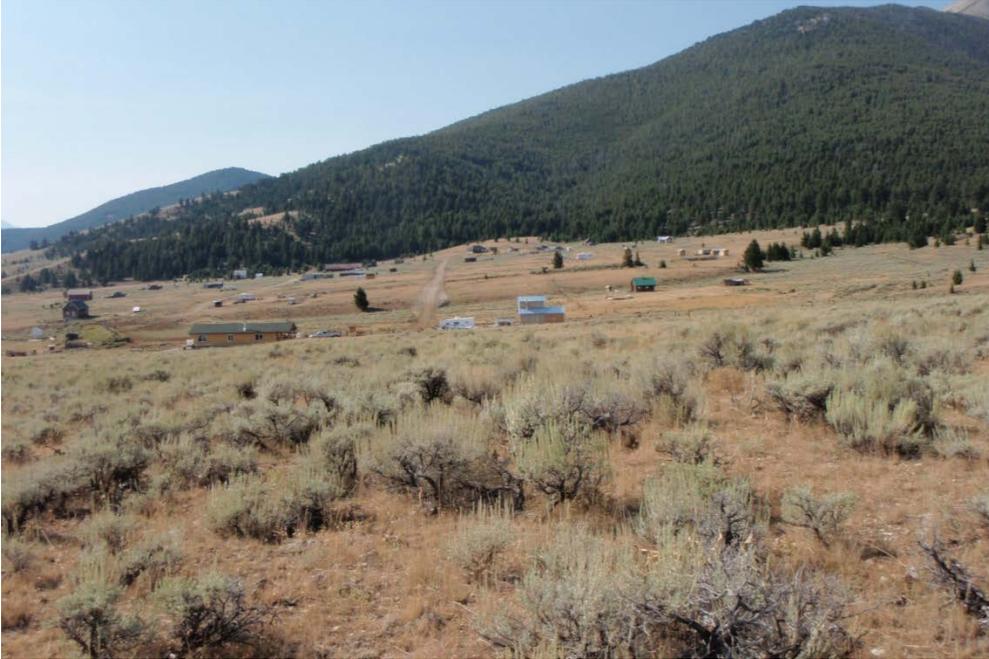
- Within a stained soil area north of the townsite on BLM property (3,030 mg/kg).
 - Along the north-south roads within the Gilmore townsite (2,340 and 2,930 mg/kg).

Photo 7: Photo taken from hillside to the north of the townsite, looking to the south. Typical vegetation on BLM property north of townsite. BLM-SS4 collected from orange stained soils in this general area.

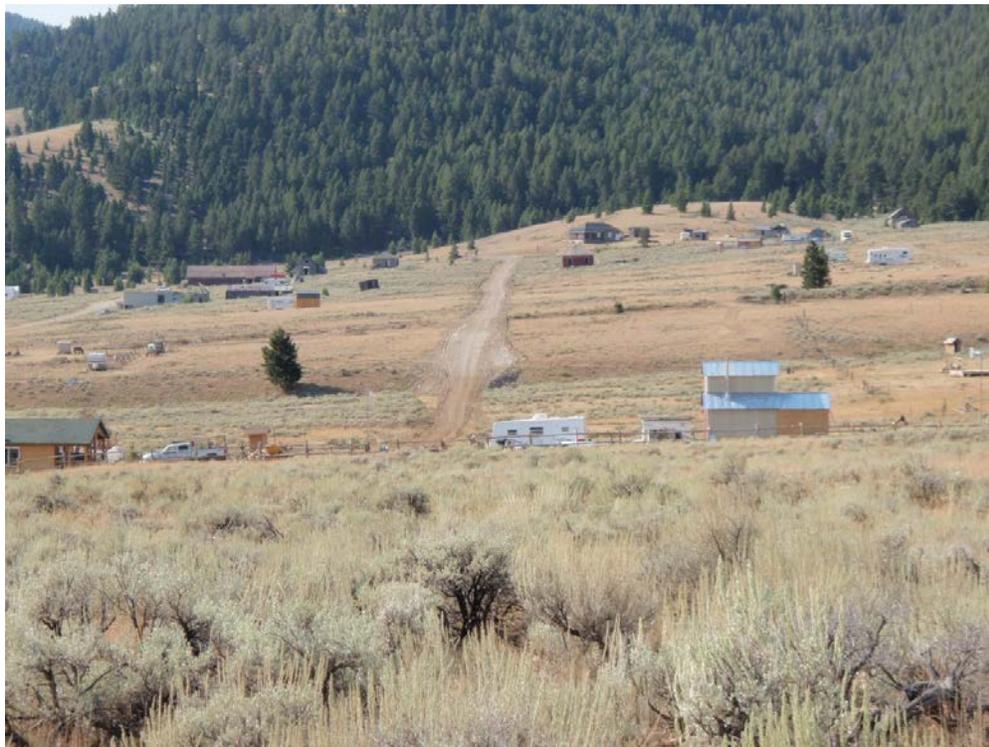
Photo 8: BLM property along north edge of townsite (looking south). Sample BLM-SS8 was collected from a 30-foot wide strip along the north edge of town on BLM land.

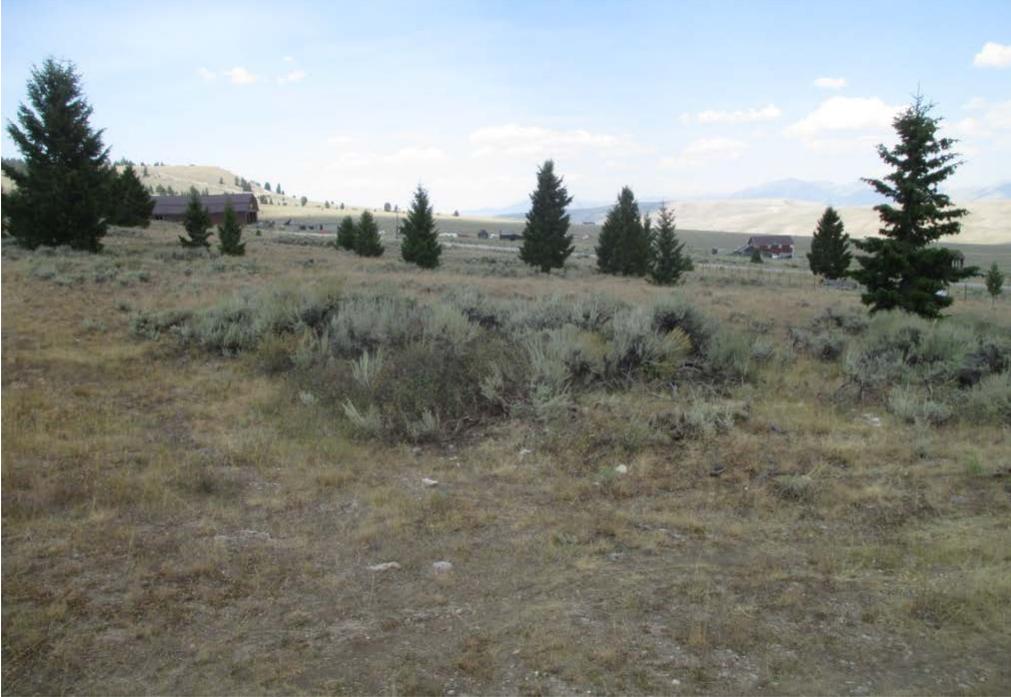
Photo 9: Sample area along west edge of townsite (looking northeast); site of sample BLM-SS9.

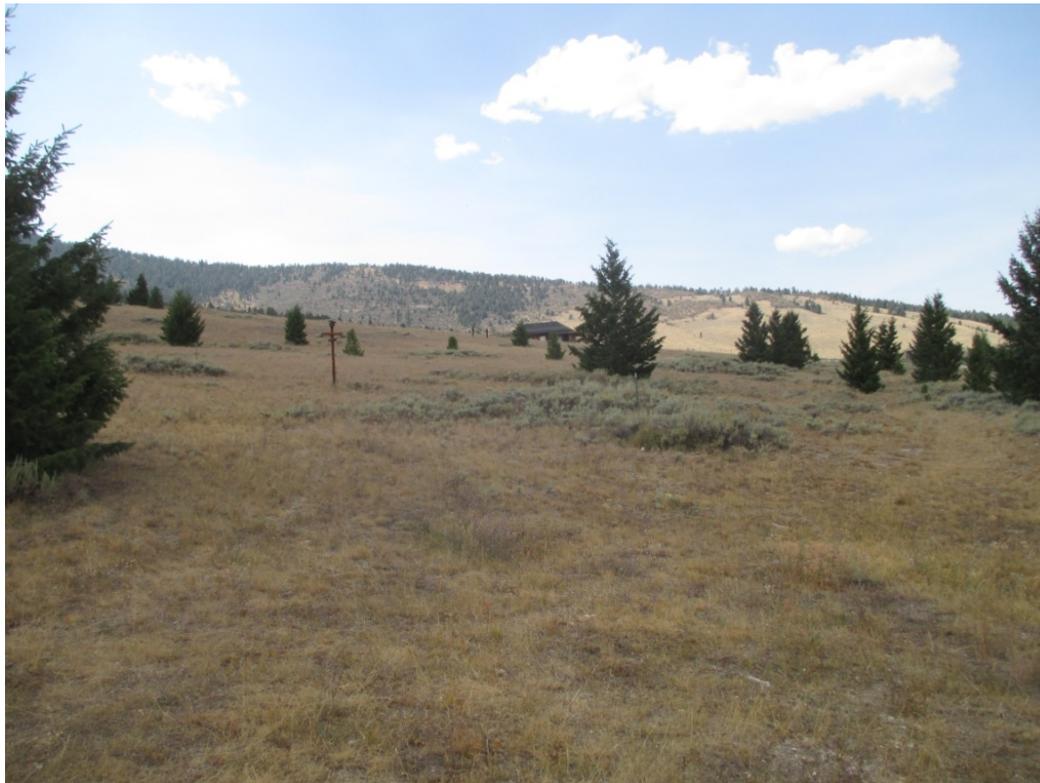
Photo 10: Sample area along west edge of townsite (looking southeast); site of sample BLM-SS9.

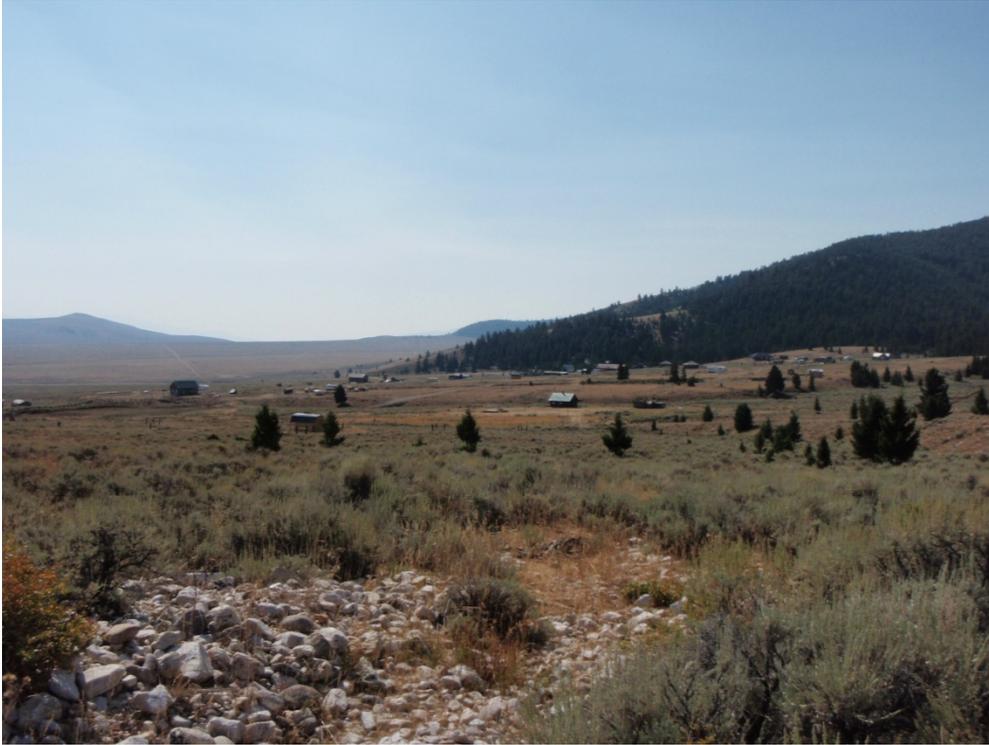
Photo 11: Dry creek downstream of ditch crossing (looking southeast). BLM-SS5 collected from dry stream sediment.

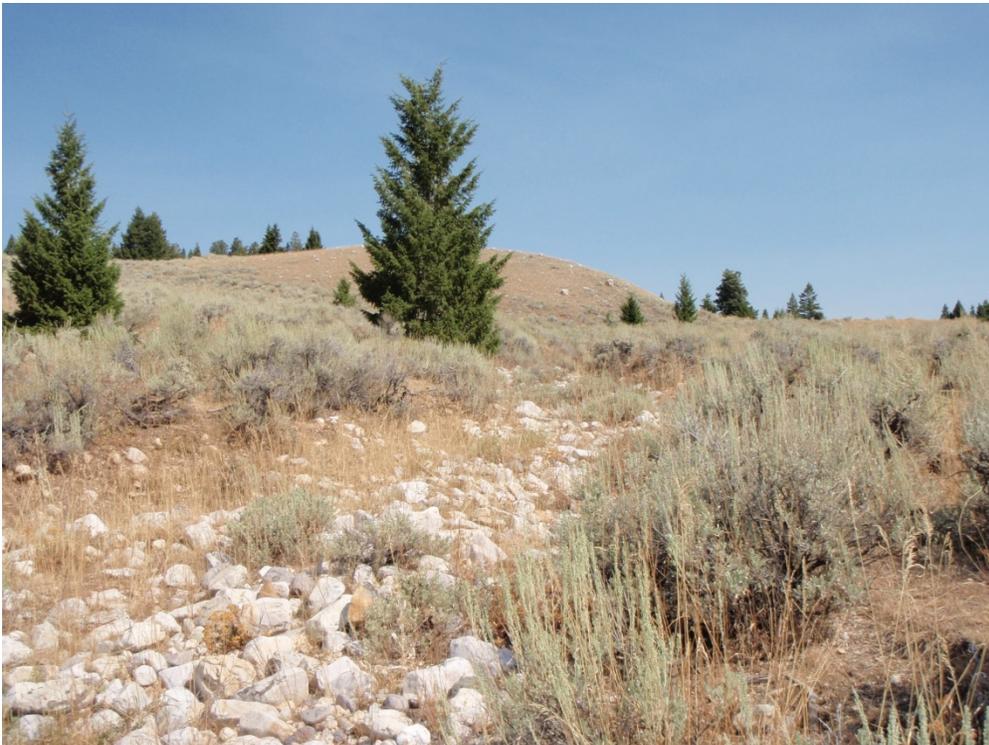
Photo 12: Dry creek bed upstream of ditch crossing (looking northwest). BLM-SS6 collected from dry stream sediment.
