Pend Oreille Lake and River Tributaries

TMDL Five-Year Review

**State of Idaho
Department of Environmental Quality
April 2017**

**Prepared by
Coeur d'Alene Regional Office
Department of Environmental Quality
2110 Ironwood Parkway
Coeur d'Alene, ID 83801**

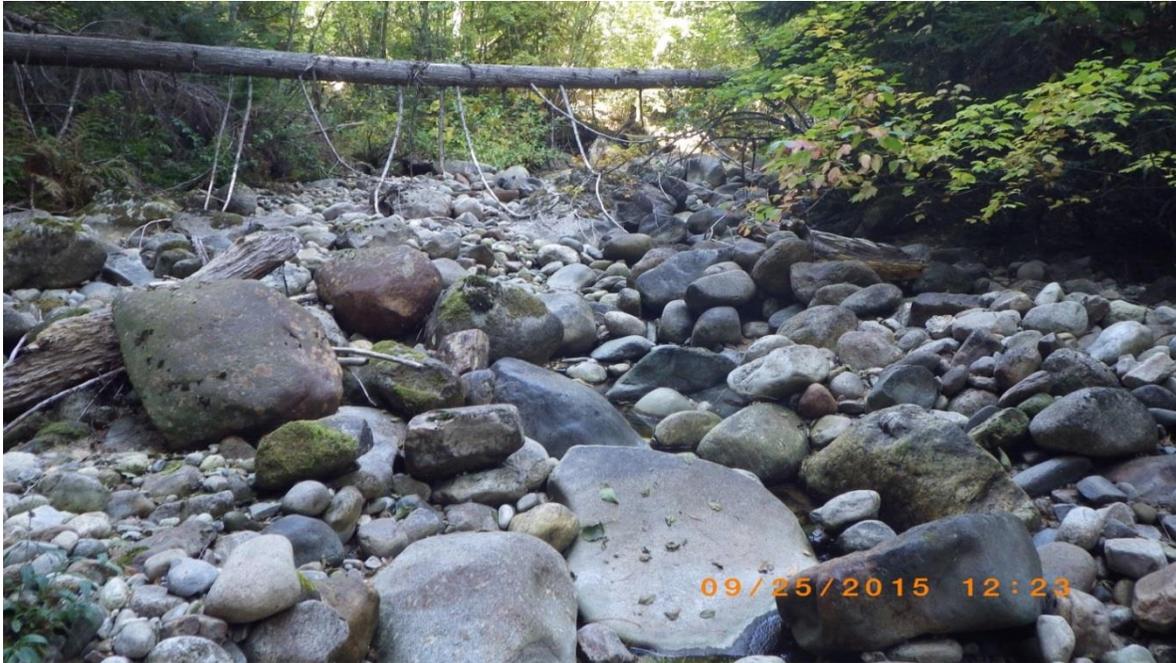
Upper Berry Creek is a step-pool stream type dominated by large alluvial substrate both above and below the Colburn Dam (D_{50} = large cobble to small boulder or 128–512 mm). Pool and pool-margin embeddedness showed a minor departure from reference conditions due to the upstream dam entrapment of fine sediment and scour downstream of the dam from the lack of sediment. In the channel below the Colburn Dam, excessive large cobble and suboptimal sediment transport capacity was evident with mobility and lack of sorting of the large-cobble substrate (Figure 13). Excessive cobble substrate is also above the dam with evidence of substrate mobility and lack of sorting (Figure 14).

Figure 13. Excess large cobble in upper Berry Creek (below Colburn Dam).

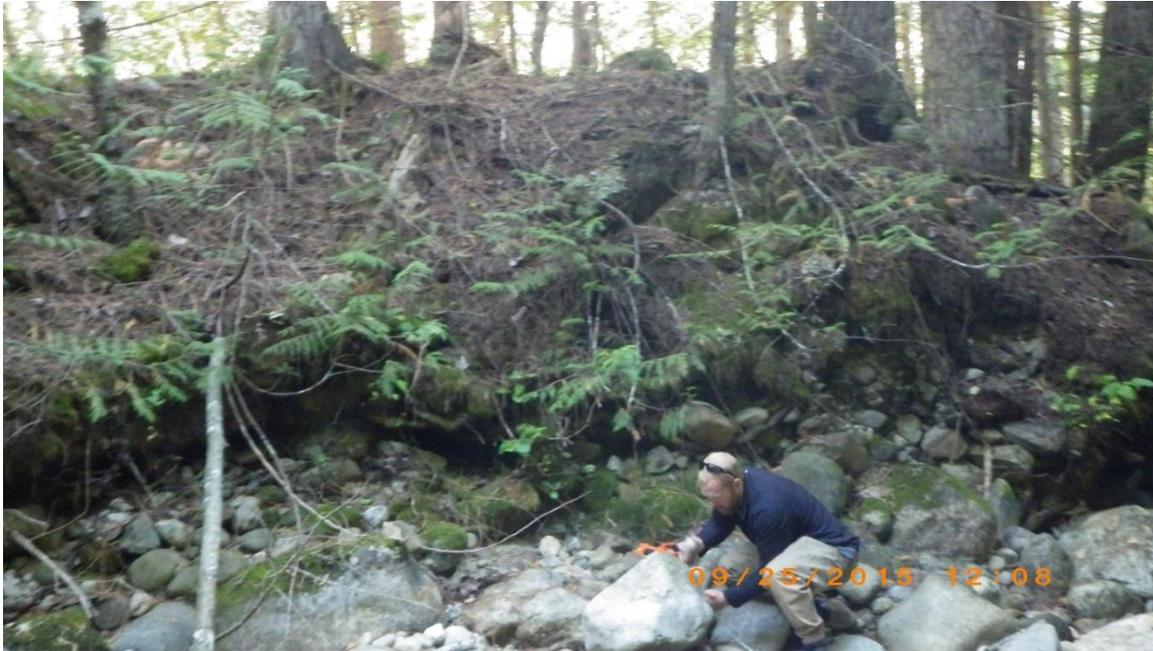
Both above and below the dam, Berry Creek channel morphology showed a major departure from reference conditions. The channel was over-widened (width/depth ratio greater than 25) and entrenched (entrenchment ratio greater than 1.2) (Figure 16). This is likely because of a historic road that paralleled Berry Creek at this location.

Figure 16. Upper Berry Creek (below Colburn Dam) channel entrenchment.

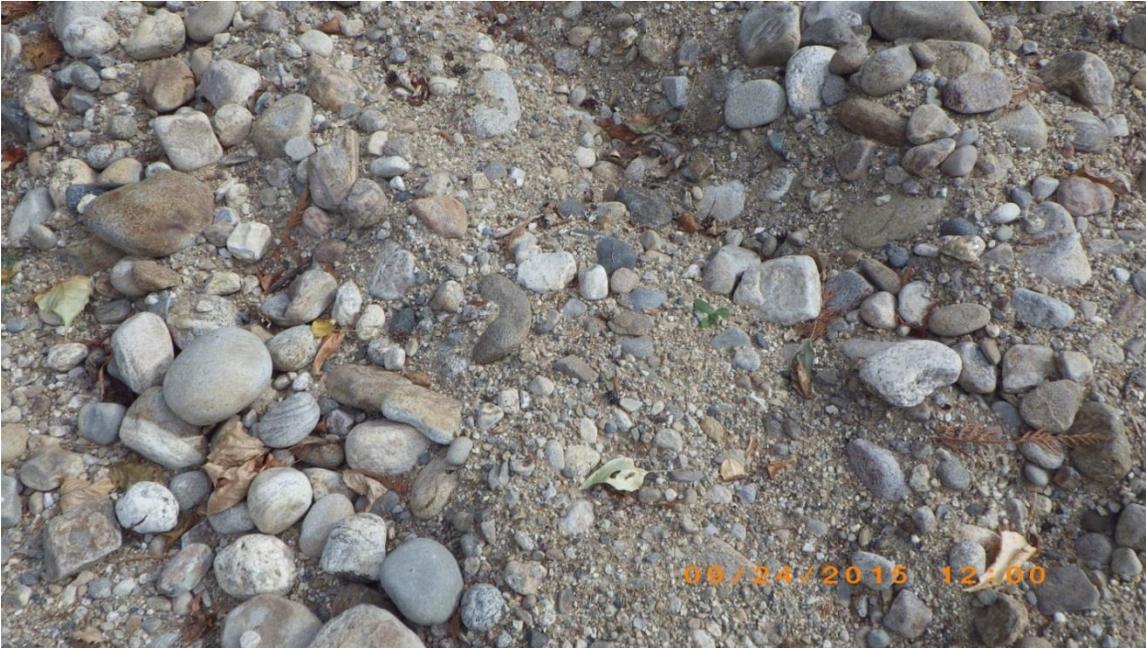
Scour and depositional features were in fair-good condition due to the excessive bedload limiting the stream's transport capacity. Due to bedload mobility, unstable point bar and mid-channel bar features were common, and a meandering thalweg was only moderately identifiable (Figure 21). Although the stream historically was straightened, the stream had good sinuosity. Pool formation on lower Berry Creek was evident, with pool size substantial in many cases. Some pools had water providing some refuge for fish (Figure 22). Cutthroat Trout and Brook Trout in various age classes (including young-of-the-year) were alive in these pools. Also observed were abundant caddisfly casings throughout the stream. Riffle formation appeared to be limited.

Figure 20. Lack of sediment sorting in lower Berry Creek.

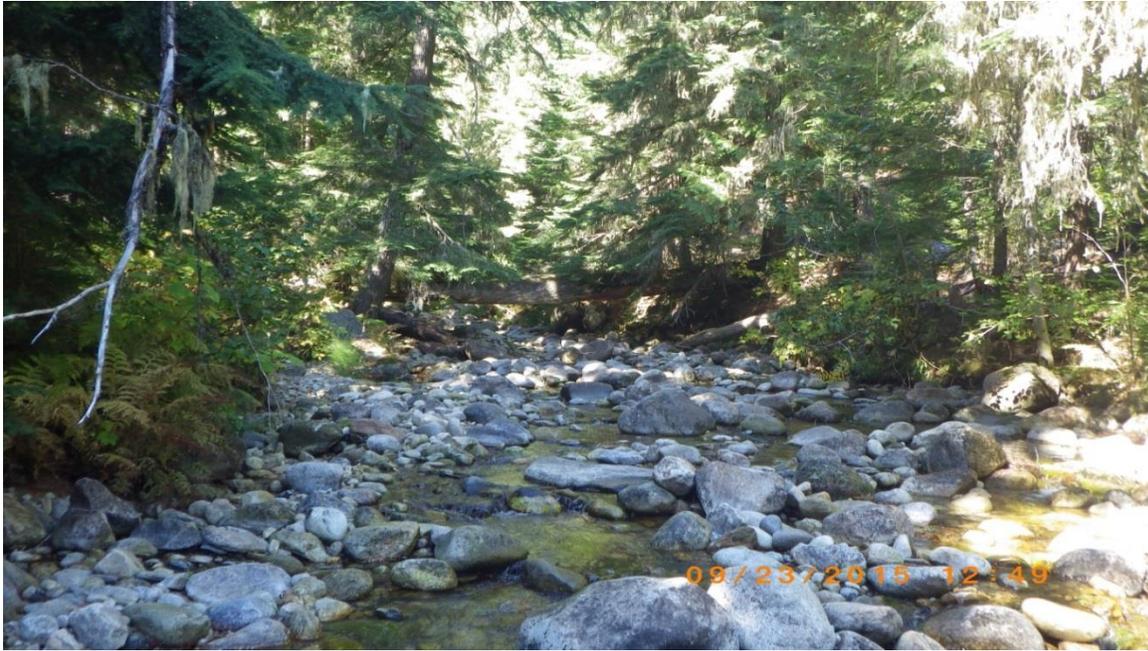
Caribou Creek was a riffle-pool stream type dominated by large alluvial substrate (D_{50} = large cobble or 128–256 mm). Riffle embeddedness was 20–40%, and riffle margin embeddedness was 40–60%—both a minor departure from reference conditions. Due to the excessive amount of cobble substrate, there was some evidence of large cobble mobility and lack of sorting (Figure 39). The substrate was free of dense algae growth.

Figure 39. Excessive cobble substrate in Caribou Creek.

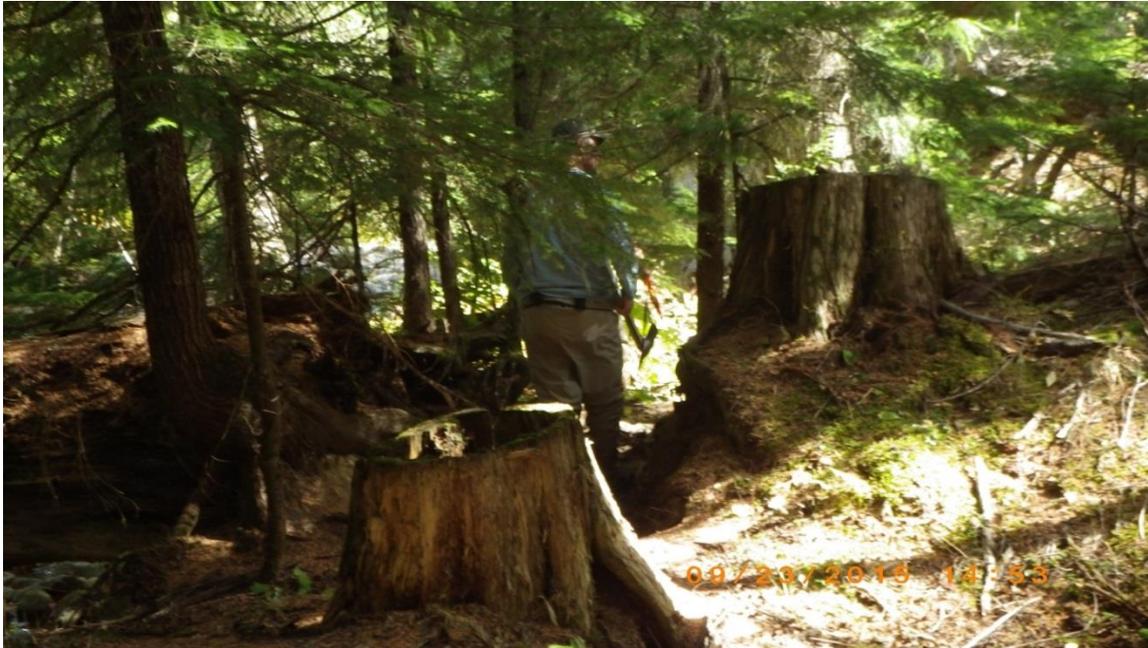
Caribou Creek in the study reach was over-widened and entrenched. Due to minimal bank erosion, excessive substrate was not the cause of over-widening. There was no evidence of channel alteration that would suggest active incision or channel widening. Therefore, the over-widened, entrenched condition was due to historical logging activity and excessive erosion in the riparian zone (Figure 40).

Figure 40. Evidence of historical timber harvest in the riparian zone in Caribou Creek.

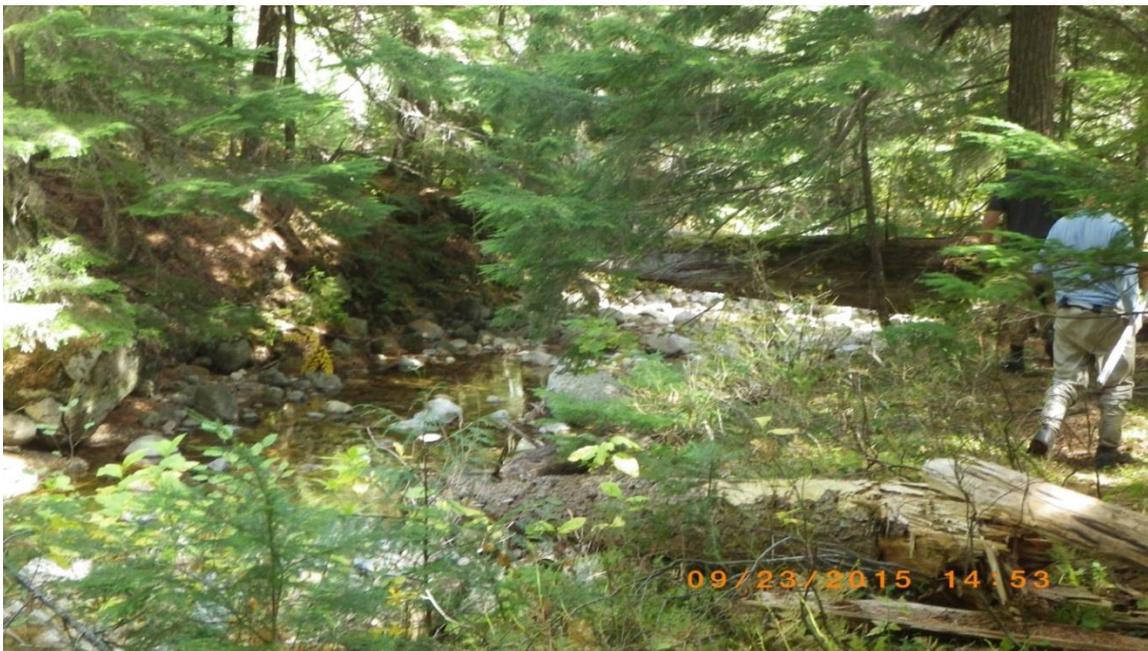
Caribou Creek has no known flow alteration or obstructions that block longitudinal movement of aquatic species. However, the over-widened and entrenched condition of the stream somewhat limits access to the floodplain (Figure 41). The floodplain was narrow due to steep side-slopes. Due to the extreme low-flow conditions during evaluation, the stream reach had a reduced wetted width and an uncharacteristic abundance of exposed substrate.

Figure 41. Moderately entrenched reach in Caribou Creek.

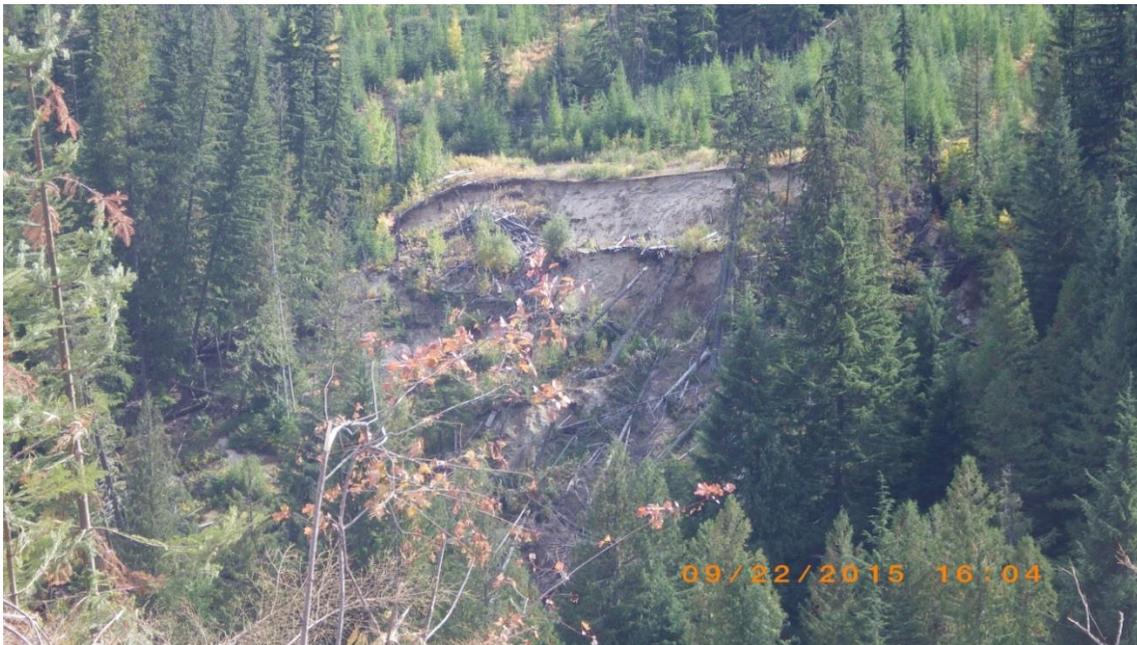
Streambank erosion was less than 10% in the study reach, which was at reference conditions. Streambank vegetation was between 75% and 90% of reference conditions with a diverse plant assemblage. Plants created good cover and roots provided bank stability. Streambank canopy was between 80% and 90%, a minor deviation from reference conditions. Undercut banks were abundant, providing excellent cover and refuge. Undercut banks had stable boundaries, abundant overhanging vegetation, and consistent water adjacency. Due to the erosive nature of the soils in this watershed, mass wasting was evident (Figure 85).

Figure 85. Mass wasting in upper Hellroaring Creek watershed.

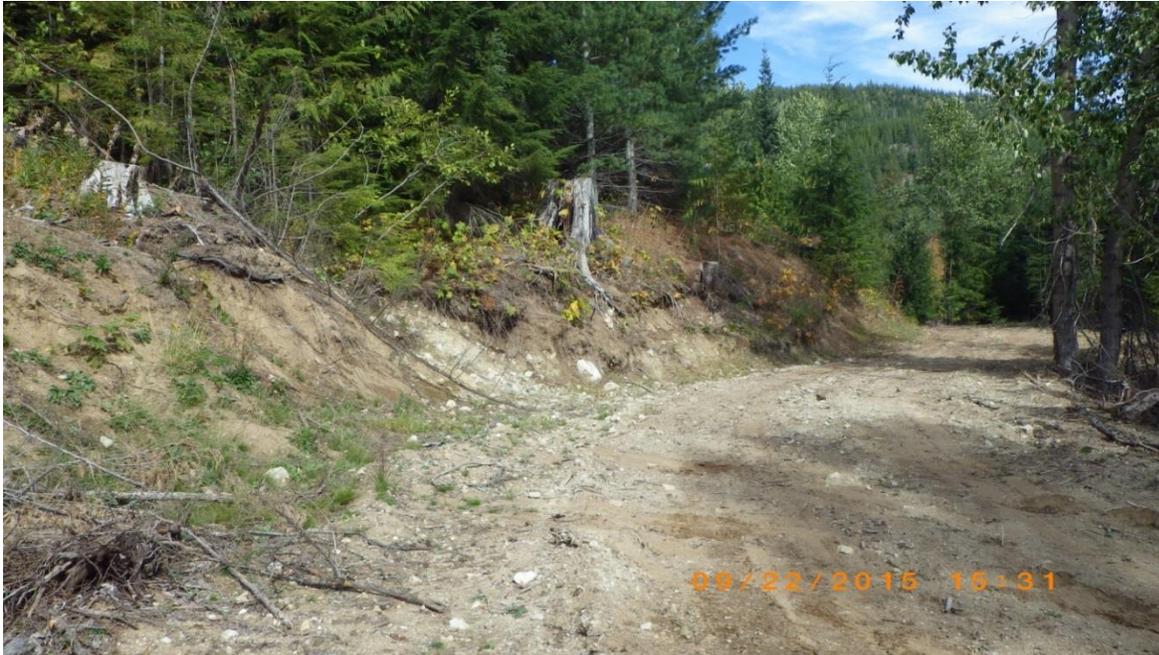
Due to the long distance between the road and Hellroaring Creek, there was a very low risk of sediment delivery to Hellroaring Creek from the road, except at the single crossing on North Fork Hellroaring Creek. However, proper maintenance of the road and water bars and limited access on this road is critical to limit the risk of rill and gully erosion on the road surface. At the North Fork Hellroaring Creek crossing, the culvert had been replaced and was well armored upstream and at the outlet (Figure 88). However, it appeared that water could flow underneath the culvert. Limited access and proper maintenance of the road surface and water bars near the road crossing is critical to protecting habitat and water quality in Hellroaring Creek.

Figure 87. Road surface, water bar, and cutslope erosion on Hellroaring Creek Road.

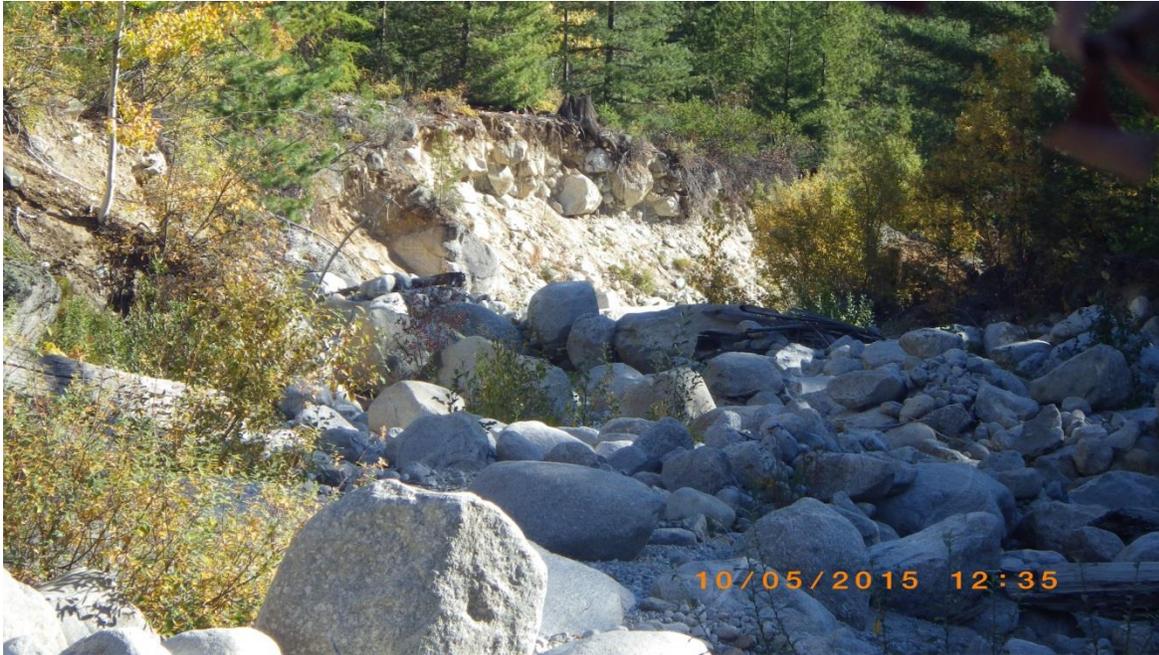
Figure 104. Vertical streambanks in McCormick Creek.

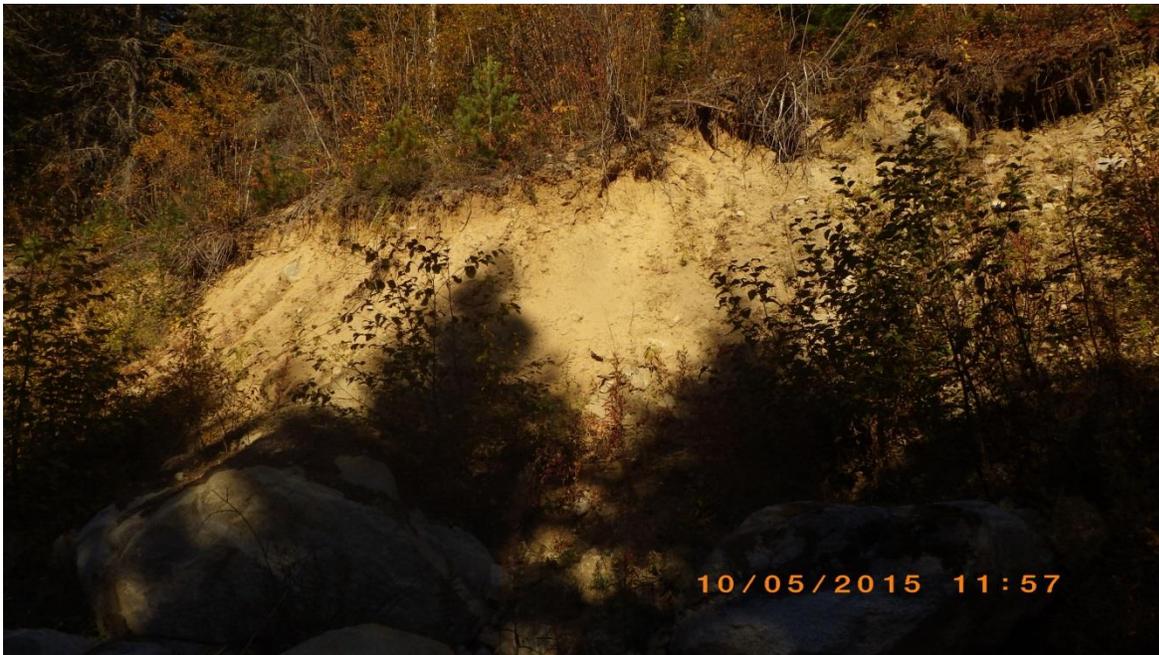
Figure 105. Mass failure near McCormick Creek.

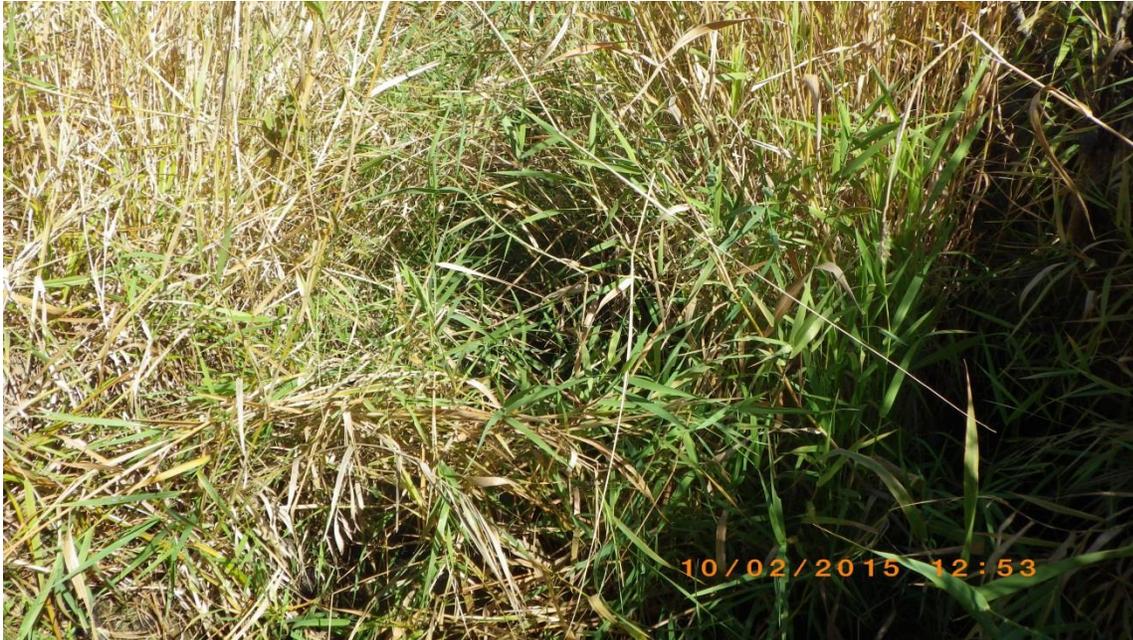
Figure 136. Reed canarygrass in upper Sand Creek.

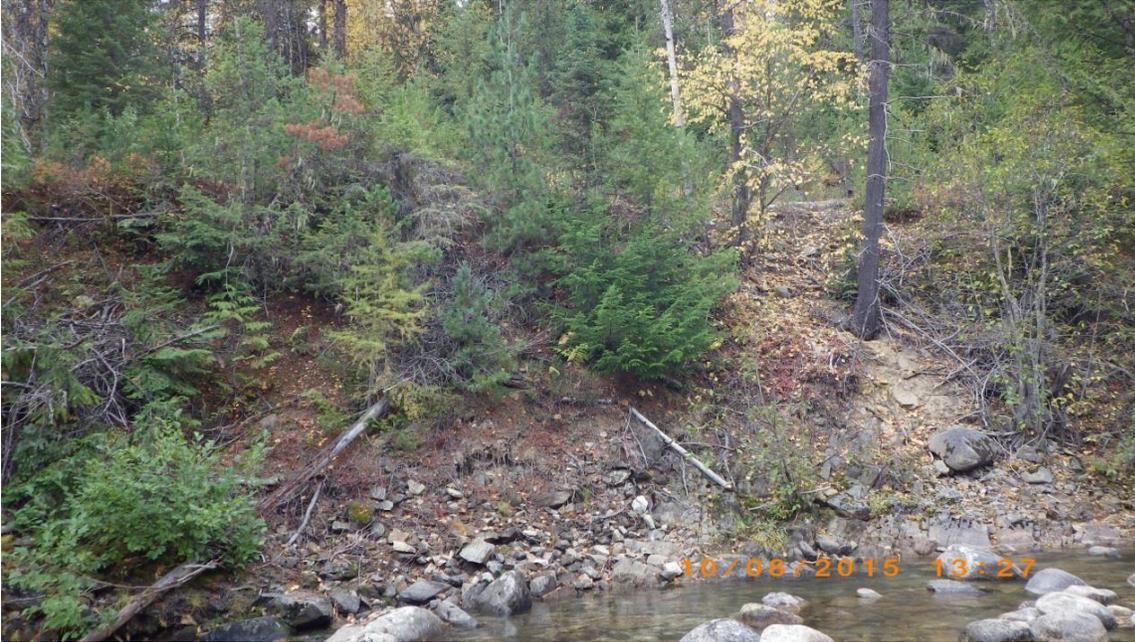
Figure 162. Channel entrenchment, upper Pack River 2.

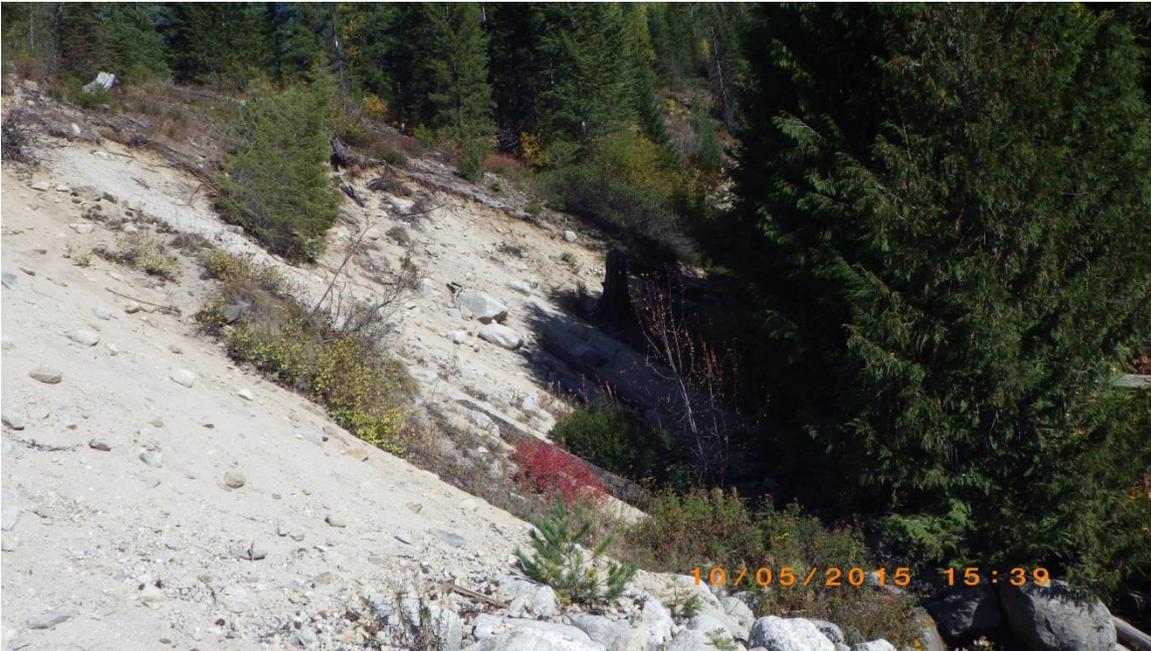
Figure 167. Mass failure upstream of upper Pack River.

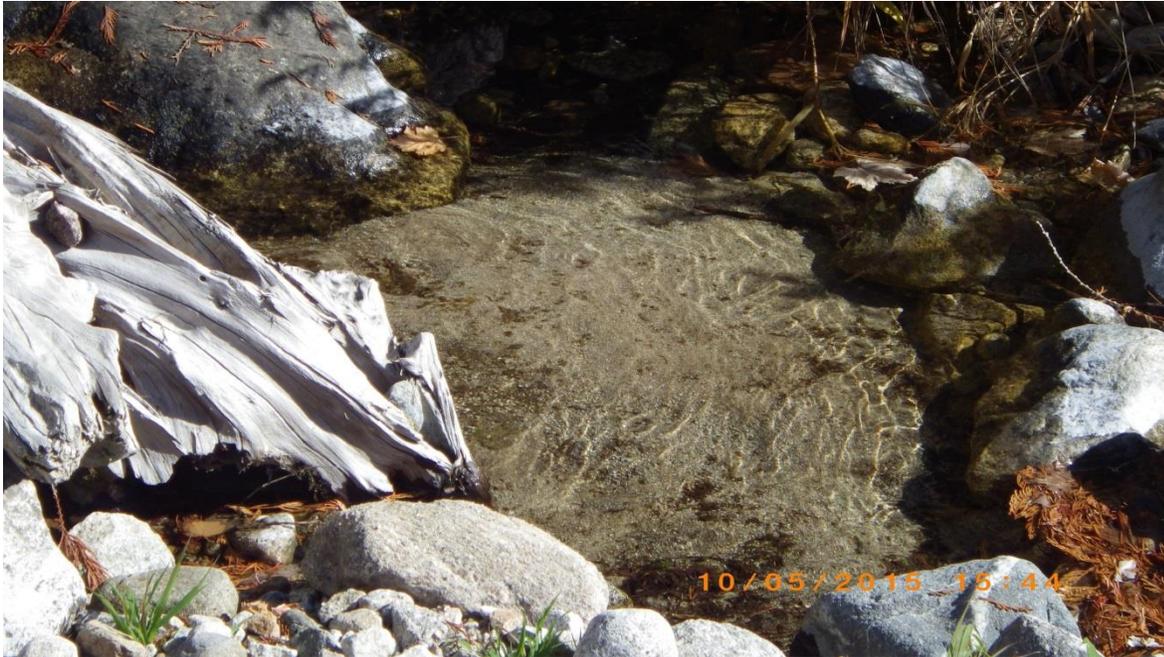
Figure 168. Excessive sediment from mass failure in upper Pack River.

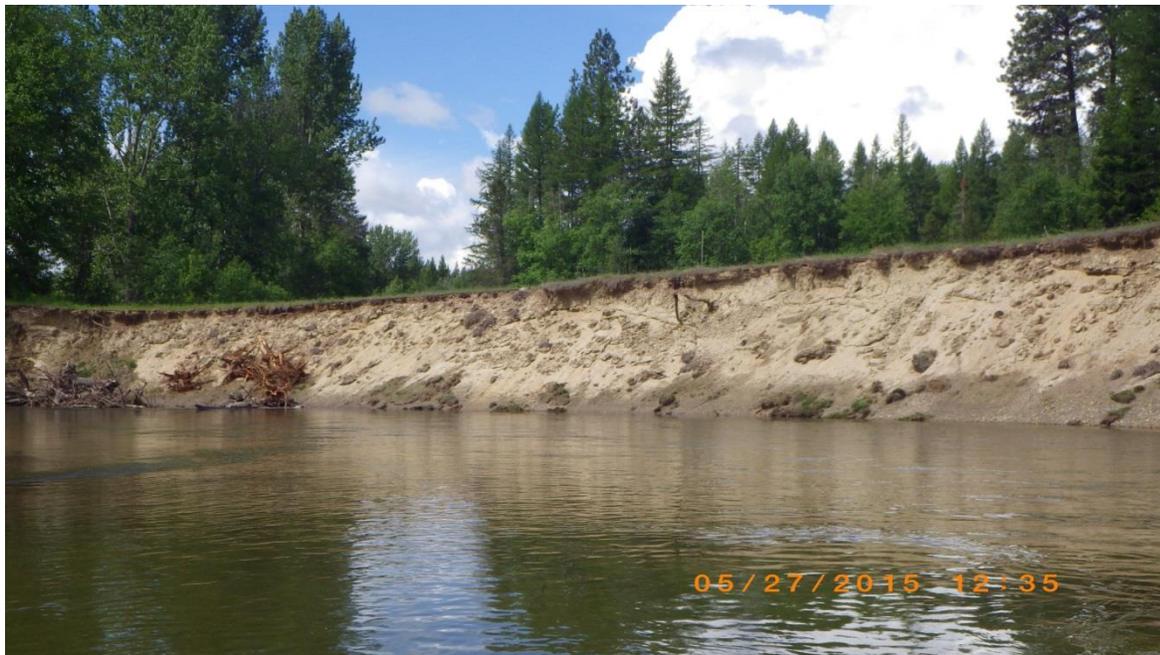
Figure 169. Eroding riverbank on the lower Pack River.

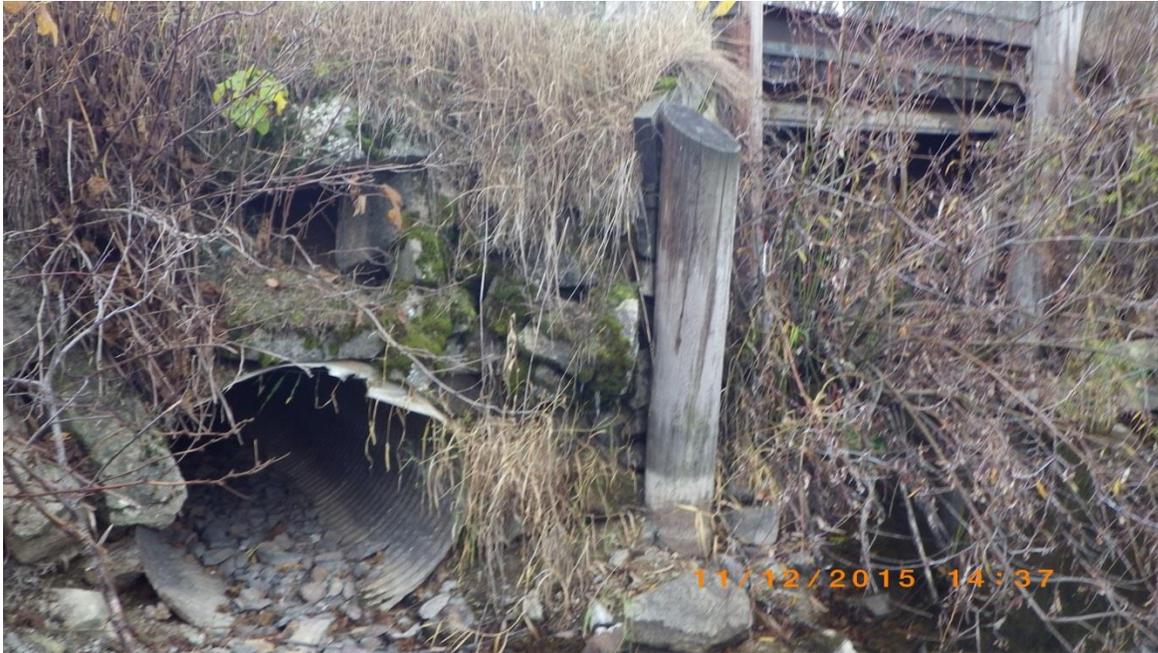
Figure 200. Rusted-out, overflow culvert at outlet of Cocolalla Lake.
