STATE OF IDAHO
DEPARTMENT OF
ENVIRONMENTAL QUALITY

Subject: Site Assessments of the Penman Mine and Homestake Mine/Badger Shafts,
Orogrande Area, Idaho County, Idaho

ABBREVIATED PRELIMINARY ASSESSMENT

Site Name: Homestake Mine and Badger Shafts

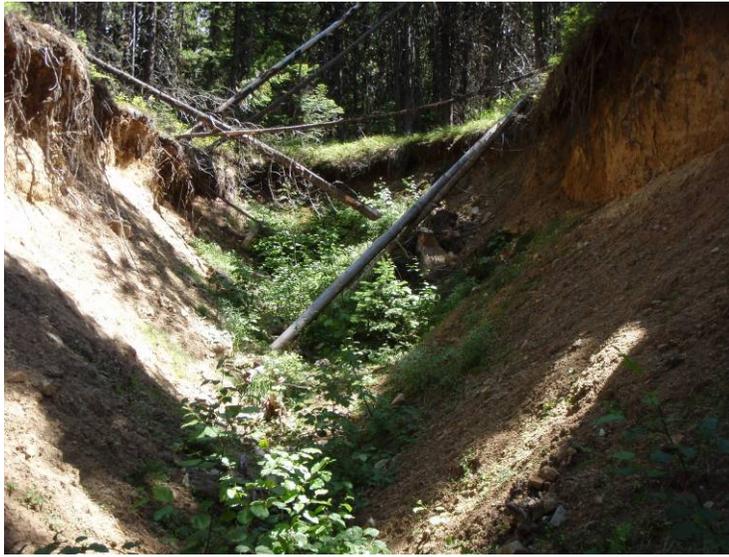
Homestake Mine: Two collapsed adits were identified and photographed. Both were well vegetated at the bottom of the trench. Both adits were dry with no water coming from the mines. The Homestake mill site (Lat. 45.66574°N, Long. -115.52543°W) consisted of fallen down buildings and debris. The mill waste dump contained approximately 1000 cubic yards of material. This material was country rock with no ore remaining. No highly mineralized material was present. The mill waste dump had a few young trees growing from it. No pathways existed for airborne or surface water run off to impact any waters or residences.

Photo 1. Homestake Mine Adit 1, collapsed. (7/29/10)

There are no direct airborne, surface or ground water pathways to any potable water sources or residences. At the time of DEQ’s visit there was no evidence the adits and mill site waste dump discharge water. The Badger shafts are collapsed with no evidence of water, but they do have well established vegetation. No streams or water bodies are within close proximity to the mine site. The closest residence is 2.5 to 3 miles away and is separated from the mine by structural geology. No significant evidence of mineralization remains at the mine site with the waste dumps being composed of country rock. Both adits were well vegetated in the trench left from the adits collapsing.

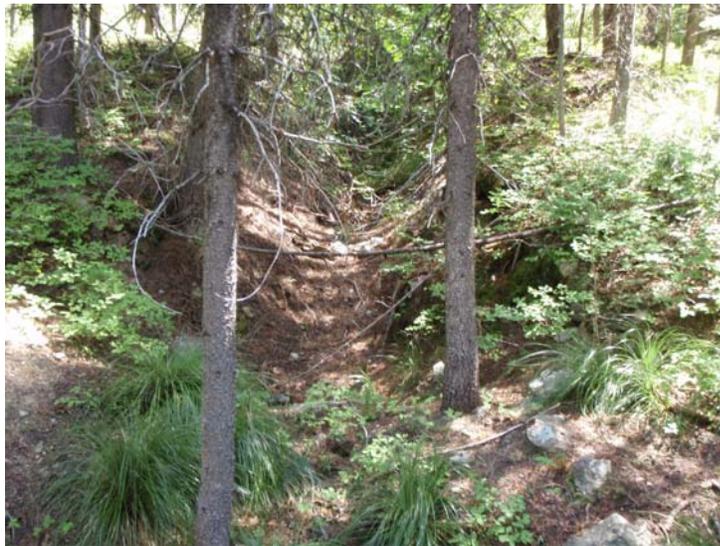
Photo 2. Homestake Mine Adit 2, collapsed (7/29/10)

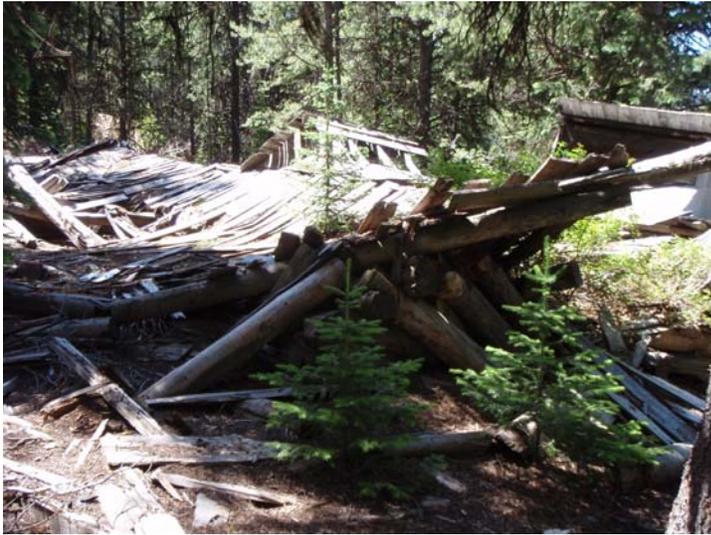
Photo 3. Homestake Mill (7/29/10)

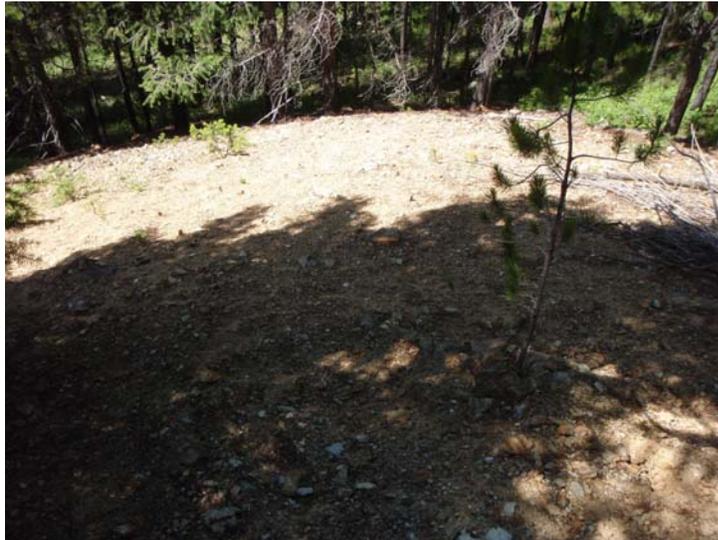
Photo 4. Homestake Mill Waste Dump (7/29/10)

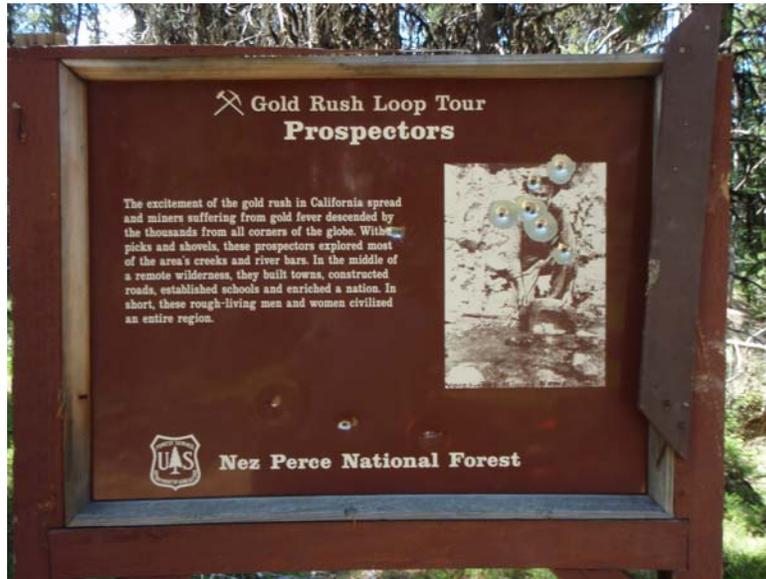
Badger Mine/Shafts: The Badger Shafts are located on Nez Perce National Forest land at Lat. 45.66338°N, Long. -115.52192°W and Lat. 45.66308°N, Long. -115.52165°W. Both shafts are composed of garnet schist type rock with no massive sulfides present. Both shafts are collapsed and have established vegetations. The shafts are located behind the “Gold Rush Loop Tour Sign.”

Photo 5. Gold Rush Loop Tour sign in front of Badger Shafts (7/29/10)

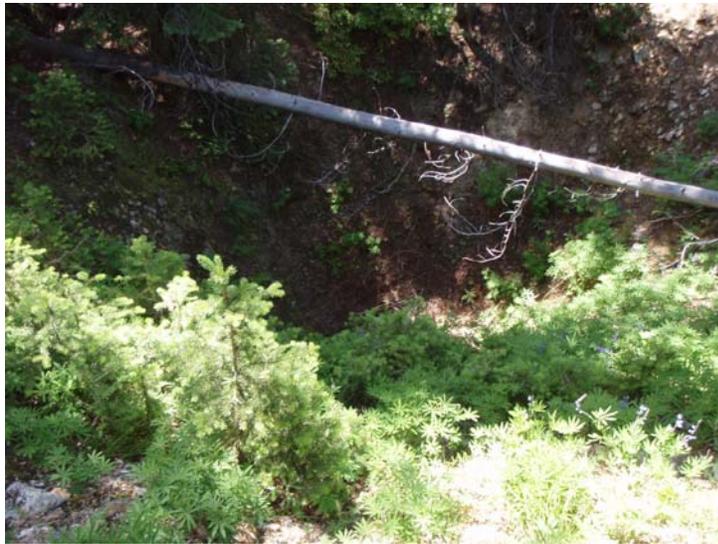
Photo 6. Badger Shaft 1, collapsed with established vegetation (7/29/10)

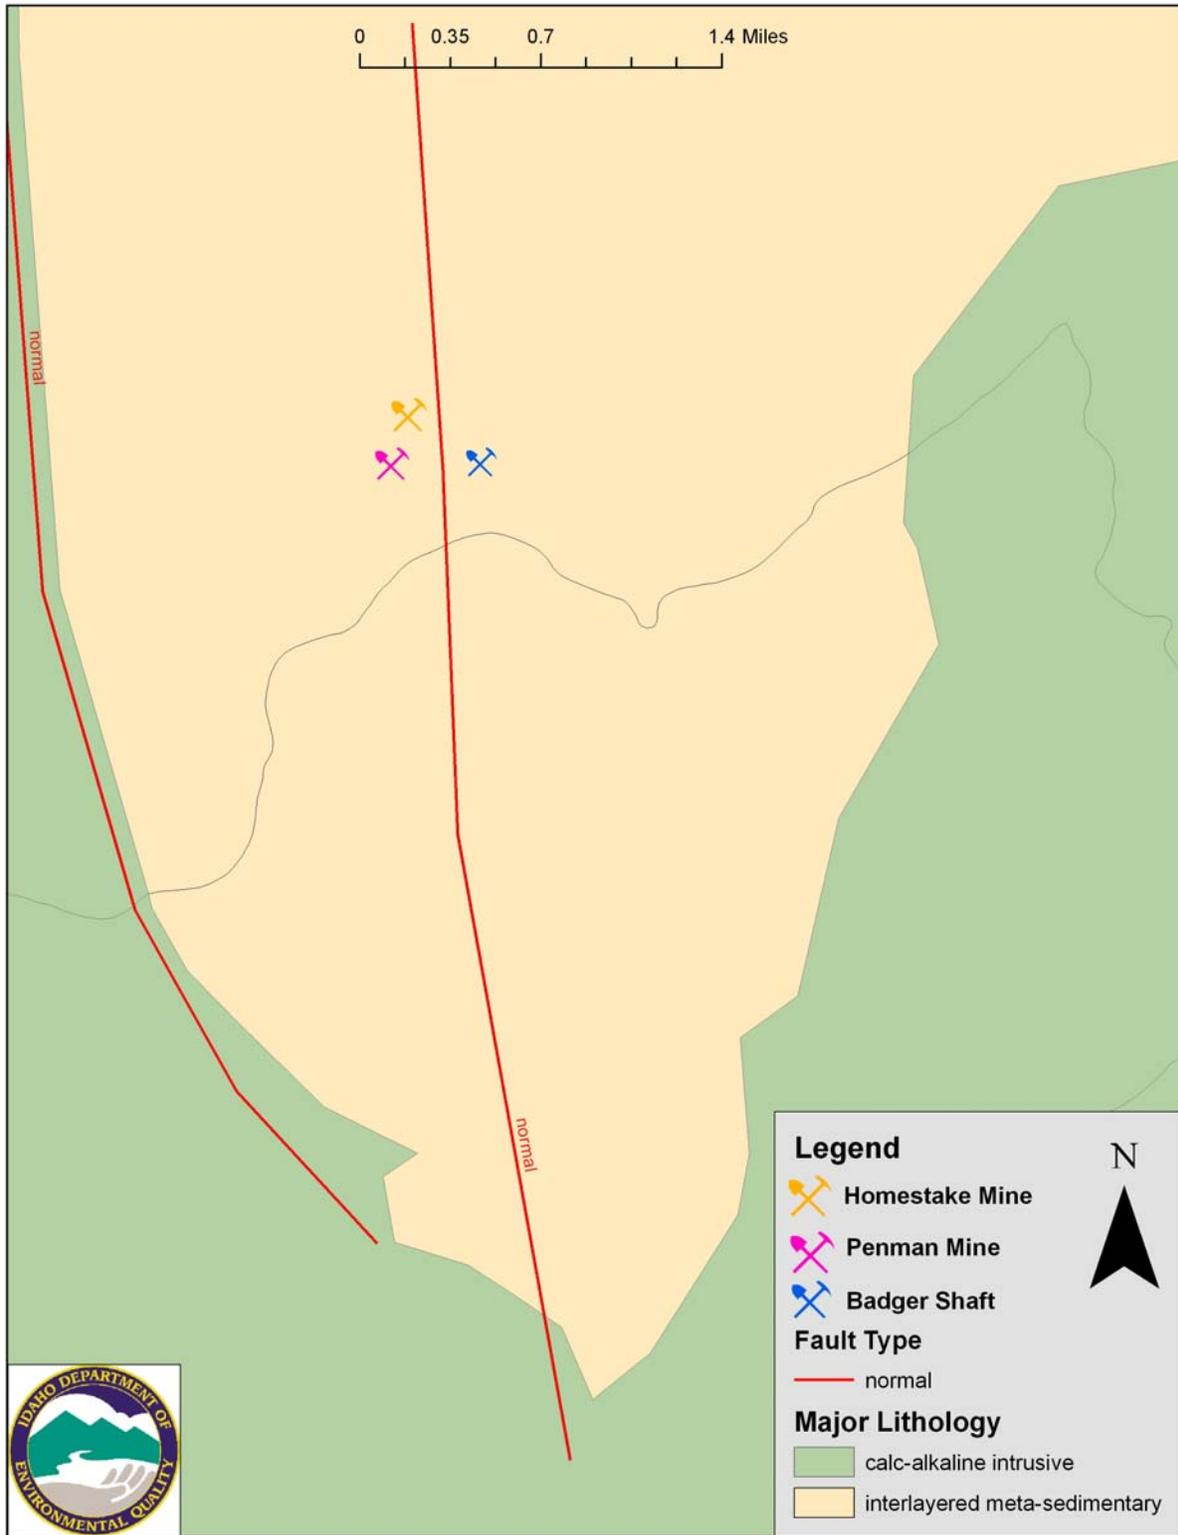
Map 2. Major Lithology of Homestake Mine, Badger Shaft, and Penman Mine and Surrounding Area (Map Source: SDE Feature Class, USGS 1995. Idaho DEQ GIS ArcSDE 9.2 Geodatabase)

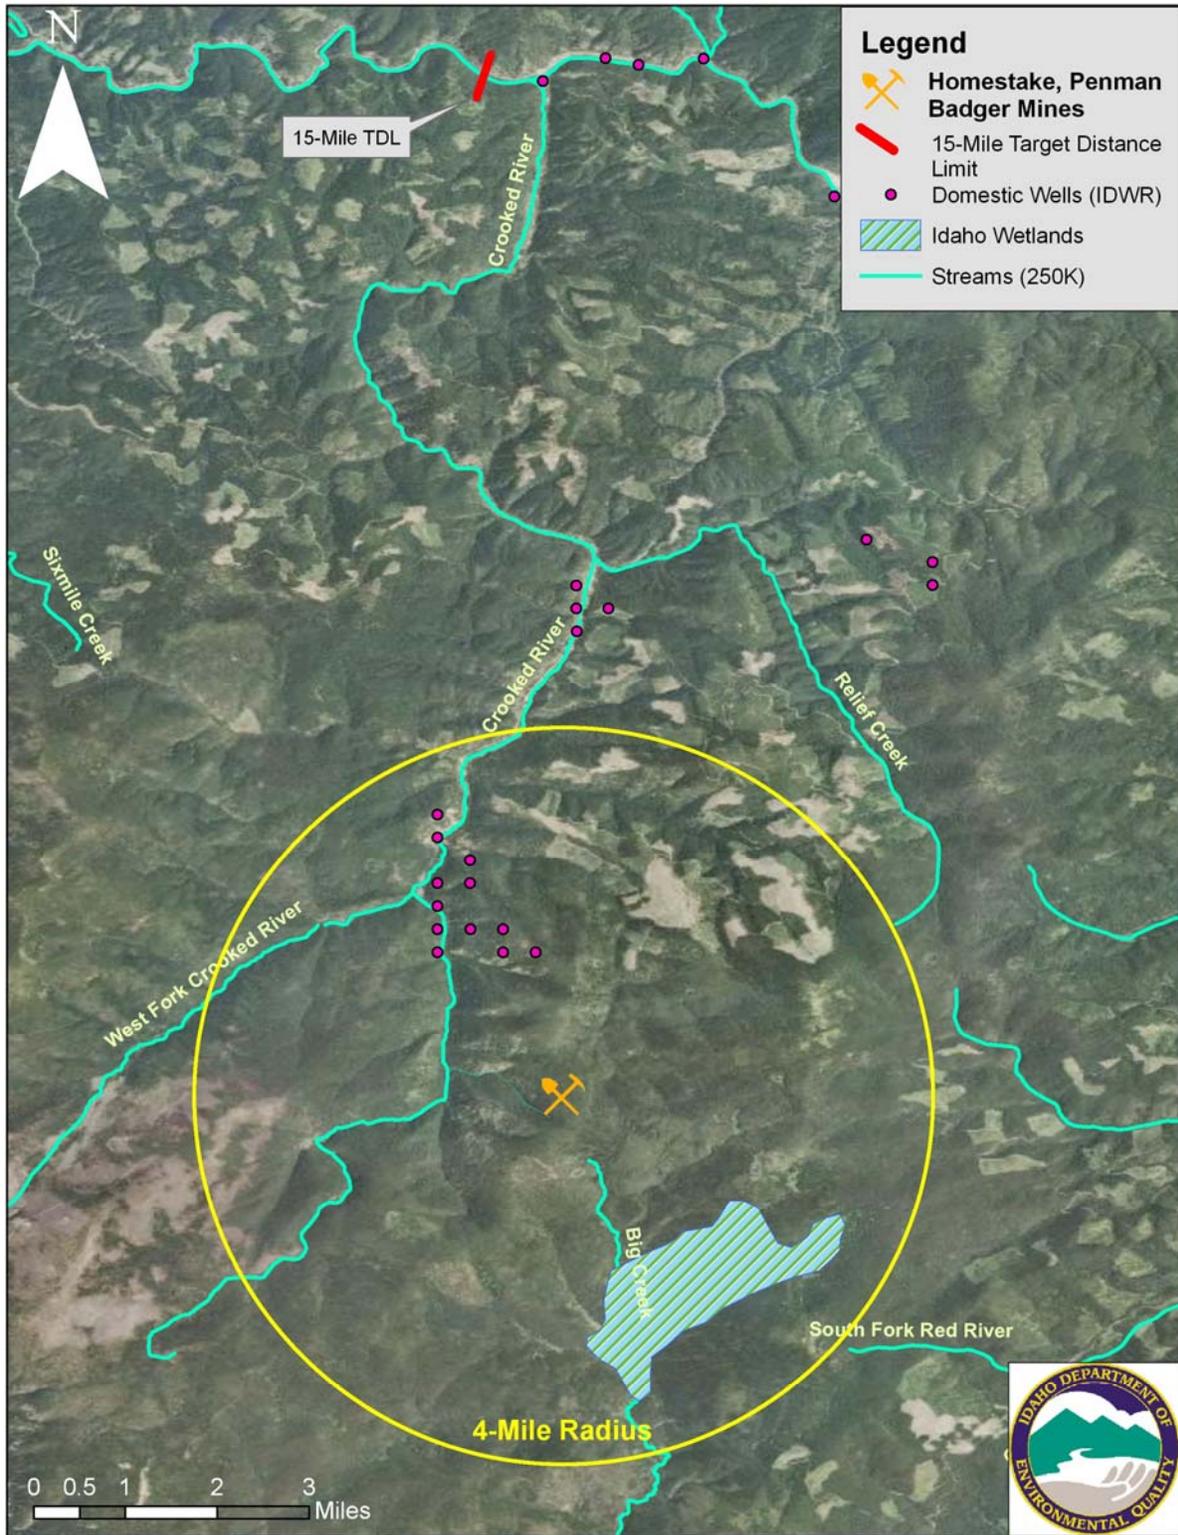
Map 3. Domestic Well Locations. There are no public water systems within the four mile radius, 15 mile target distance limit (TDL). Wetlands run along Big Creek, however they are segregated by structural geology. (Map Source: 2009 Natural Color 1-meter NAIP Idaho Map)

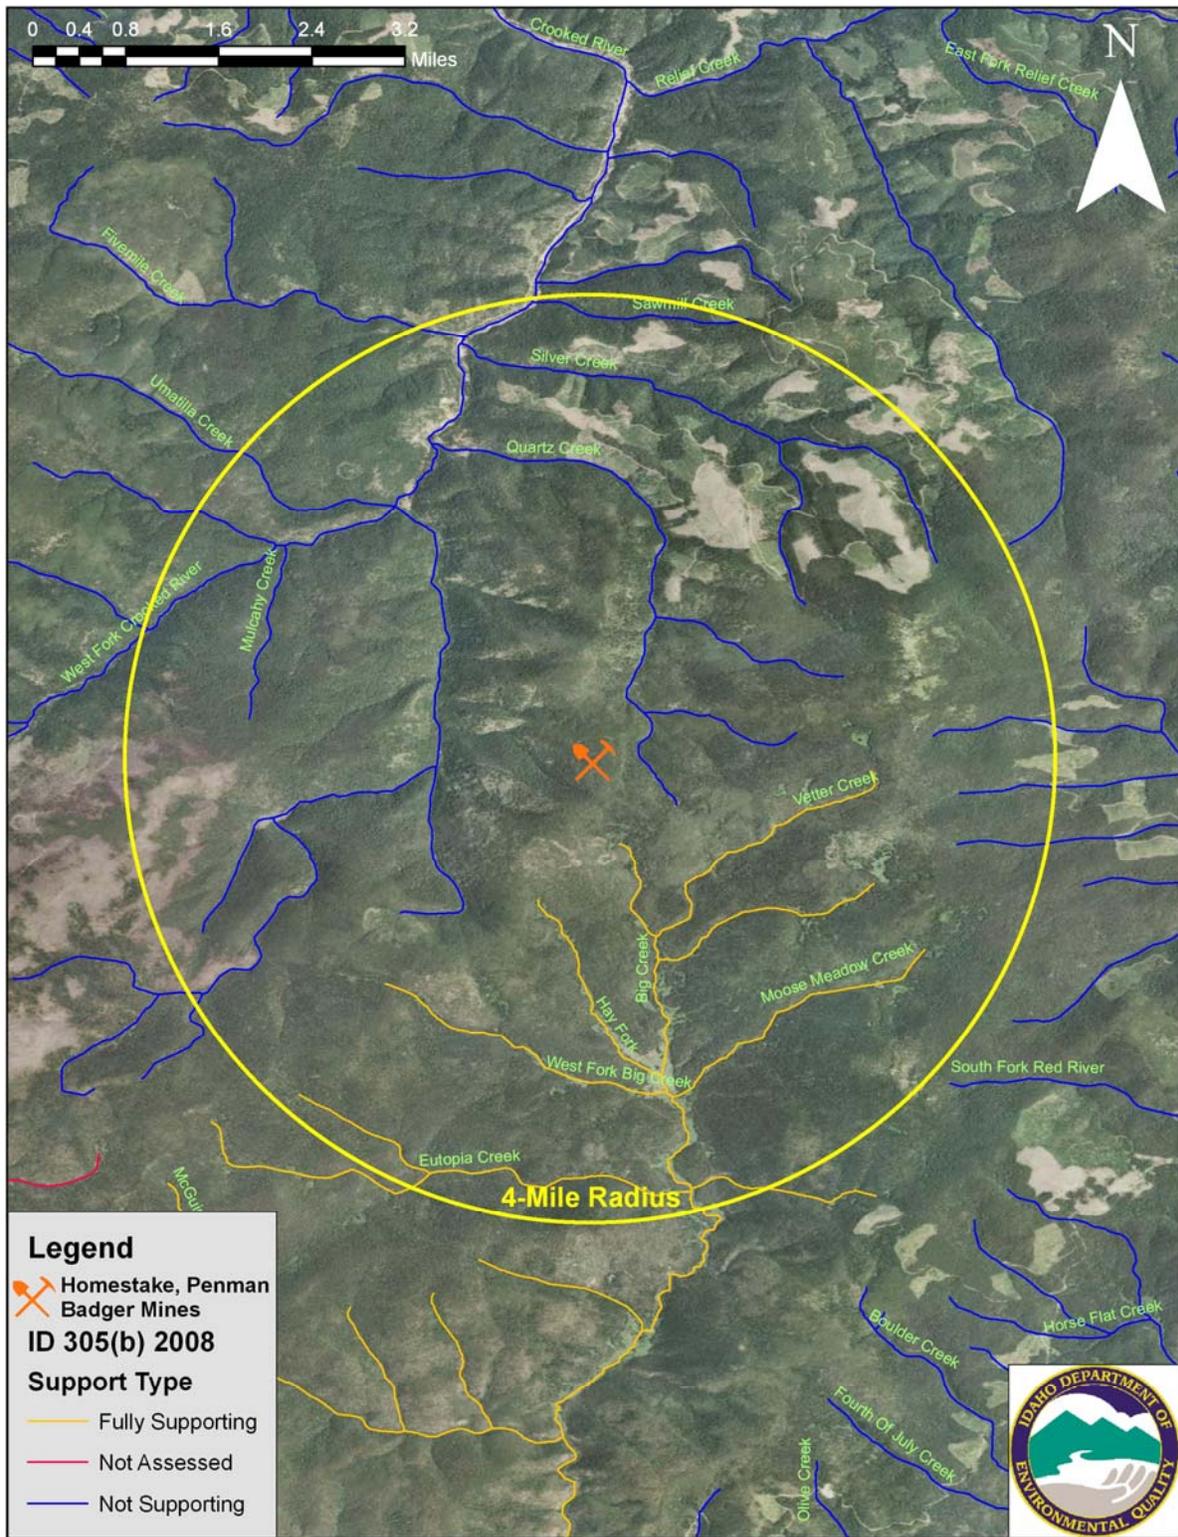
Map 5. Sensitive Waterways within Four Mile Radius and Surrounding Area (Map Sources: SDE Feature Dataset, Animal Conservation Database and Idaho DEQ GIS ArcSDE 9.2 Geodatabase, 2009 Natural Color 1-meter NAIP Idaho Map)
