RE: Site Assessment of the Knob Hill Pit Mine

ABBREVIATED PRELIMINARY ASSESSMENT CHECKLIST

Site Name: Knob Hill Pit

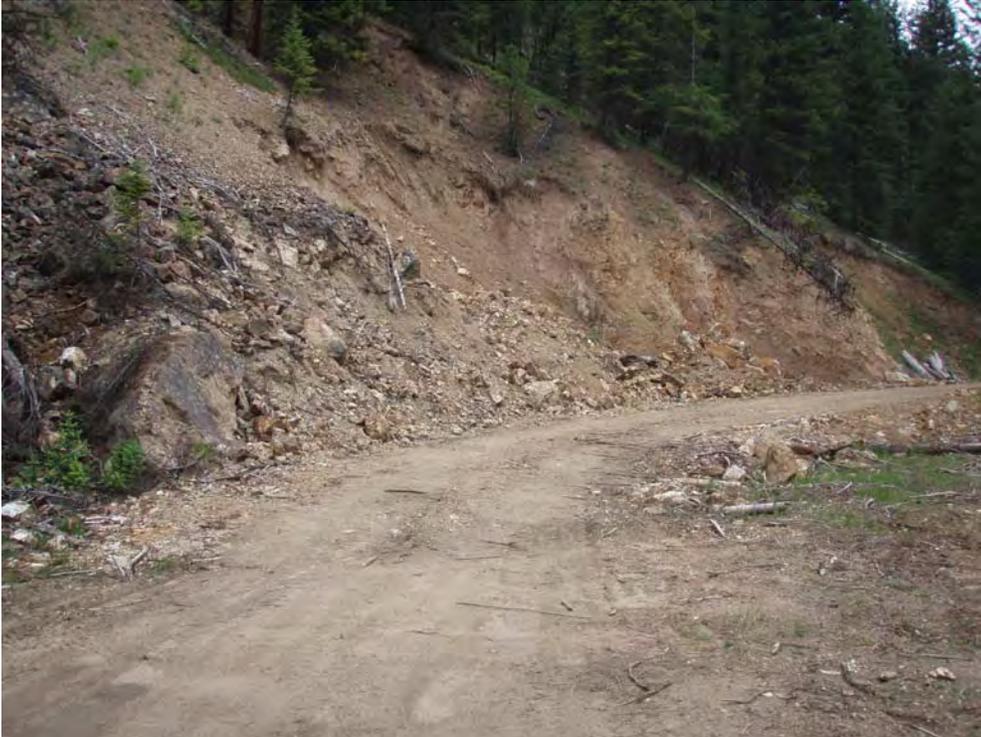
Knob Hill Pit. The remaining high wall material is native material and country rock.

This site was investigated for potential releases of heavy metals and sediment from mine waste dumps and potential discharges of other deleterious materials, such as petroleum products and ore processing chemicals. No evidence or indications of these materials were located on site. See site photograph at the end of this report.

A site inspection involving direct observations confirmed contaminants of concern do not exist in concentrations that present a threat to human health or environments. No contaminants, equipment, or mining related articles are on the site. No evidence of tailings piles or waste dumps remains. The pit at this site is a large excavation into the slope on the north side of Road 233A. The excavation forms a 100 foot high concave high wall. (See photograph at the end of this report.) The excavation material, extensively modified by the road, does not impinge on Quartz Creek. The road serves as a drainage/water barrier between the high wall and the creek.

As demonstrated by the picture at the end of this report, no mining related equipment or activities remain, with the exception of the high wall. A well established and long standing road is at the toe of the high wall effectively forming a barrier between the high wall and the creek. The high wall is composed of native material lacking any significant mineralization. It appears that if any ore was present it was transported elsewhere for milling.

There were no direct airborne, surface water, or ground water pathways to any water sources or residences. What appears to be a seasonal cabin is approximately ¼ mile down slope and well away from the site. Any historic mining related material, such as tailings, have either been incorporated into the road or hauled off site long ago. The remaining high wall material is native material and country rock. No significant evidence of mineralization remains at the mine site.

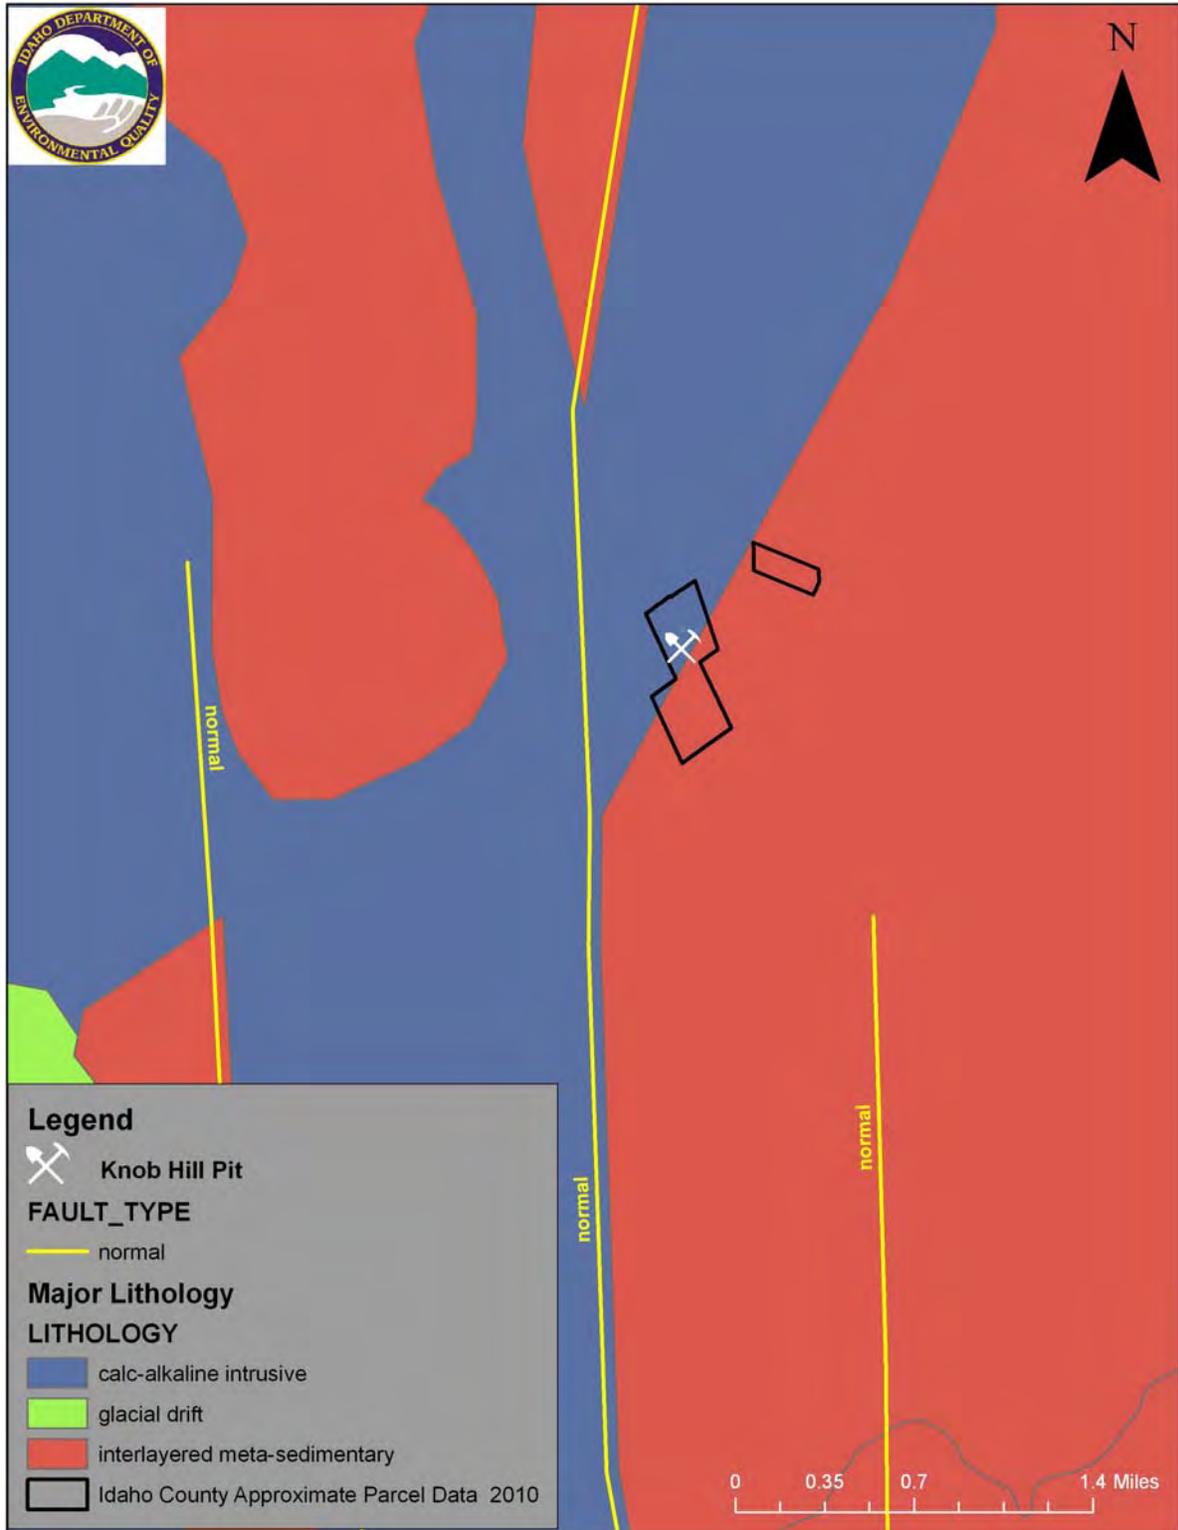
Map 2. Major Lithology of the Knob Hill Pit and Surrounding Area. (Map Source: SDE Feature Class, USGS 1995. Idaho DEQ GIS ArcSDE 9.2 Geodatabase)

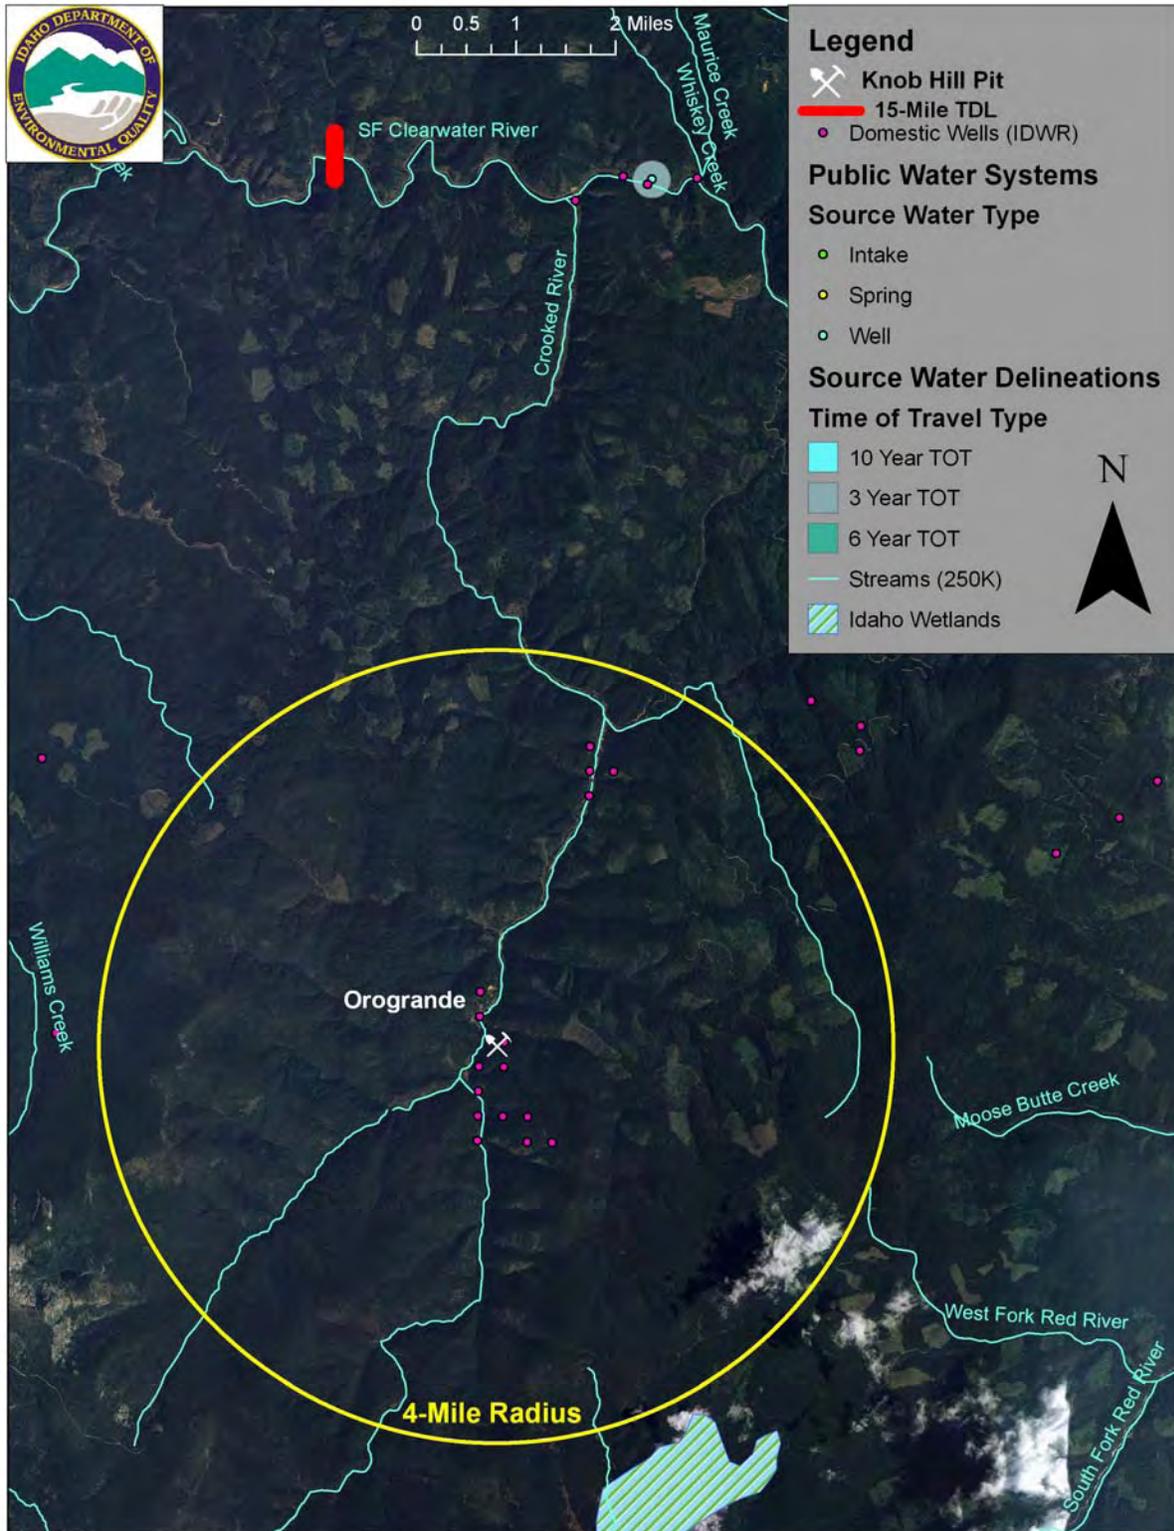
Map 3. Domestic Well Locations. There were no public water systems within the four mile radius. 15 Mile Target Distance Limit (TDL). Wetlands run along Big Creek outside of the four mile radius. (Map source: 2004 NAIP).

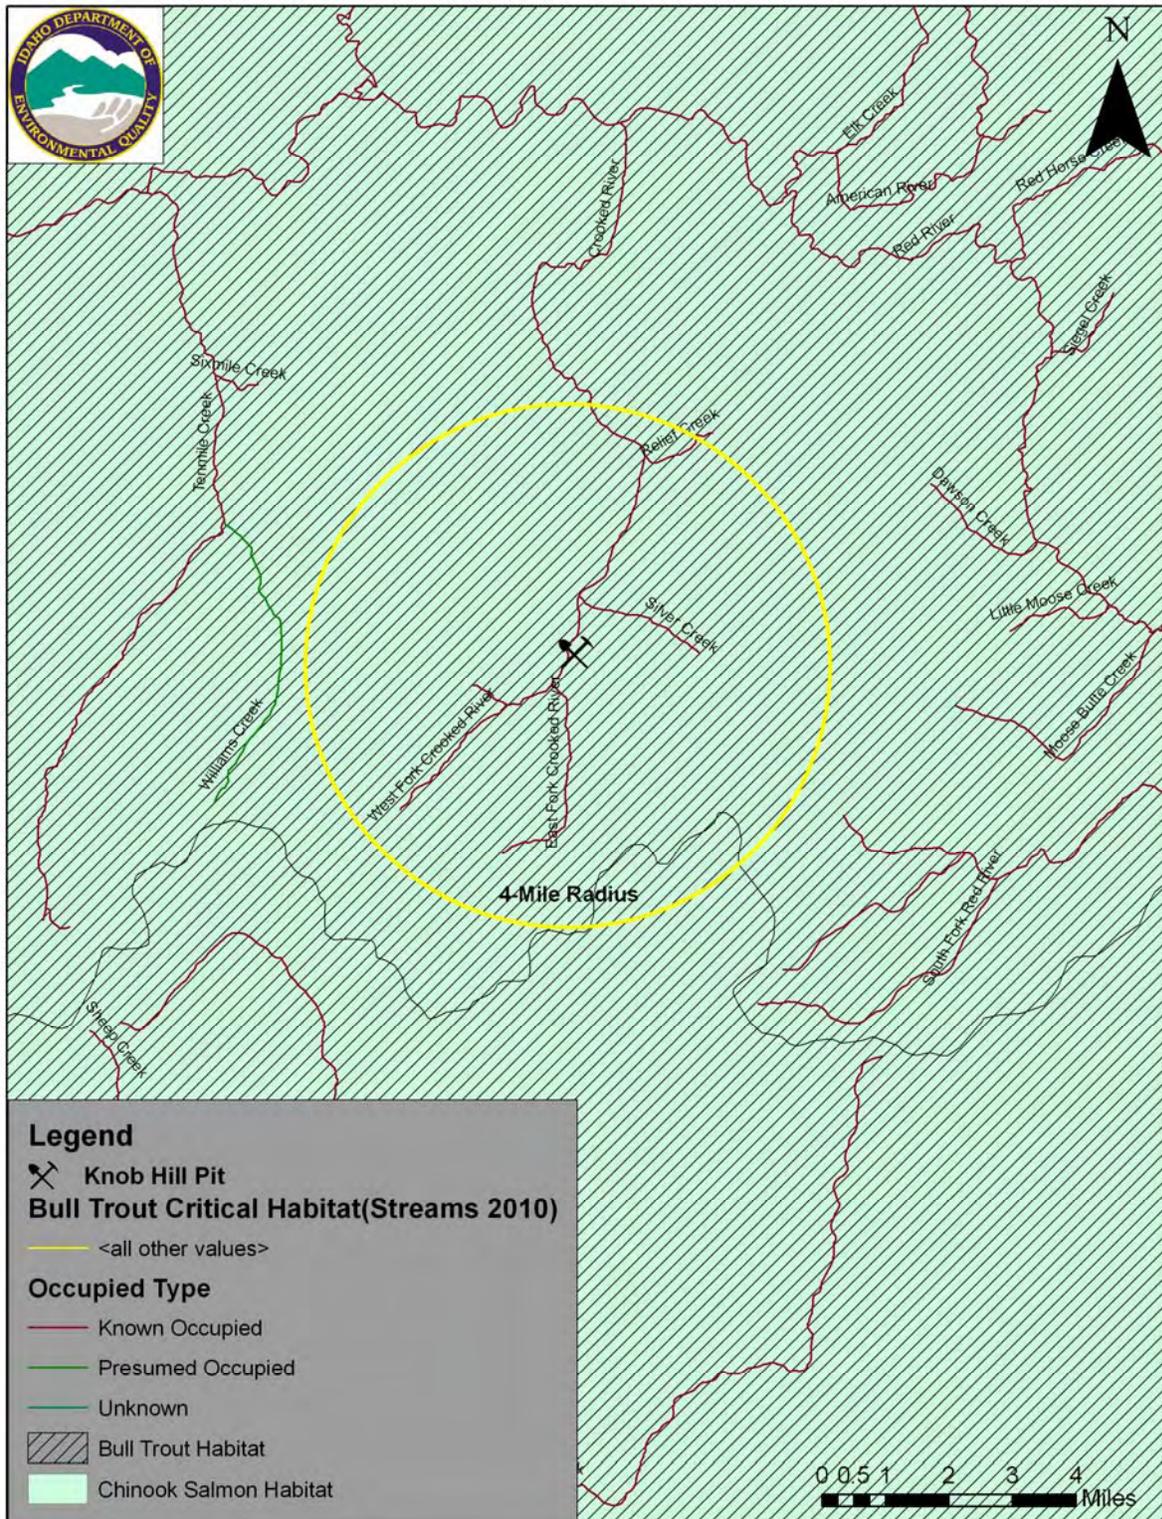
Map 5. Fisheries Within Four Mile Radius and Surrounding Area. (Map Source: SDE Feature Dataset, Animal Conservation Database. Idaho DEQ GIS ArcSDE 9.2 Geodatabase)
