RE: Abbreviated Preliminary Assessment Report and Recommended Determination for the Spring Mountain Mines, aka Annex Lode, Excelsior, Excelsior No. 1, Excelsior No. 2, Excelsior No. 3, Excelsior No. 4, Excelsior Fraction, War Eagle, Constance, Constance No. 1, Constance No. 2, Newport, Weiss, Pay Rock, Winnie, Winnie Mill Site, Relief, and Apex patented mining claims.

ABBREVIATED PRELIMINARY ASSESSMENT CHECKLIST

Site Name: Spring Mountain Mines

Spring Mountain Mines and Mill Sites Photo Log and Site Conditions

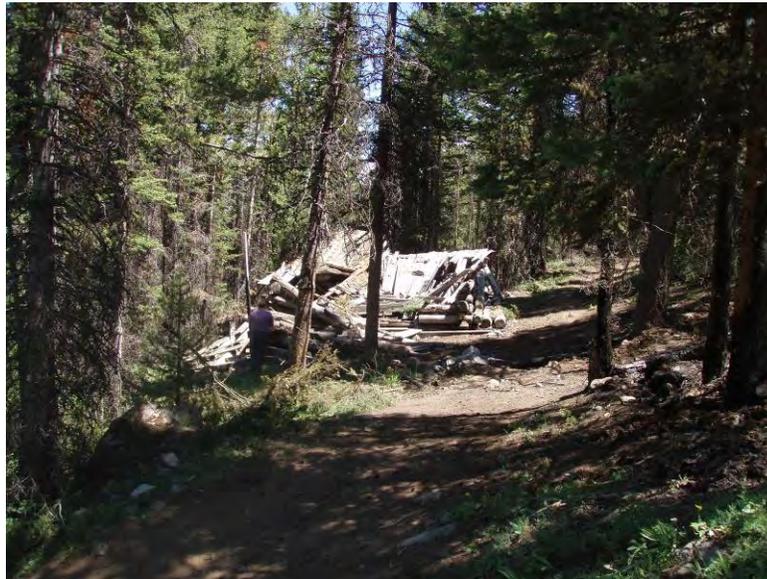
The Rex Mill Site aka Winnie Mill Site(?) located at the mouth of Horseshoe Gulch burned to the ground in 2010 after a lightning strike. It was obvious the site was frequented by recreational users, but other than the extensive evidence of mill building construction, there was no evidence of tailings or other wastes generated by operations.

Photo 1. The week before the site visit, the Winnie Mill Site was struck by lightning and burned to the ground. (Photo by Schuld 5/12/10)

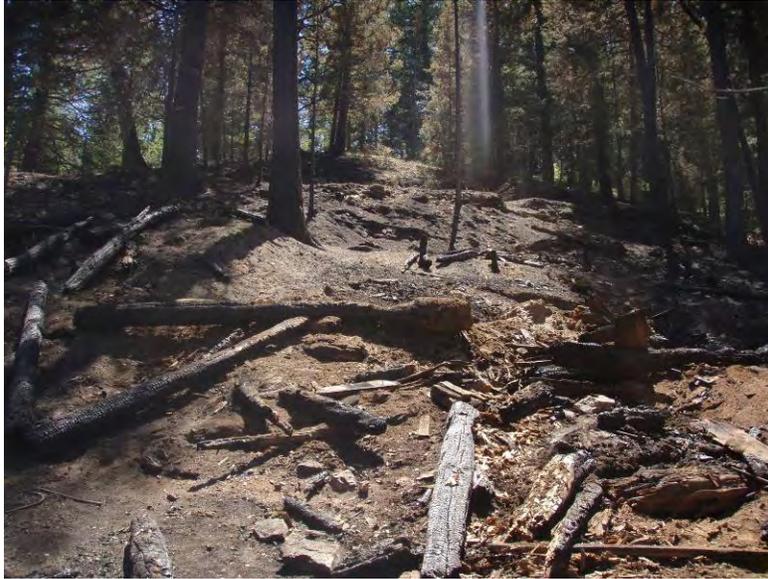
Photo 2. Burned ruins of the Winnie Mill Site. (Photo by Schuld 5/12/10)

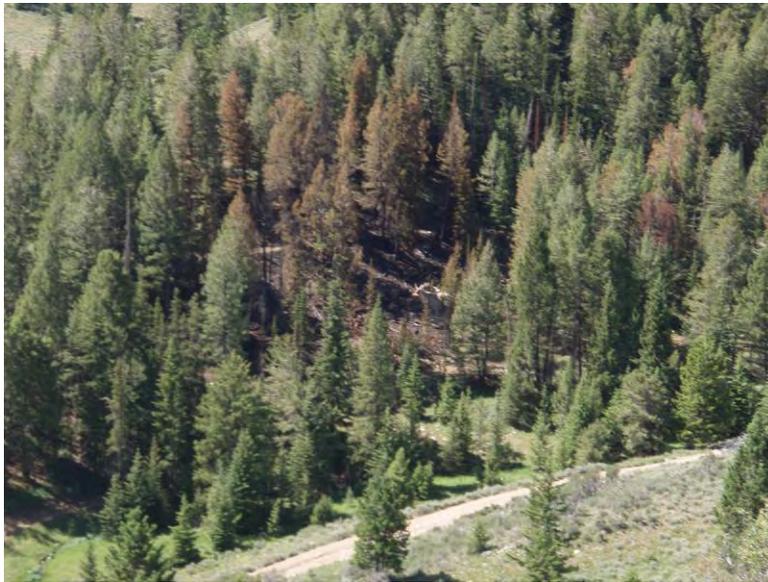
Photo 3. Winnie Mill Site. (Photo by Schuld 5/12/10)

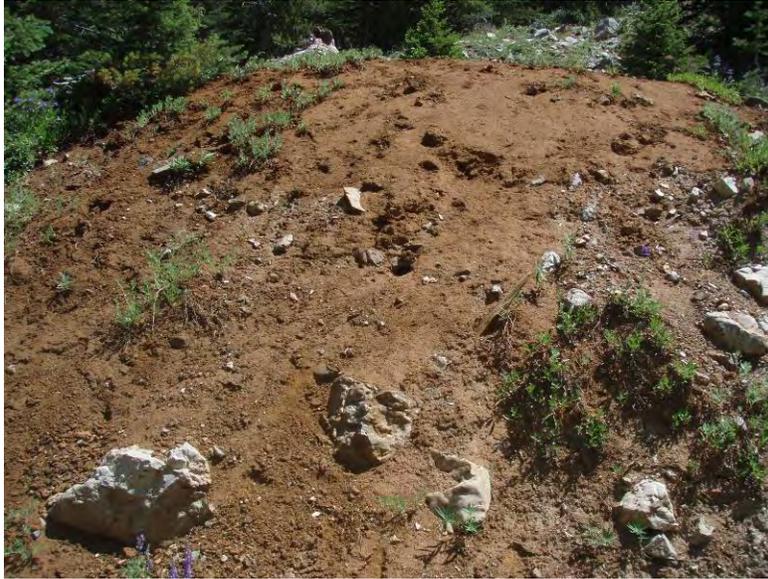
Photo4. Oxidized jig tailings. (Photo by Schuld 5/12/10)

In upper Spring Mountain Canyon there were signs some ore may have been produced (<10 yards) and a very small attempt was made to run them over a jig for concentration. There were no indications of connectivity to wetlands or perennial waterways (Tramway Creek).

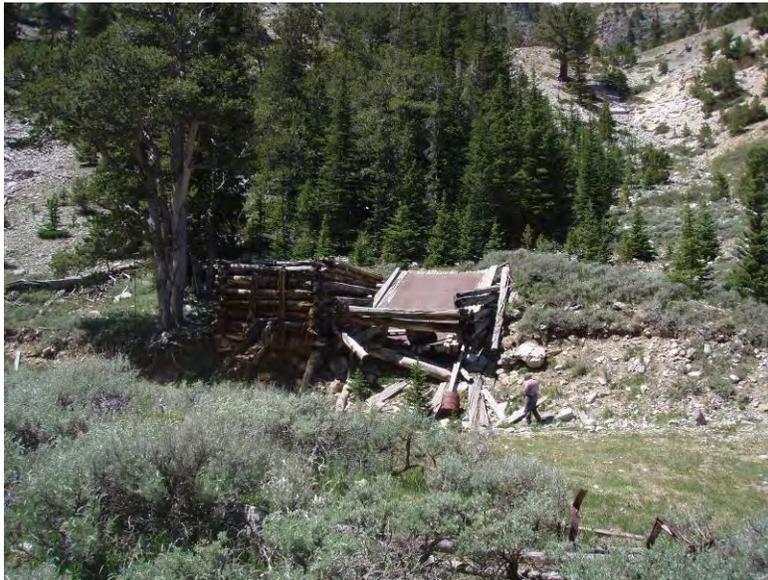
*Photo 5. Ore chute in Upper Spring Mountain Canyon.
(Photo by Schuld 5/12/10)*

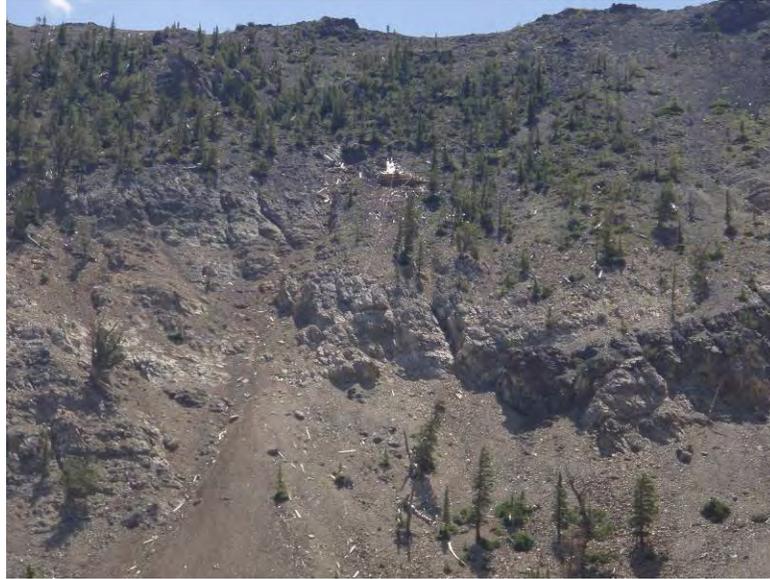
Photo 8. Tramway to adit in Upper Spring Mountain Canyon (Photo by Schuld 5/12/10)

Although the remains of four tramways and adits were identified in Upper Spring Mountain Canyon, none of the workings appeared to have generated significant waste rock.

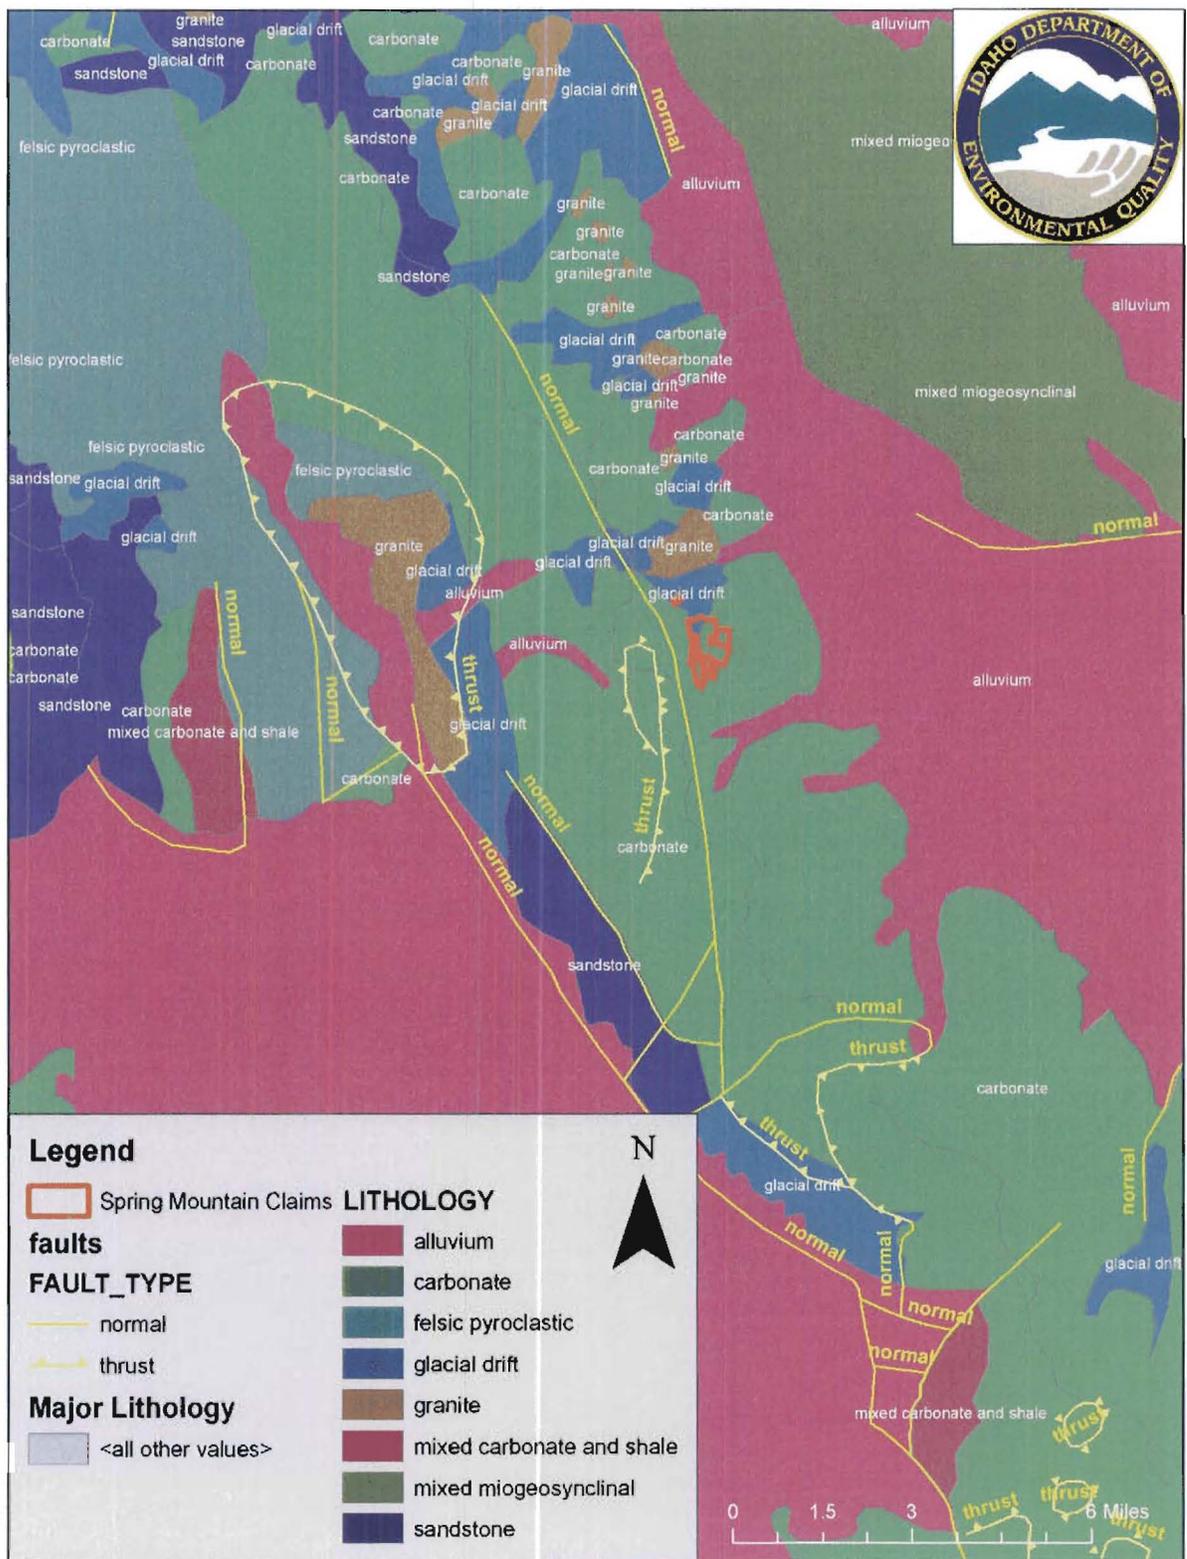
Figure 2. Lithology of the Spring Mountain Claims. (Map source: Idaho DEQ ArcSDE 9.2 Geodatabase)

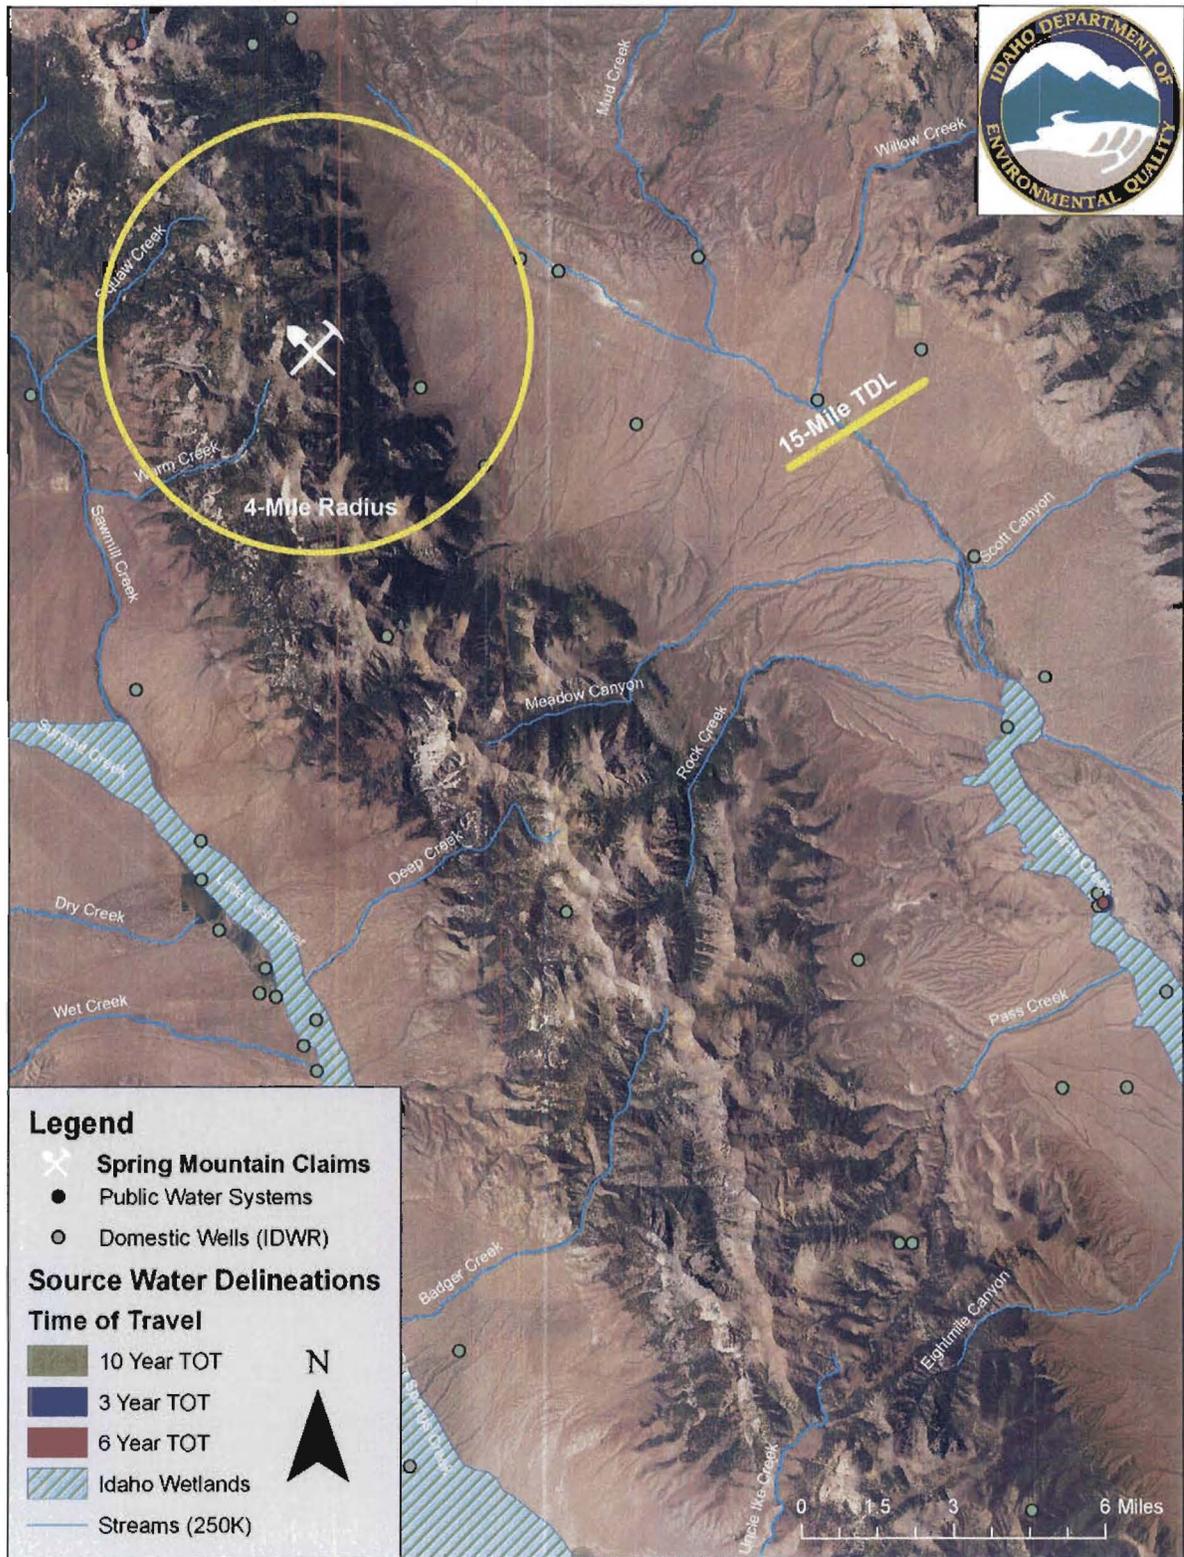
Figure 3. Drinking water well locations and source water delineations. 15-Mile Target Distance Limit (TDL). Wetlands are present on Birch Creek, approximately 6 miles past the 15-Mile TDL. (Map source: Lemhi County NAIP 2004)
