The Challenge of Managing Large Woody Material and Protecting Water Quality in the NF Coeur d'Alene River System

January 28, 2010

Kajsa Stromberg, IDEQ

Prepared for NFCDA Watershed
Advisory Group

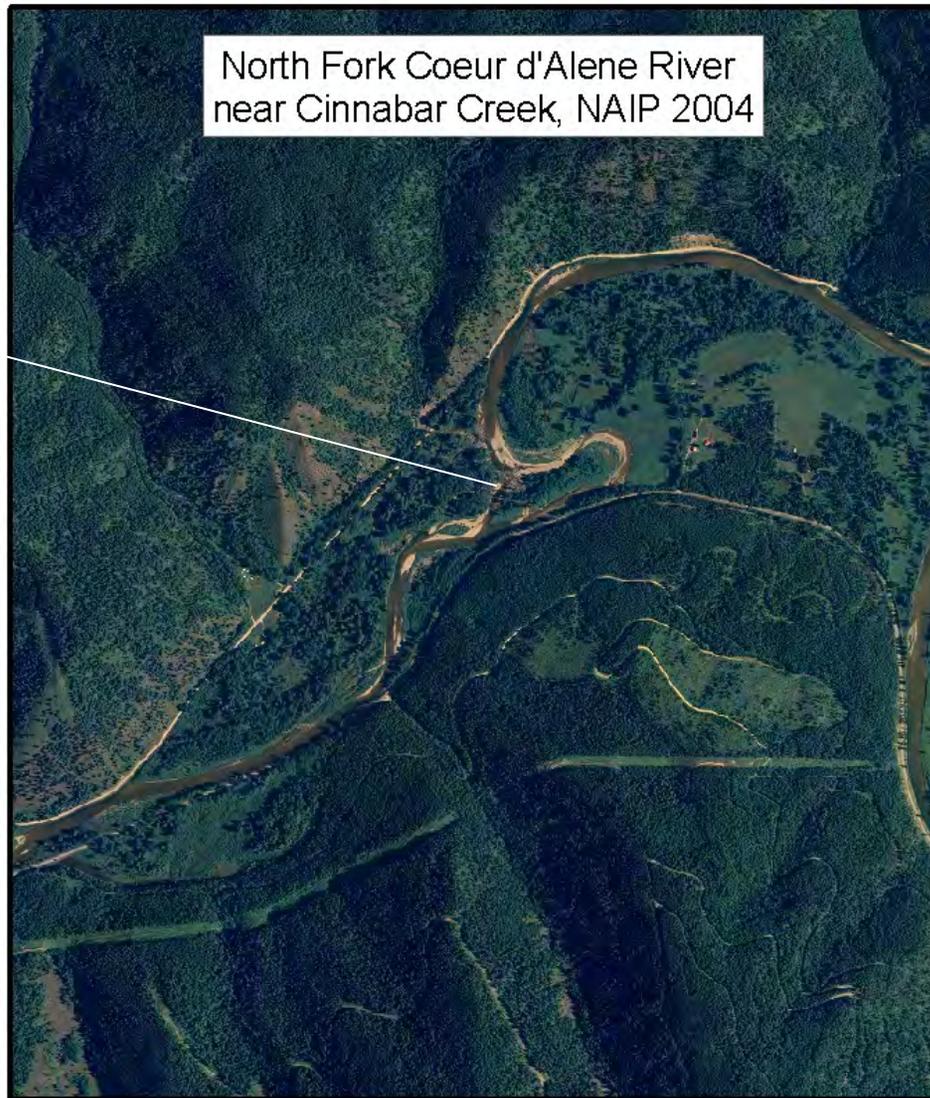
11/09/2009

Log jam visible
in 2004 aerial
photo.

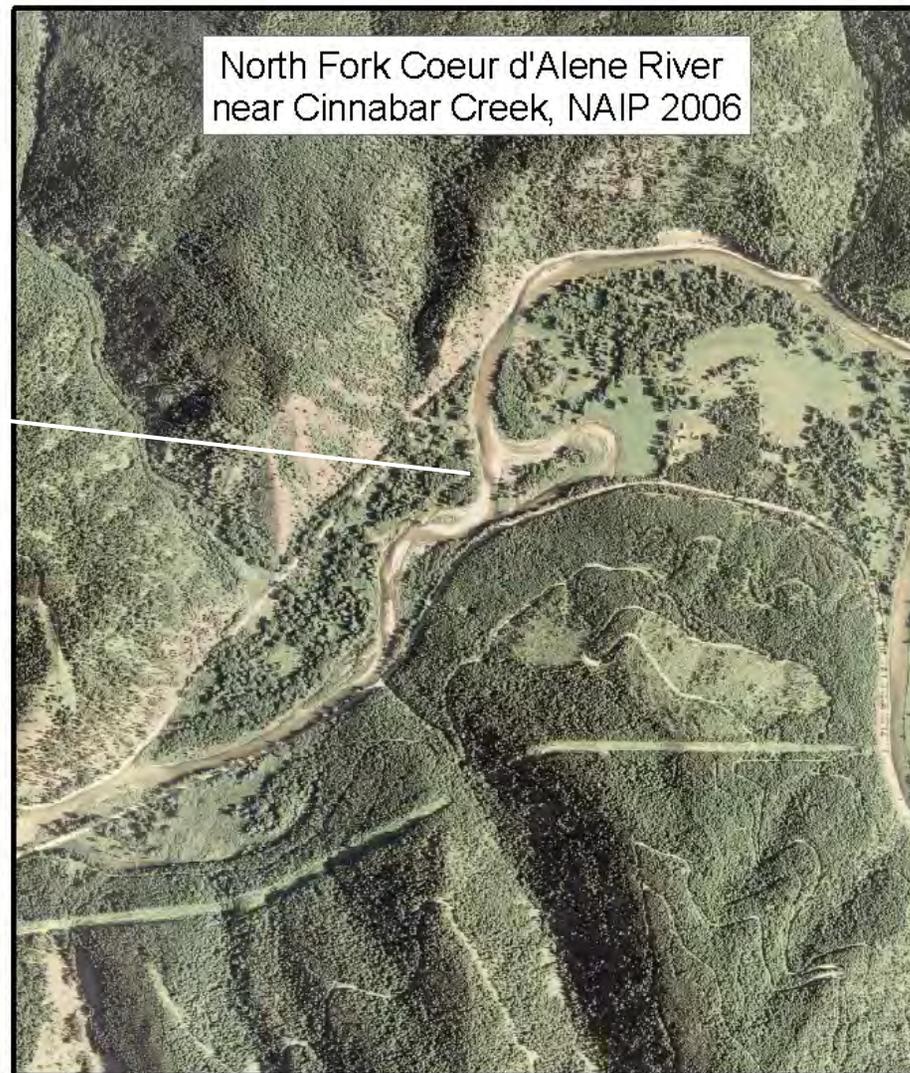
11/09/2009

By 2006 aerial photo, the log jam was no longer in this location and channel shifts are observed.

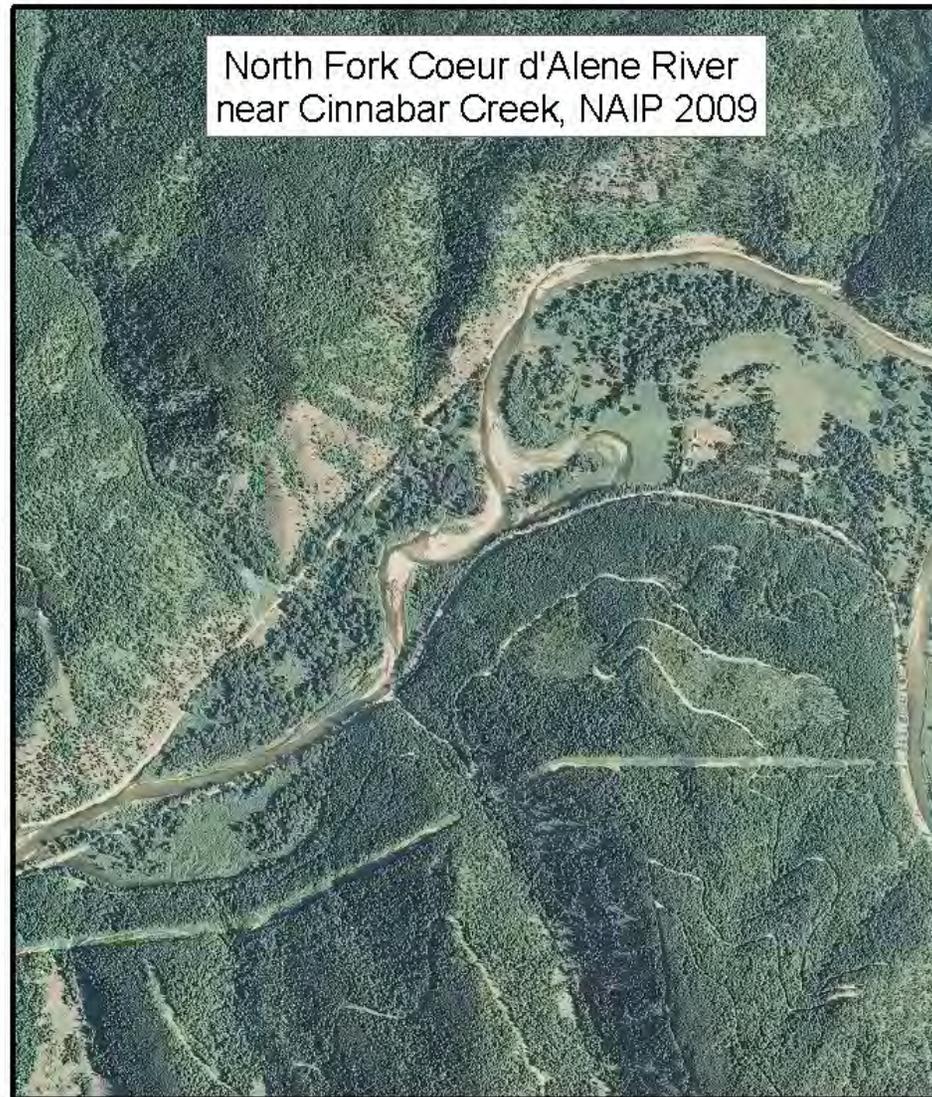
11/09/2009

2009 satellite images show large shifts in channel in this very dynamic reach of the NFCDA River.

DEQ suggests photomonitoring to evaluate effects of wood management

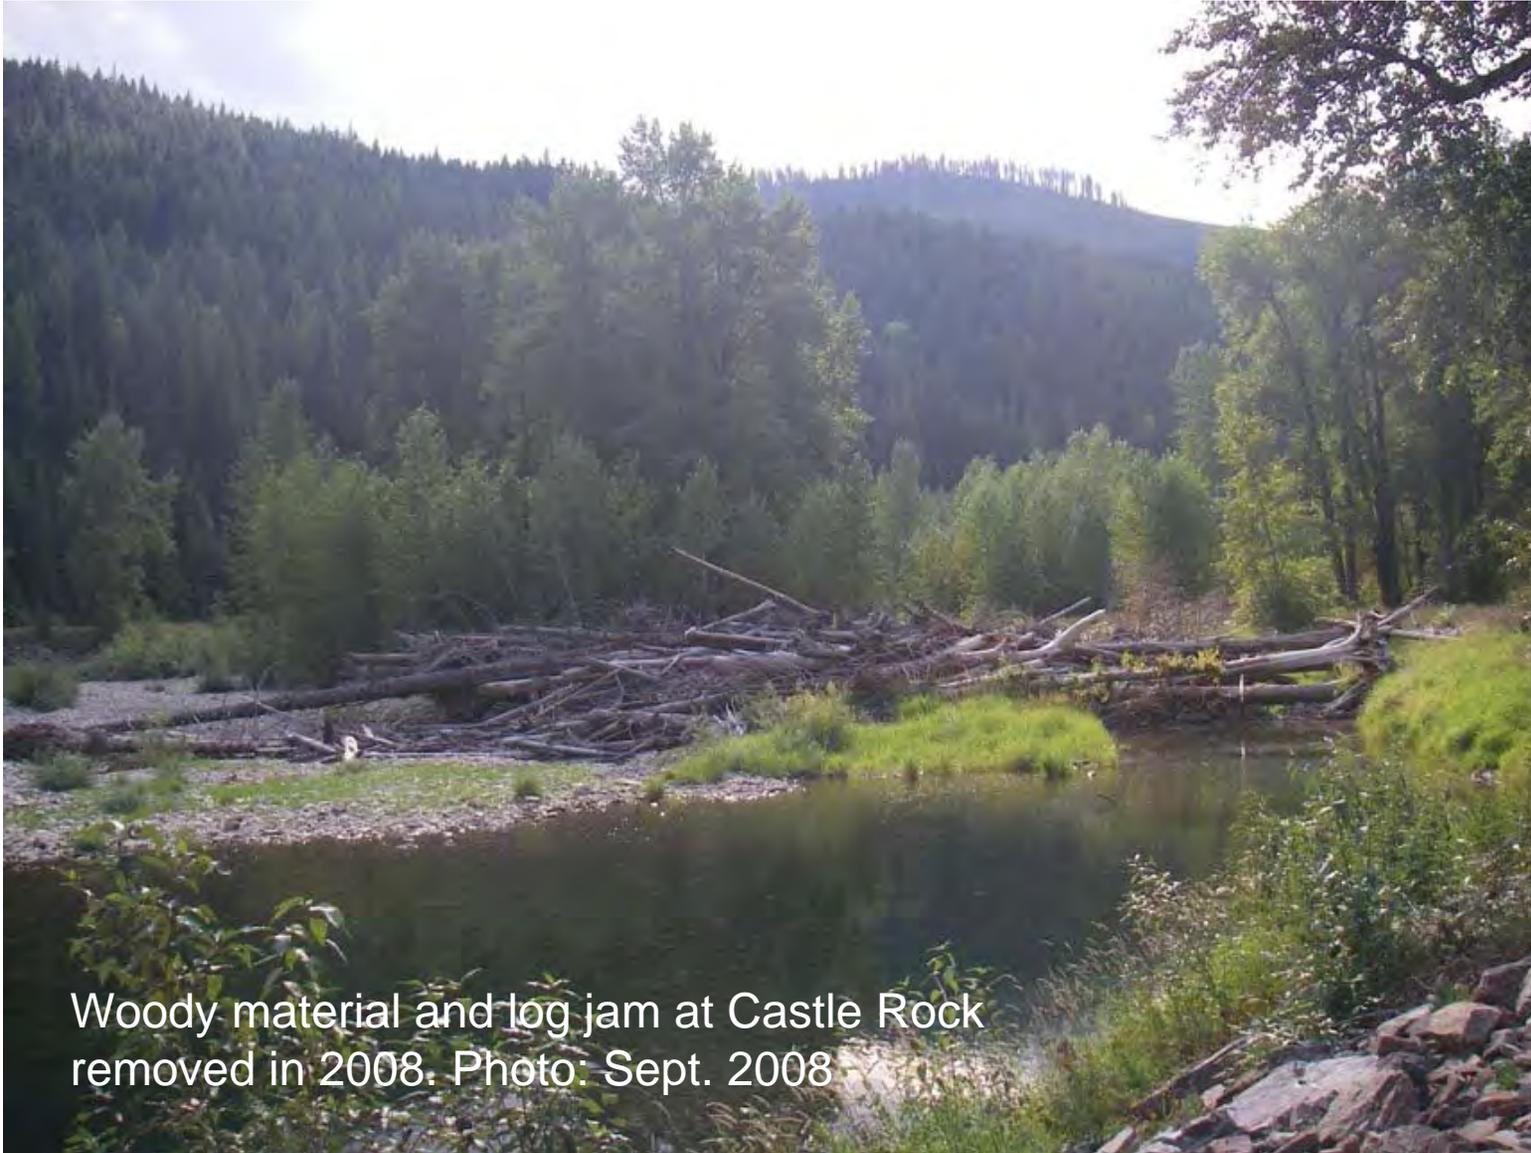
Example photomonitoring – Castle Rock

Woody material and log jam at Castle Rock removed in 2008. Photo: Sept. 2008

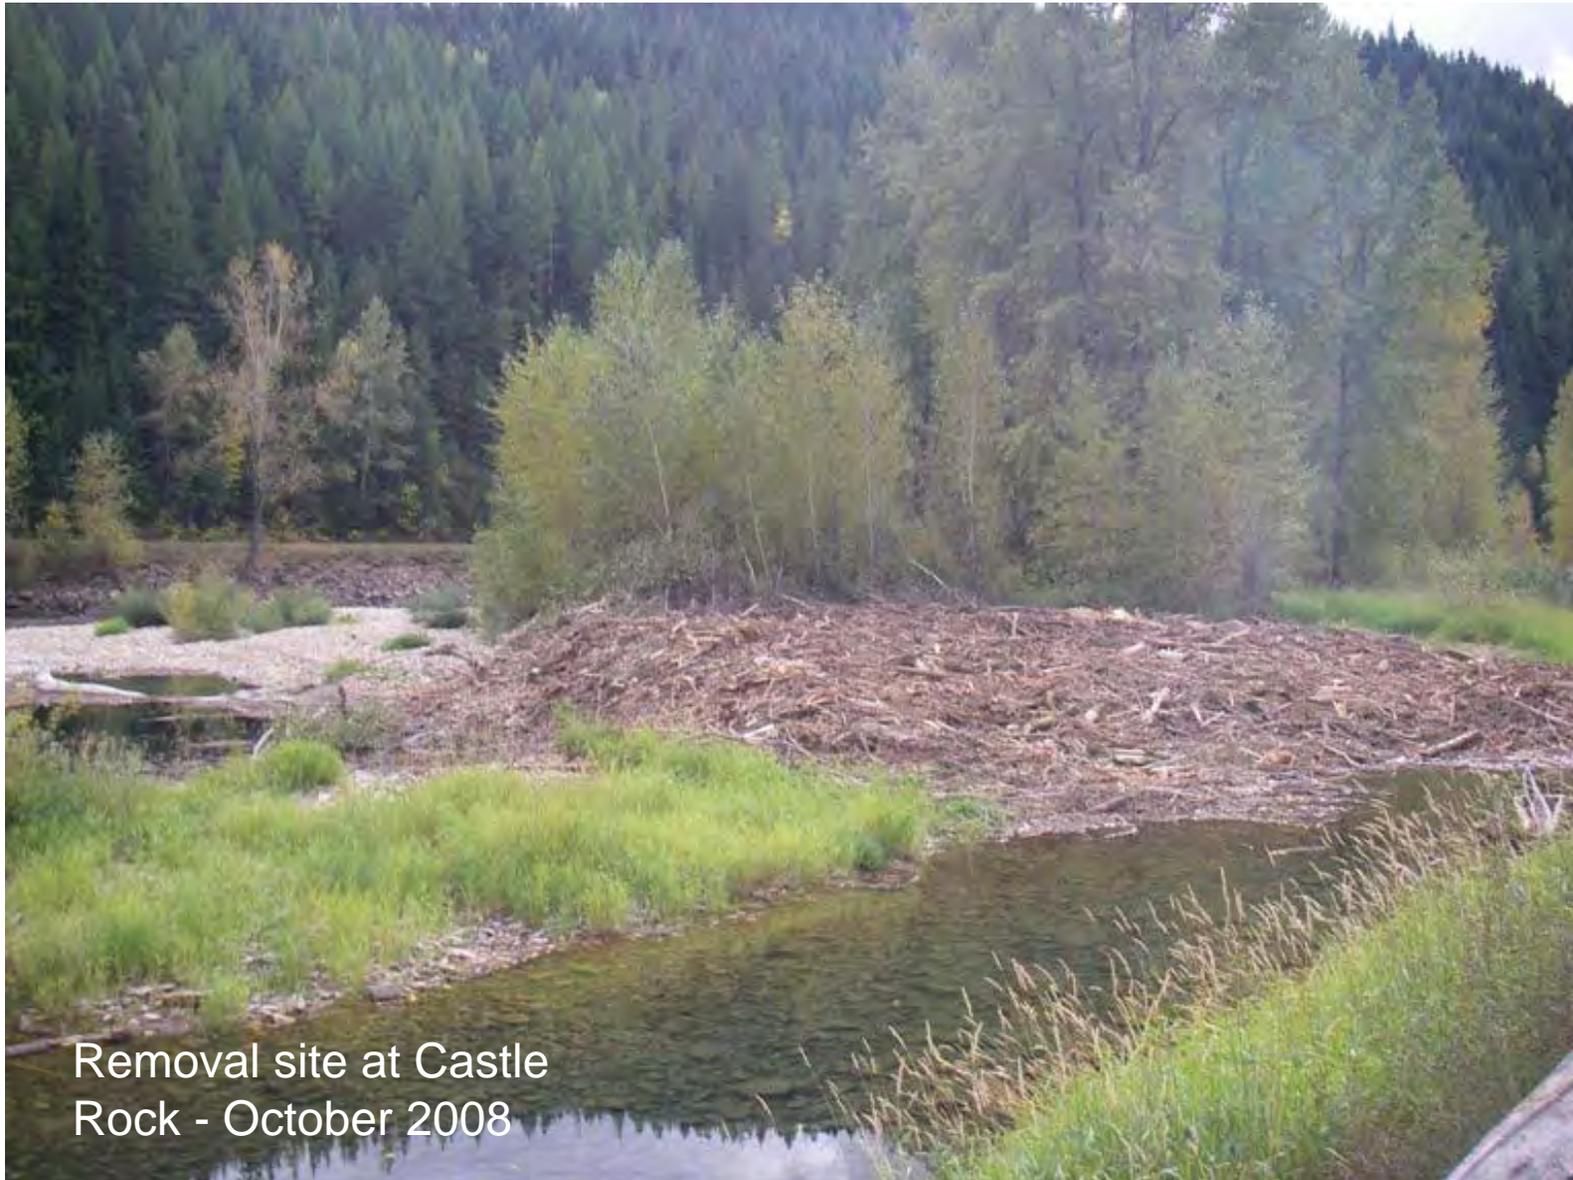
Example photomonitoring – Castle Rock

Removal site at Castle
Rock - October 2008

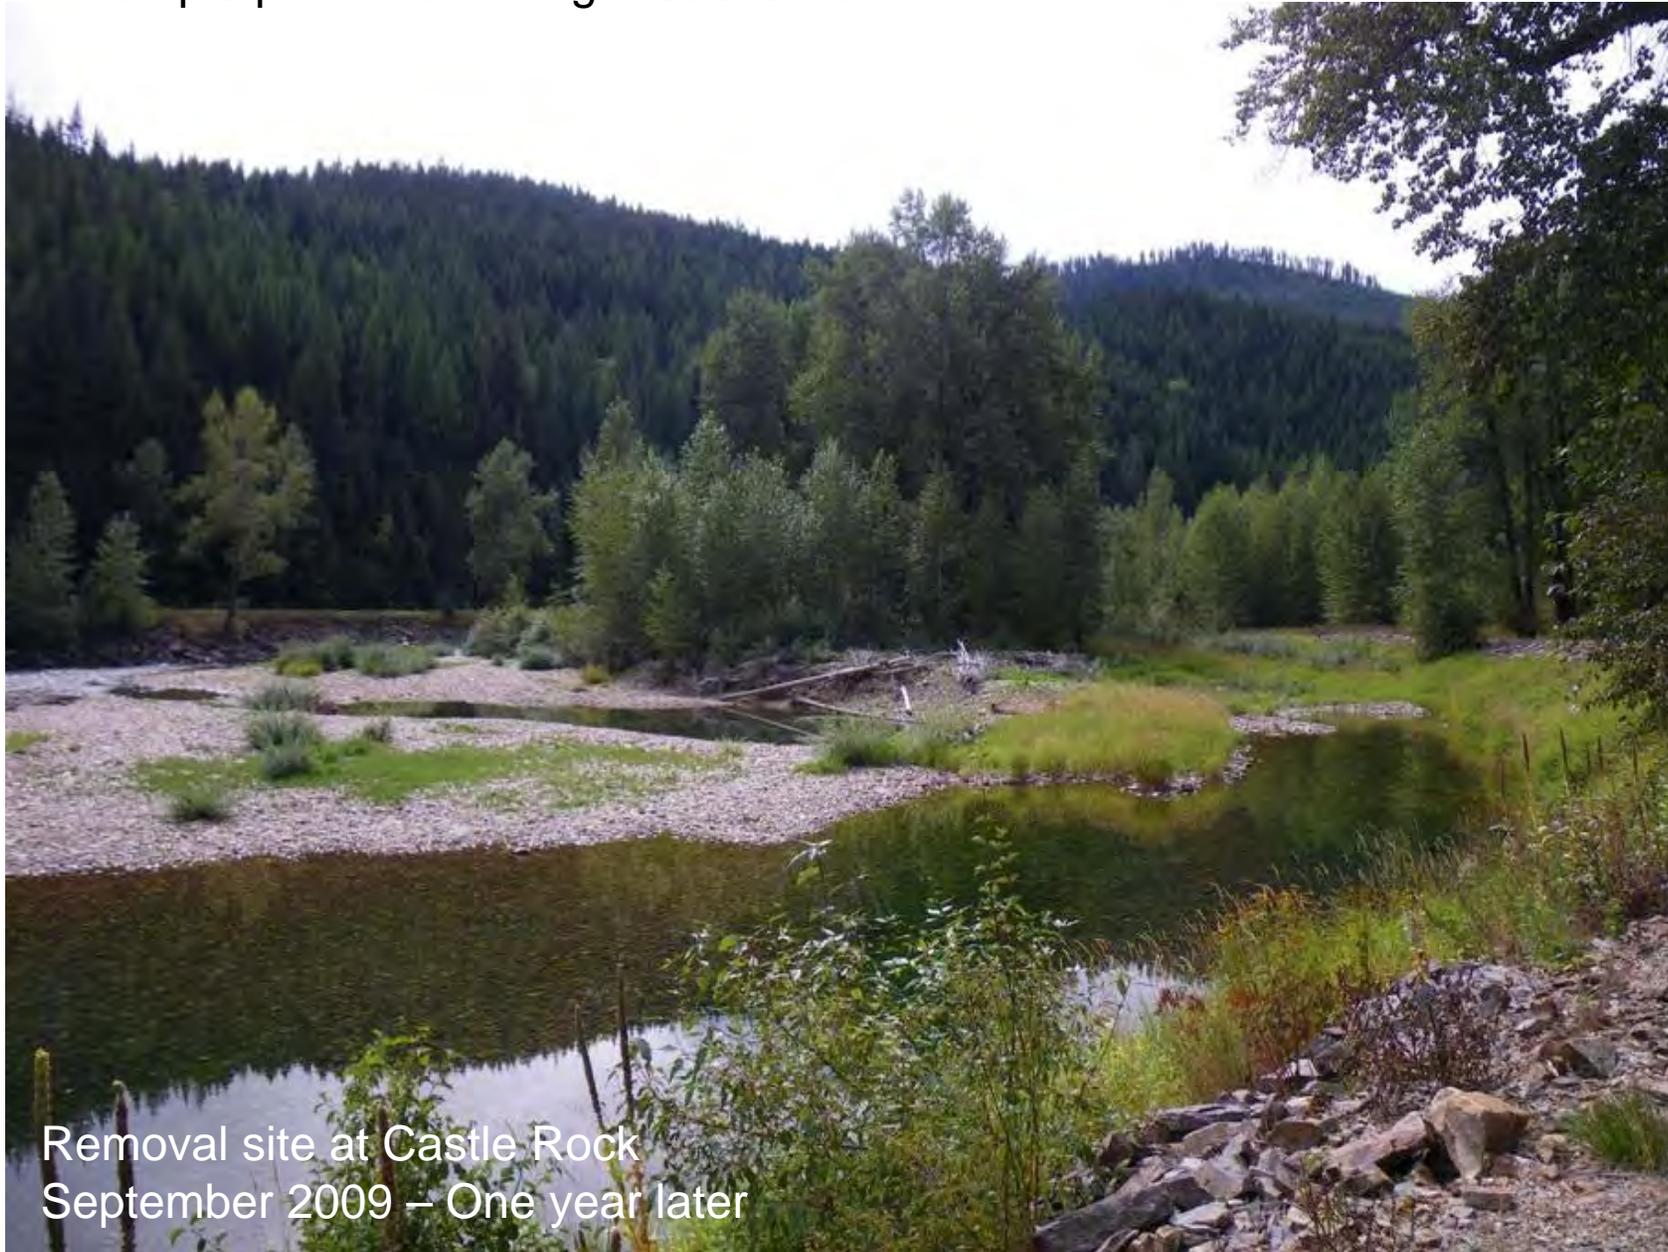
Example photomonitoring – Castle Rock

Removal site at Castle Rock
September 2009 – One year later

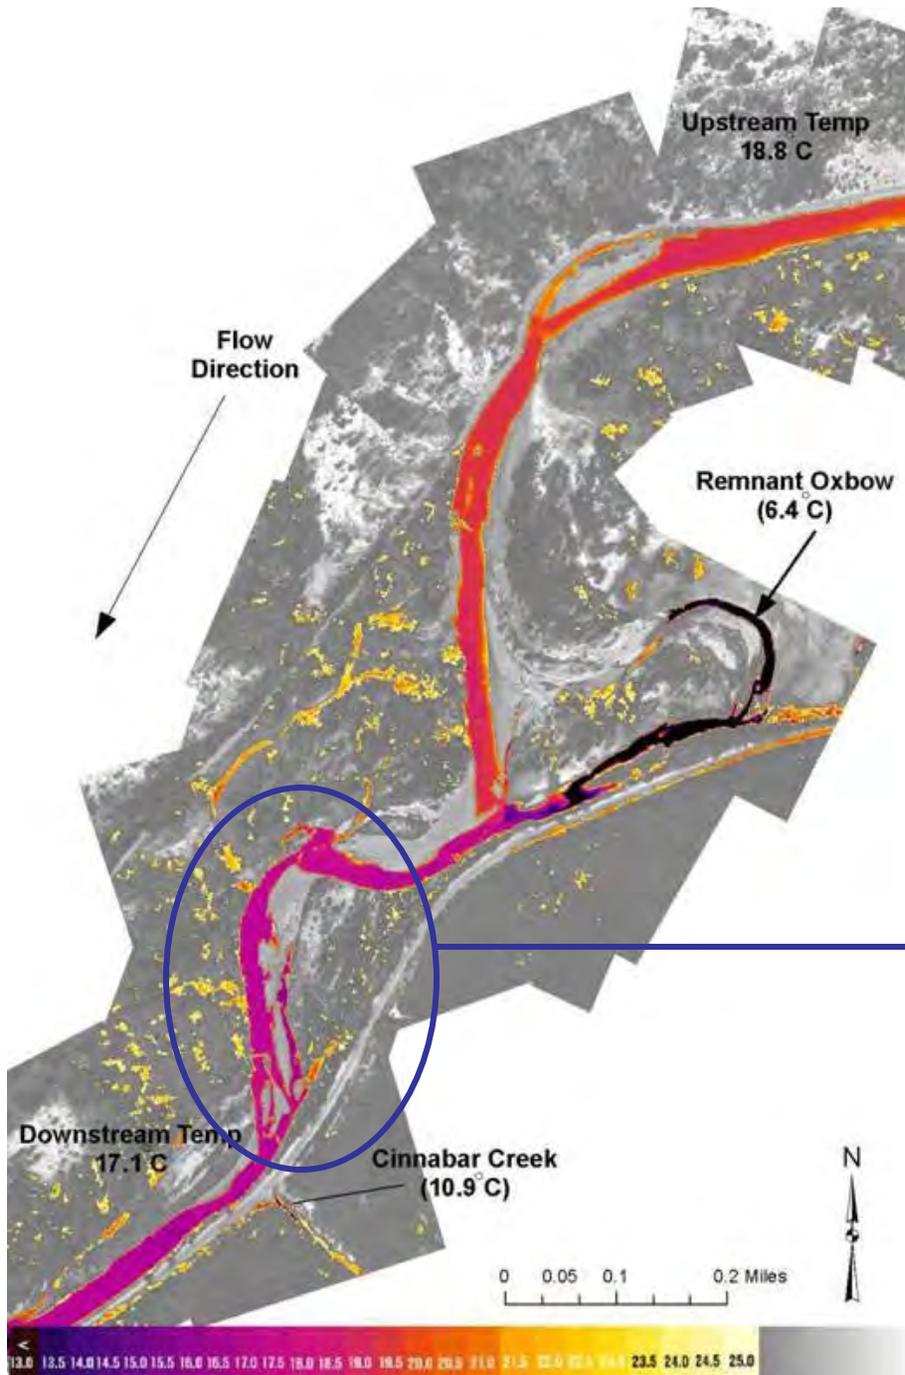
Temperature study, 2007

Log removal and management area

DEQ suggests future temperature monitoring in this reach.

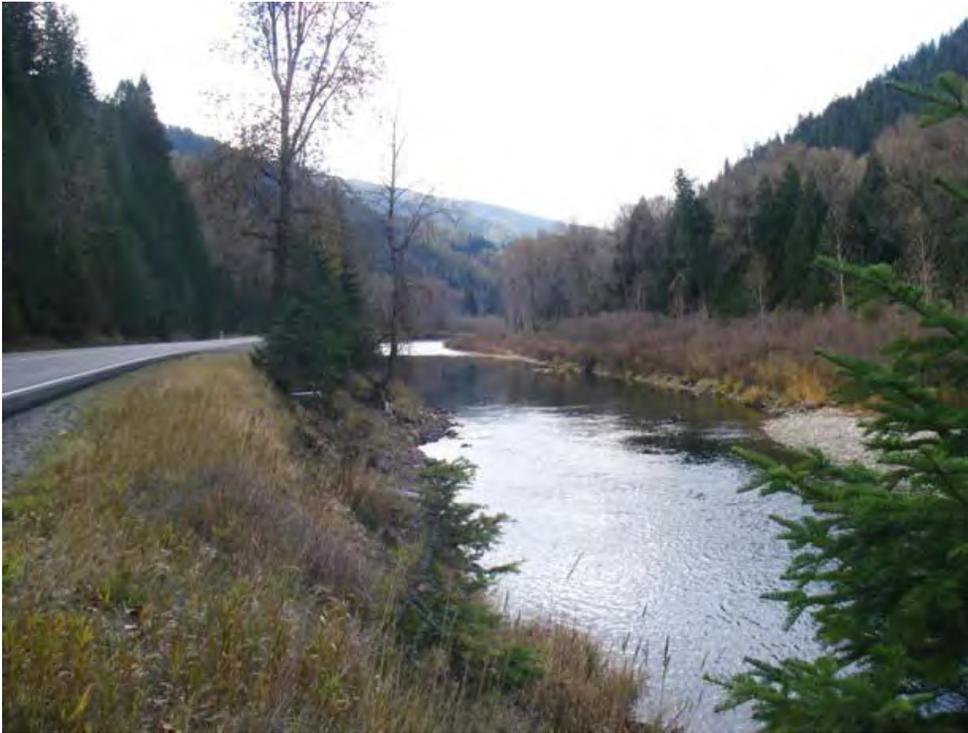
Failing culvert and eroding road bed / river bank. Future projects may include bank stabilization projects and replacement of the culvert with a bridge at Cinnabar Creek. All of these issues are significantly related to water quality.
