Monitoring Surface Water for *Escherichia coli* in the Lindsay Creek Watershed

Final

**State of Idaho
Department of Environmental Quality**

April 2016

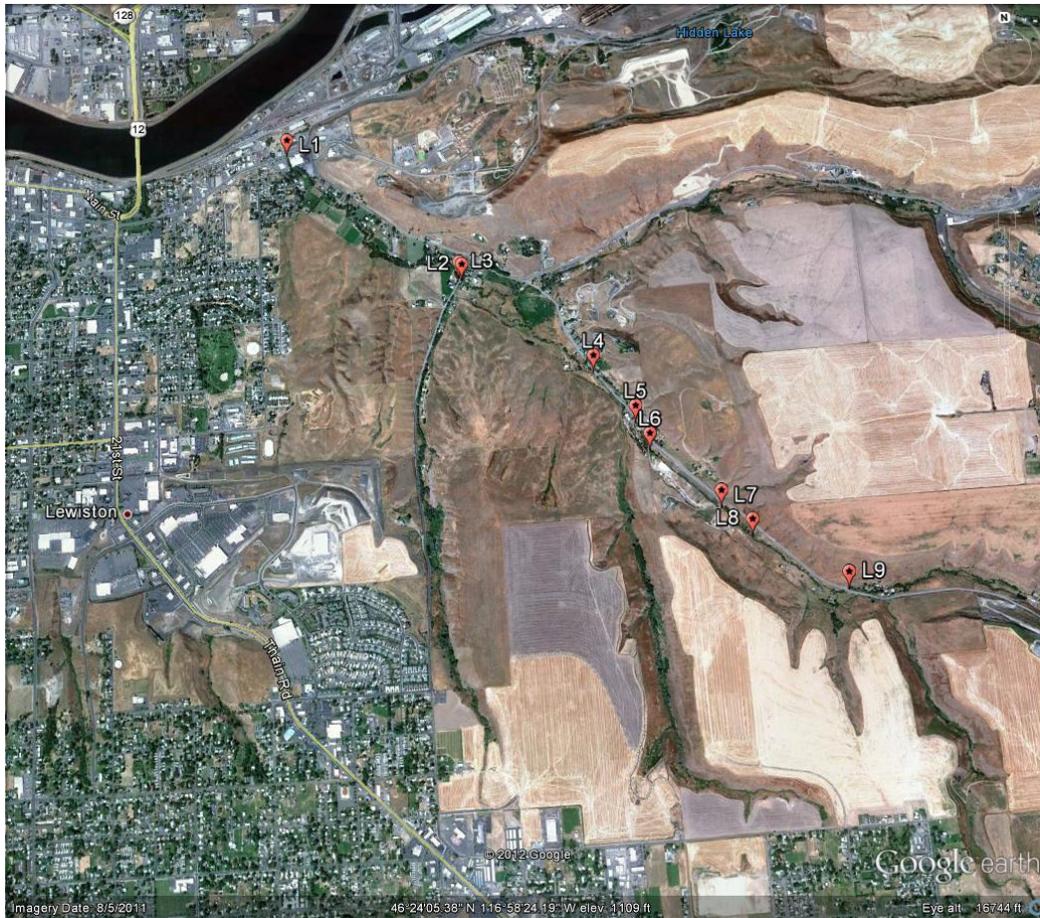
Figure 1. Sampling locations.

Initial monitoring focused on validating the concern of *E. coli* contamination at the site that generated the complaint (L4). Subsequent monitoring expanded the sampling network to identify and quantify bacteria loading upstream. Beginning on October 29, 2012, a total of nine sites were routinely sampled on Lindsay Creek in 2012 and 2013 to assess *E. coli* bacteria contamination (Figure 1).

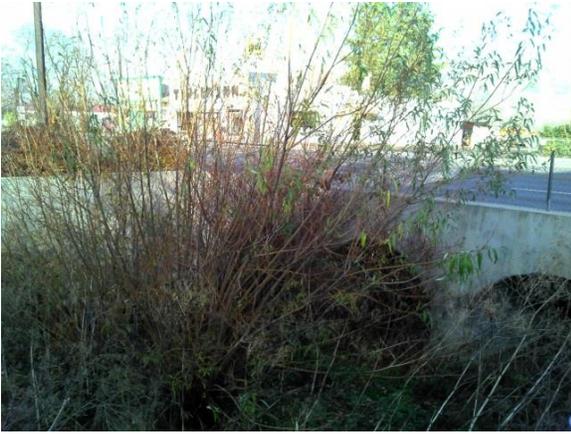
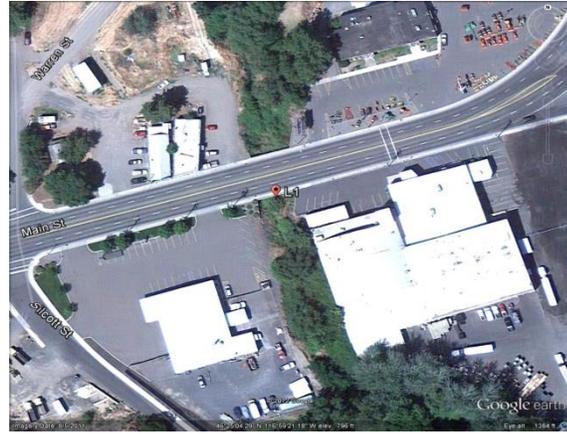
Figure 2. Site L1: at the bridge on Main Street to the west of the Odom Corporation Wholesale Beverage Distributors buildings. Samples were taken from the bridge using a bridge sampler.

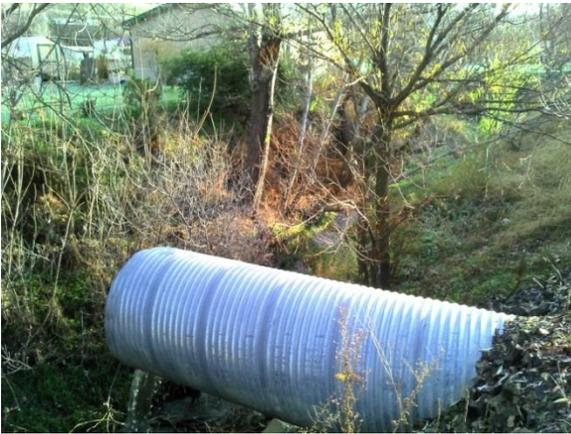
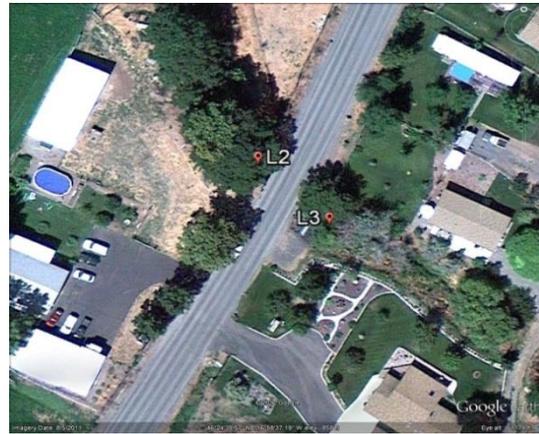
Figure 3. Site L2: upstream from where Gun Club Creek enters Lindsay Creek and from the bridge that crosses Lindsay Creek on Gun Club Road.

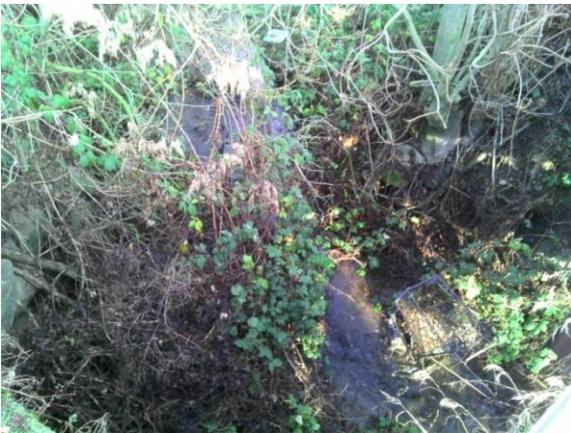
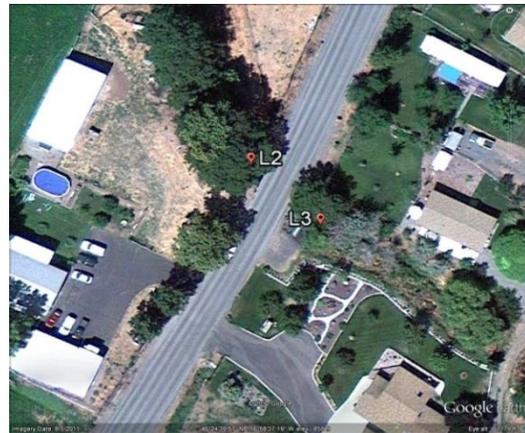
Figure 4. Site L3: downstream from where Gun Club Creek enters Lindsay Creek and from the bridge that crosses Lindsay Creek on Gun Club Road.

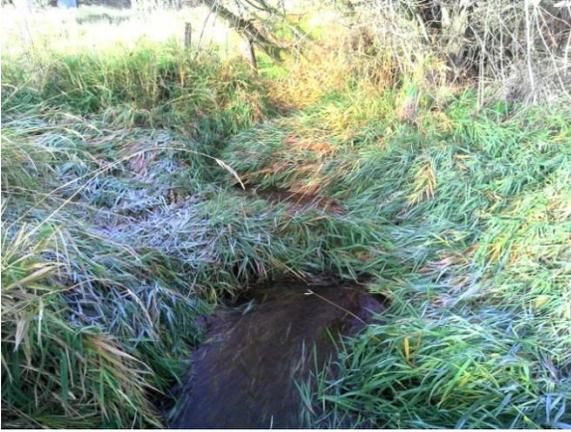
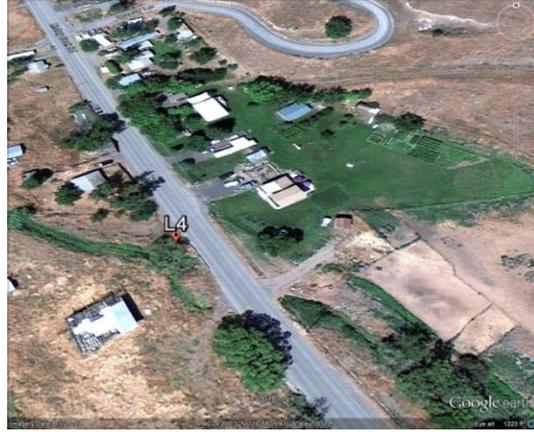
Figure 5. Site L4: on the west side of Lindsay Creek Road where creek exits culvert.

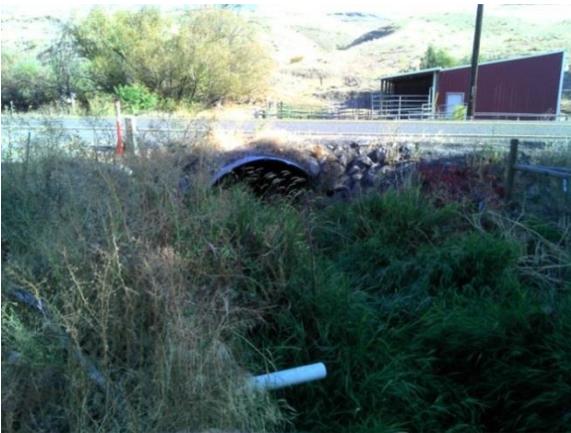
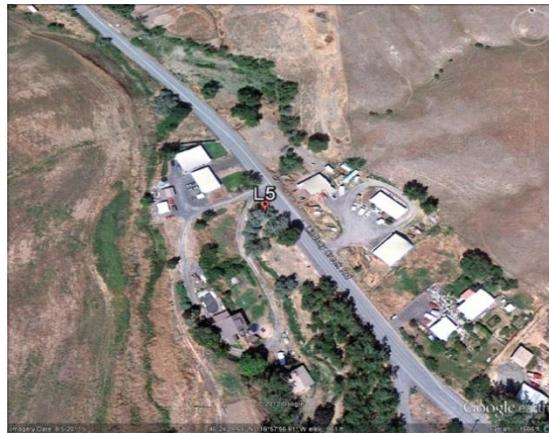
Figure 6. Site L5: on the west side of Lindsey Creek Road at the intersection of Hamilton Lane.

Wildlife and livestock numbers near sites L5 and L8 are less than or similar to downstream sites, suggesting the highly elevated concentrations found at L5 and L8 are from another source. DNA analyses of samples collected at L5 and L8 indicate that portions of the *E. coli* load at those sites can be attributed to human waste material entering the creek.

DEQ will provide this report to Public Health—Idaho North Central District for further action regarding the potential of residences near L5 and L8 having a failed or inadequate on-site sewage disposal system.

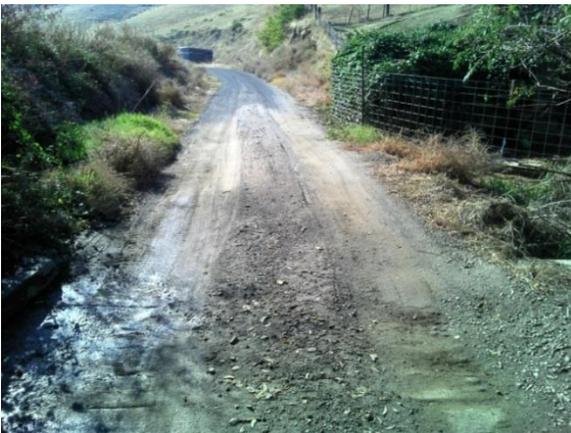
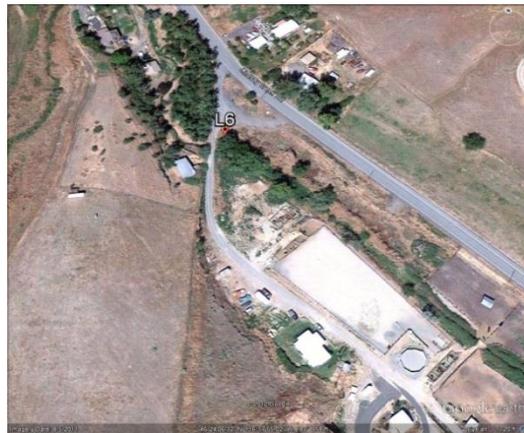
Figure 7. Site L6: approximately at 543 Lindsay Creek Road on the southwest side of the road. There is a circular pullout with a road leading to a private residence. A bridge crosses Lindsay Creek on this road. A bridge sampler was used to collect this sample.

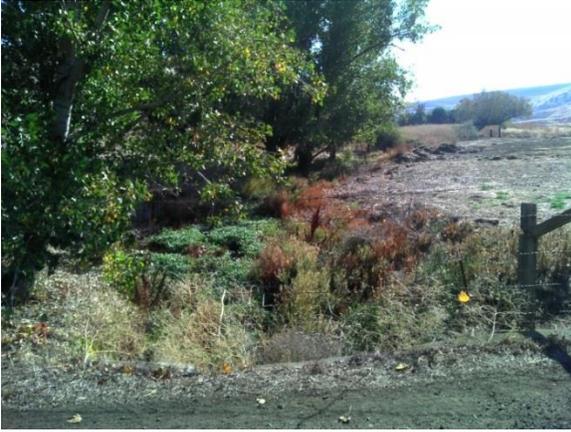
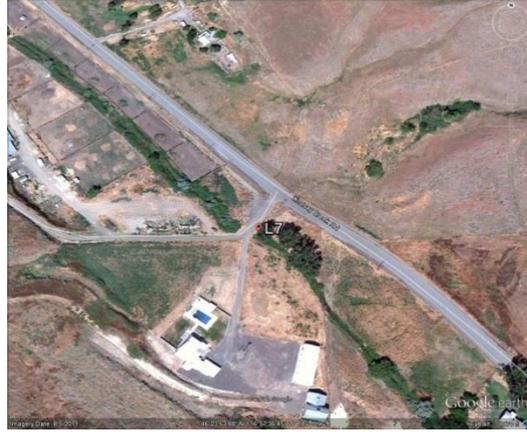
Figure 8. Site L7: upstream from where Lindsay Creek crosses Lindsay Lane. A bridge sampler was used at this site.

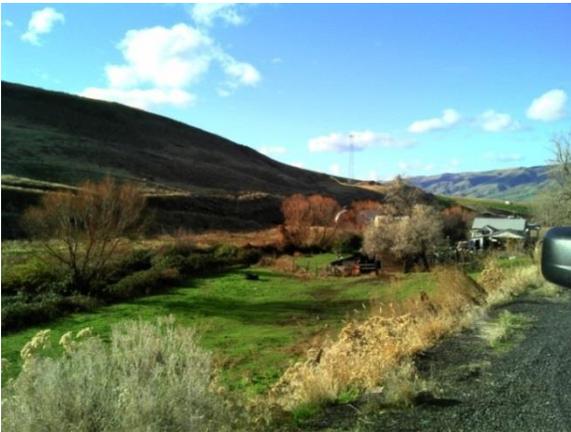
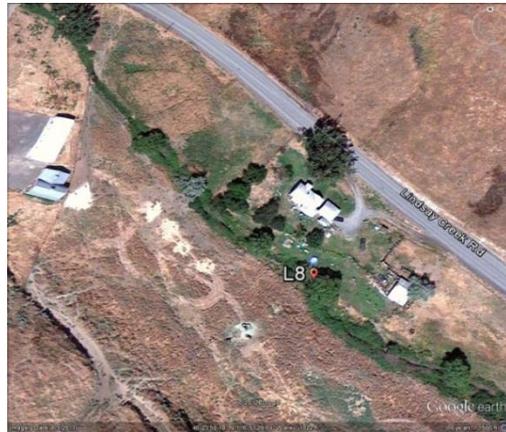
Figure 9. Site L8: on private property with Lindsay Creek on the west side of the property. There is a path leading to the creek and a plank bridge where sampling occurred with permission from the resident.

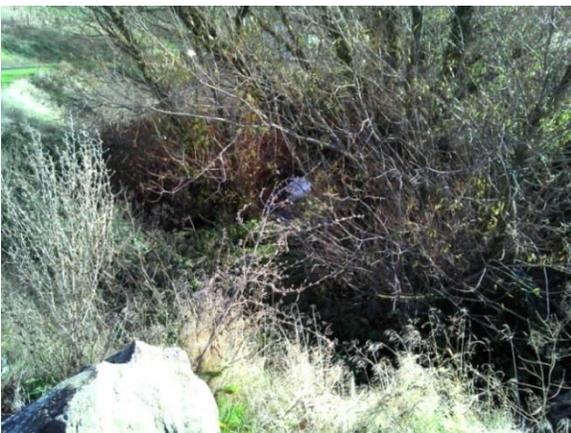
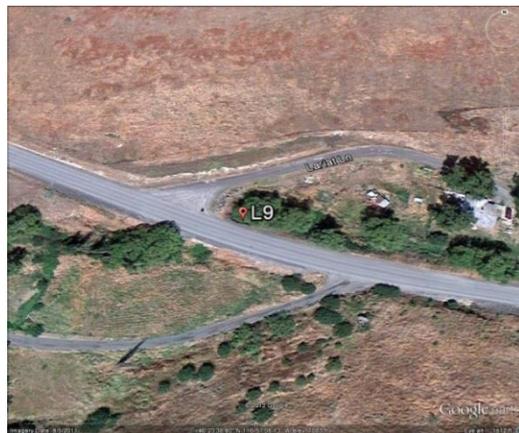
Figure 10. Site L9: on the north side of Lindsay Creek Road where Lariat Lane intersects. A bridge sampler was used at this site.
