2016 Performance and Progress Report

State of Idaho Nonpoint Source Management Program

**State of Idaho
Department of Environmental Quality**

April 2017

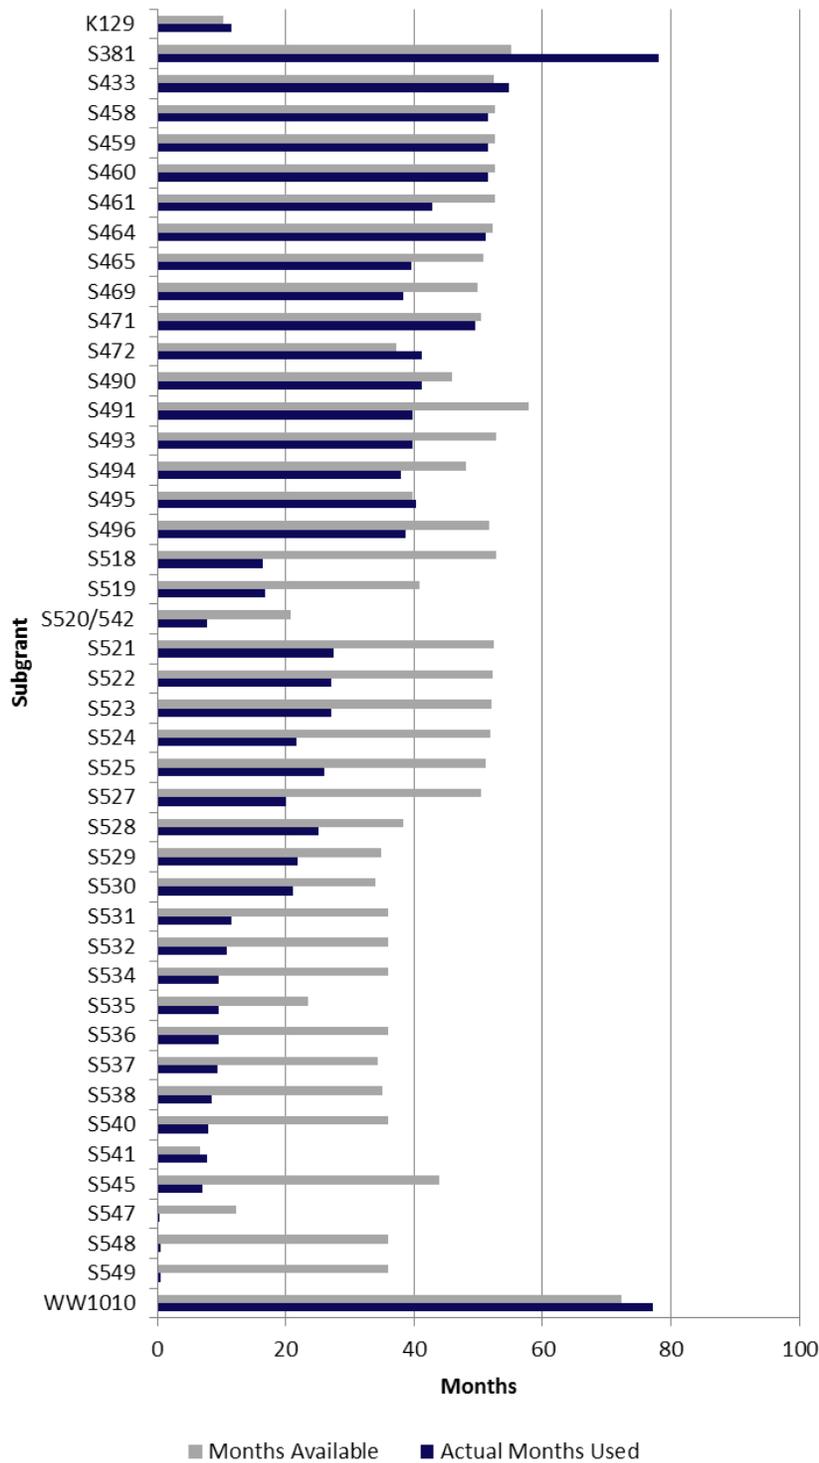
Figure 1. Active projects, time used, and total time available. The blue bars represent the total number of months the project has been underway. The gray bars represent total months available for project completion. (Note: Active projects are any projects funded in federal grant years 2009–2016, inclusive.)

Figure 1 compares the number of months work has been underway on each active project to the amount of time the project had at the outset to have its work completed. Figure 2 compares the amount of funding that has been expended (through November 30, 2016) on each active project to the amount of funding that was granted to the project at the outset.

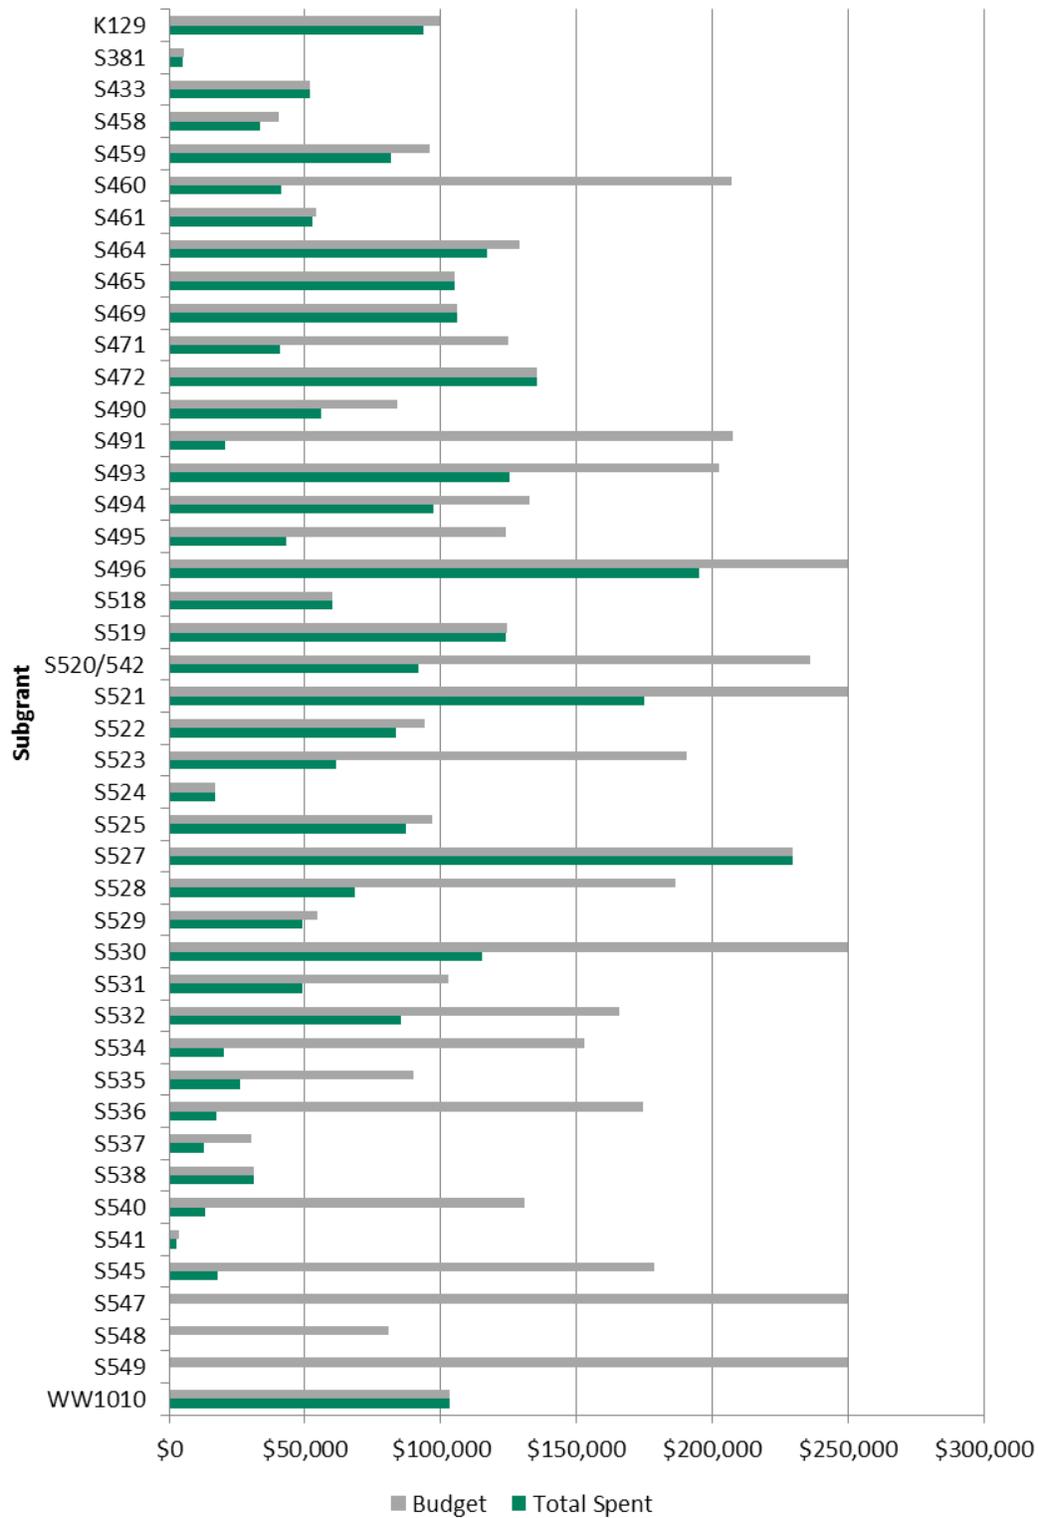
Figure 2. Budget usage by active projects. The gray bars represent the total federal funding granted to each project. The green bars show the amount spent by each, through November 30, 2016.

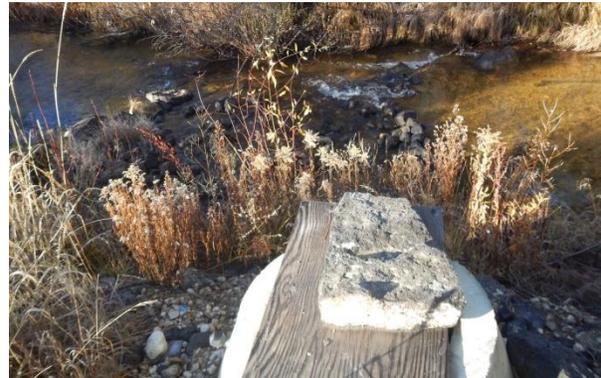
Idaho City operates another intake and pump house on Elk Creek. This infiltration gallery was covered with heavy angular rock to keep the pipes from being exposed during high flows.

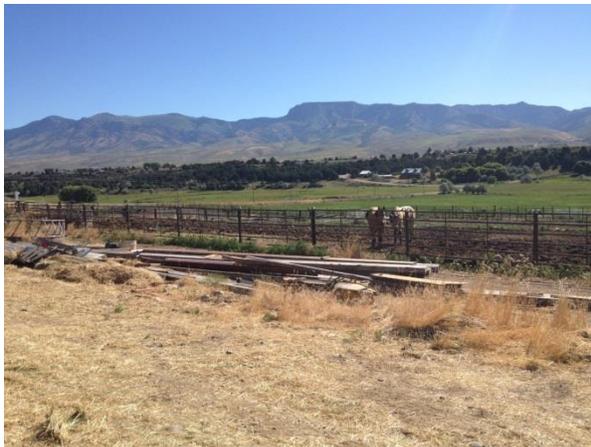
A containment pond can be seen on the back side of the relocated corrals, just below the tree line.

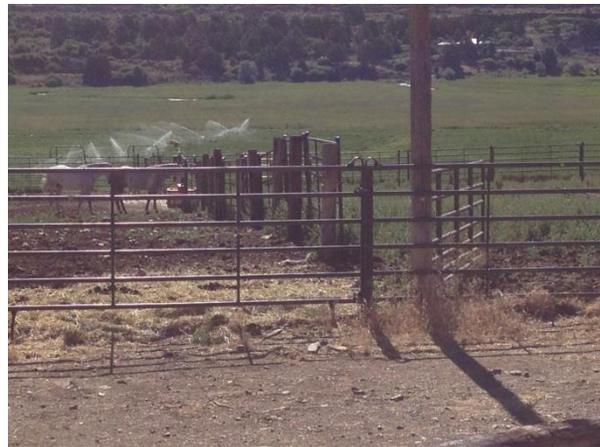
A frost-free trough in the corral provides water to livestock. The stream is seen in the background, at a distance from the corrals. The corrals are bermed and include a containment pond to capture and store any runoff.

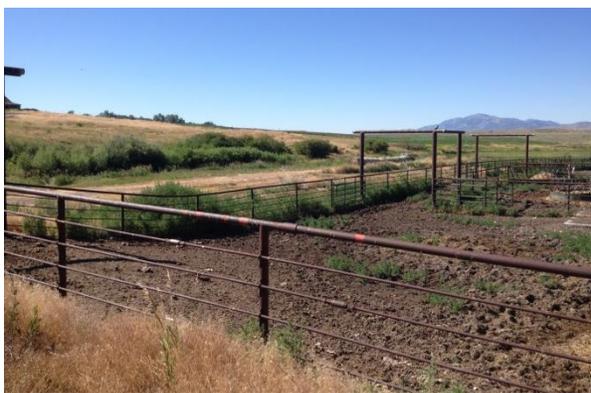
The area in and around the old corrals has been revegetated, and a berm was built to prevent runoff from entering the stream.

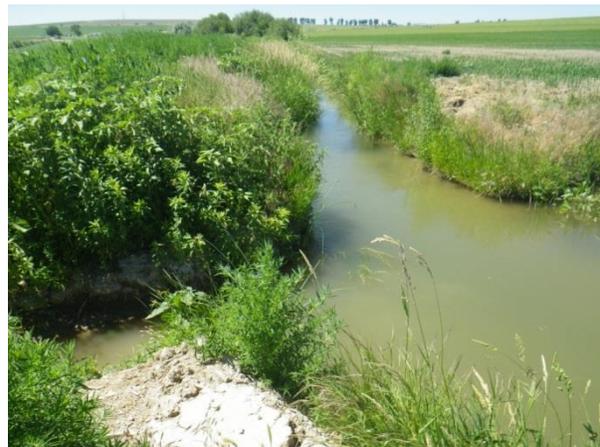
The stream seen on the right carries water from the Phase I ponds. The stream entering on the left carries water off an adjoining field and is untreated.

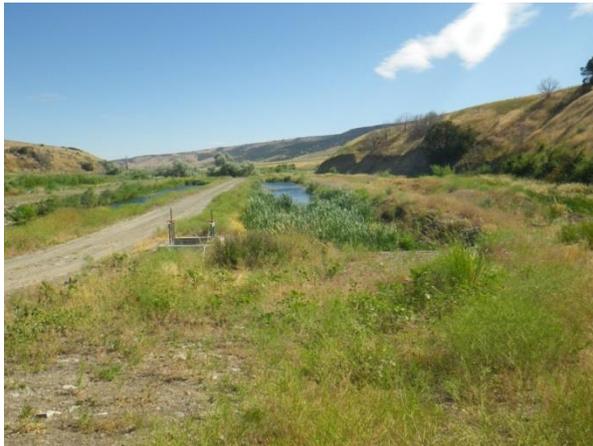
Two cleaning cells were constructed near the upper end of the project site.

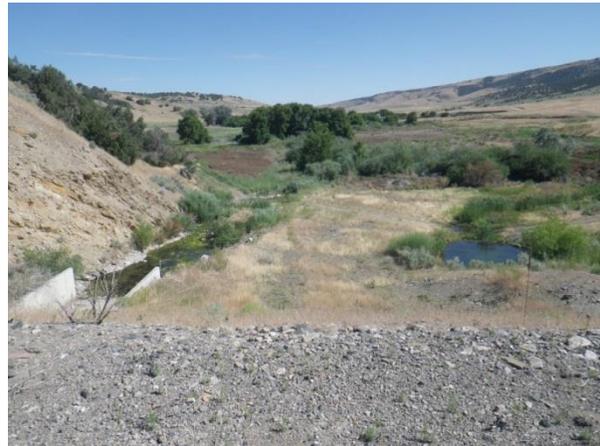
This view is from the upper reservoir/retention pond looking downstream on the wetlands and a diversion structure.

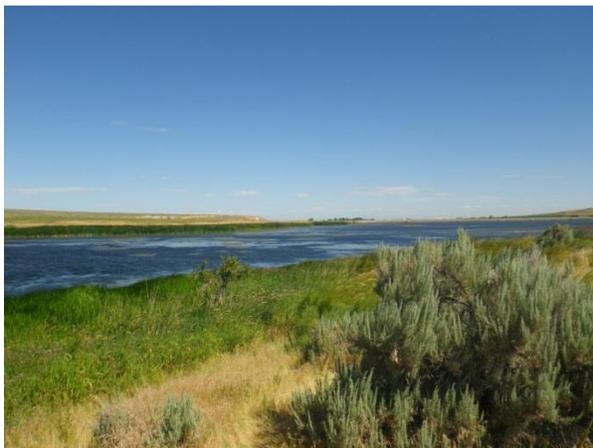
The riparian area around the lower reservoir/retention pond was well established and the uplands well vegetated.

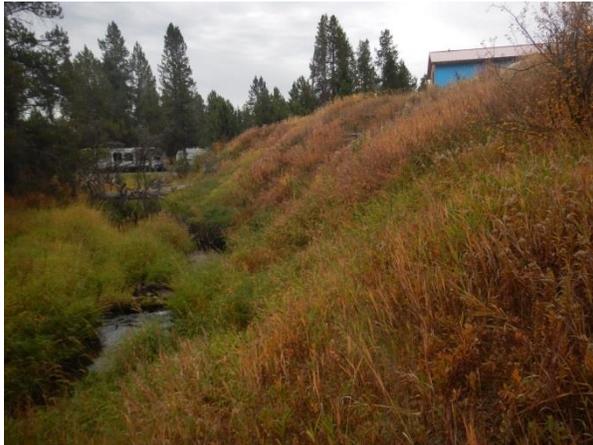
A log grid structure was used to cover the soft, steep embankment. Individual cells in the structure help to stabilize eroding soil and allow a mix of vegetation to take root. This BMP was applied in 2011. Plants are now well established and help decrease erosion.

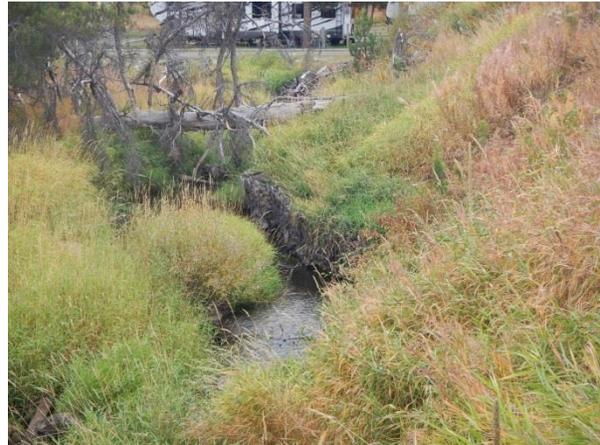
The toe of the slope is stable, and streambank vegetation is vigorous.

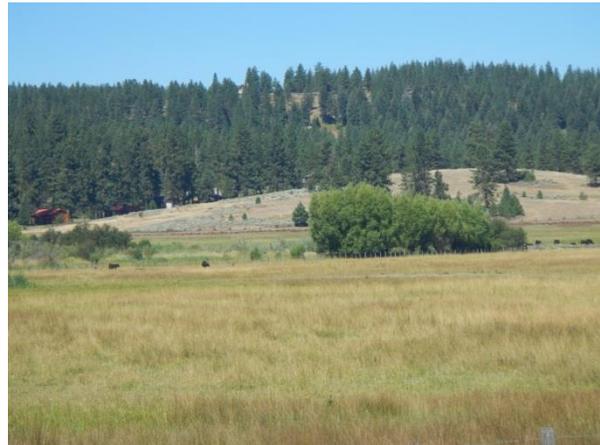
The land along Fourmile Creek has changed hands over the last couple years. The exclusion fence seen here is being maintained but there is ongoing grazing in the riparian area.

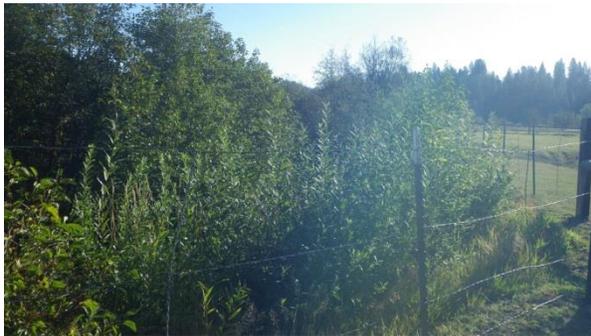
Vegetation planted in the riparian area has helped to stabilize the bank.

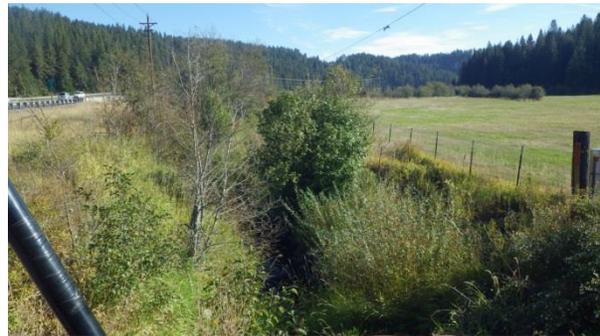
Riparian areas that were once severely degraded are now recovering nicely.

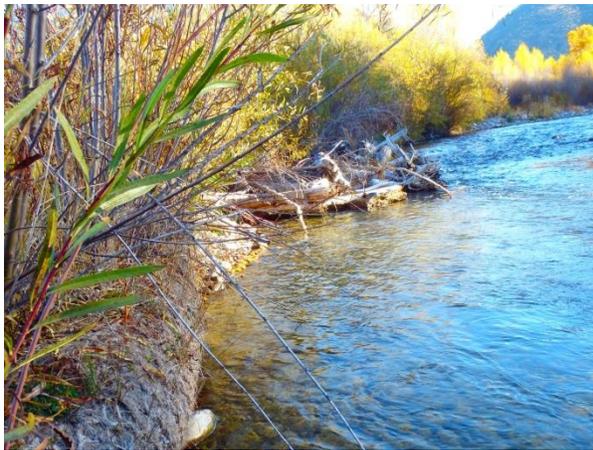
Coir bio logs help stabilize the bank and provide a matrix for vegetation to establish. Herbaceous cover was planted in the riparian area, and a number of root wads were placed along the bank to reduce flow velocity and provide refugia for fish.

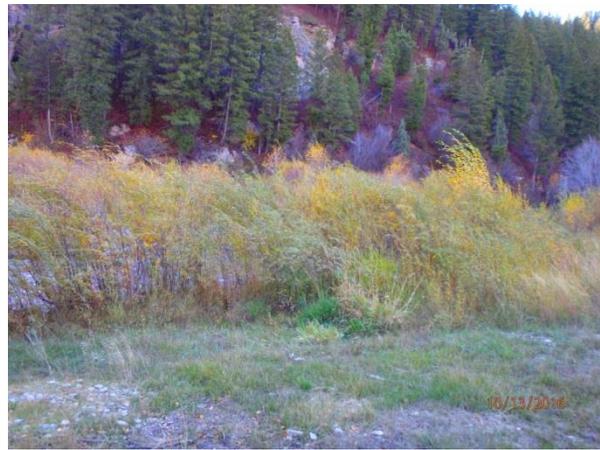
Willows planted along the bank are becoming well established.

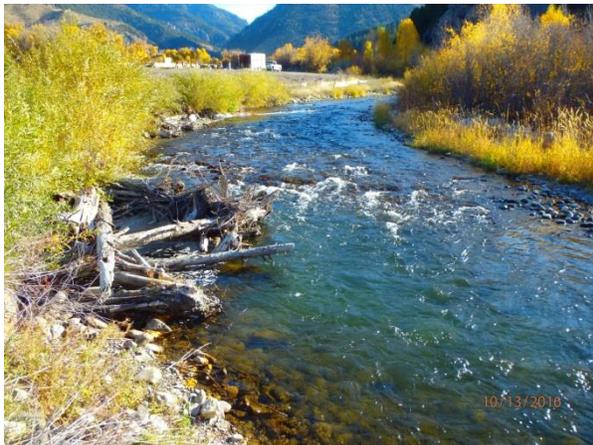
Root wads were placed in the channel, which was also graded.

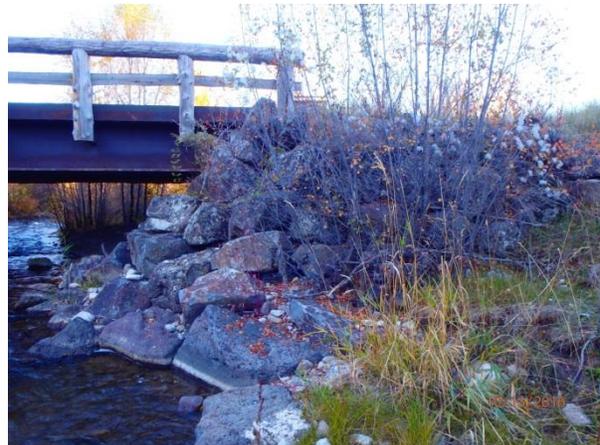
Large rock was placed close to the bridge abutments on both banks to further reinforce the bridge and stabilize the bank.

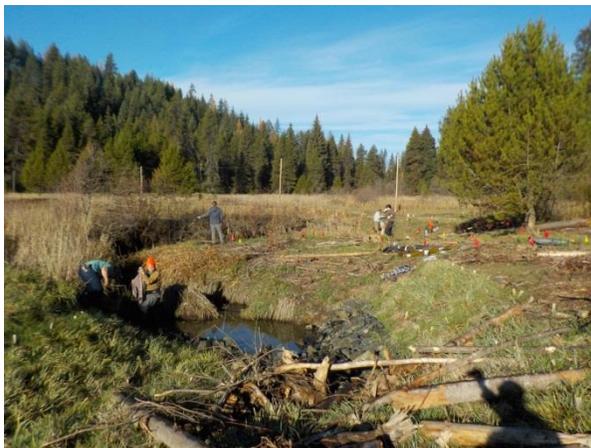
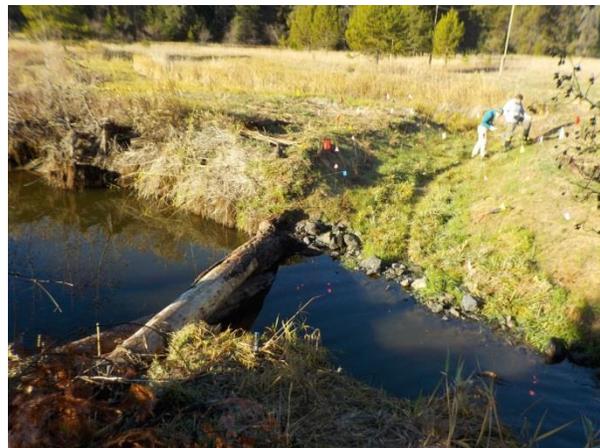
Field crews planted native riparian plants, trees, and shrubs and installed sedge mats.

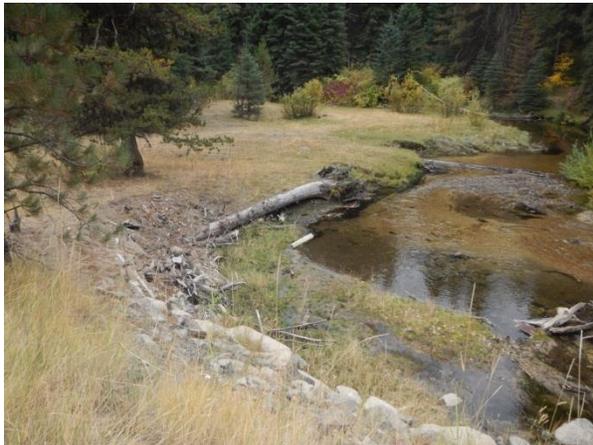
This rip-rap treated length of bank and log revetment has stopped scouring on this outside bend of Clear Creek.

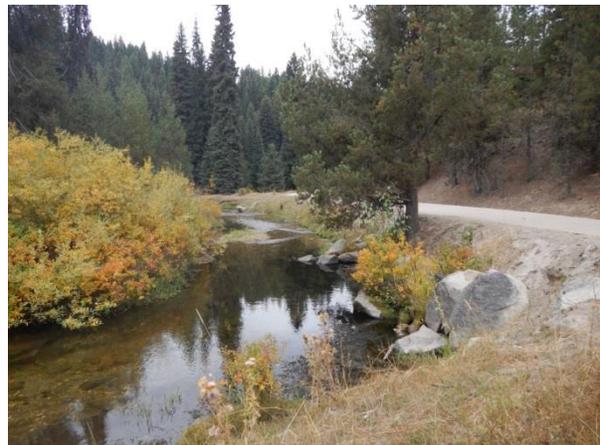
Rock barsbs were constructed to redirect currents, moving hydraulic forces away from the streambank. Vegetation can be seen establishing itself downstream in areas between the barsbs.

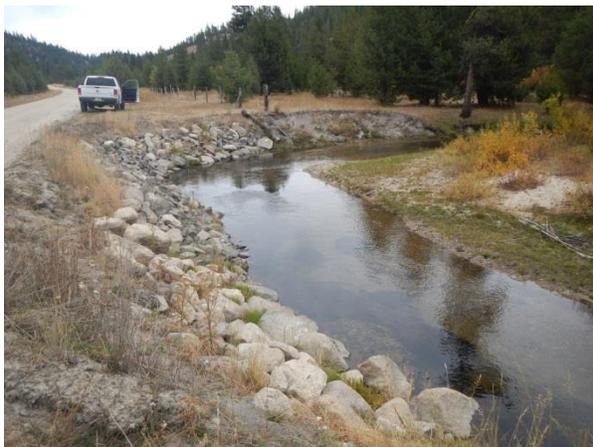
Rip-rap was used to stabilize the bank and protect the adjacent roadway.

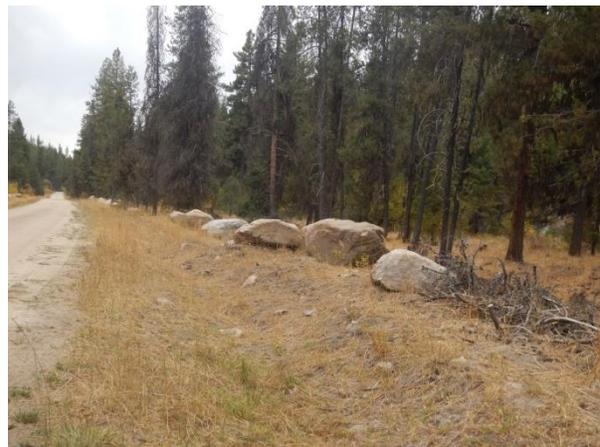
Six miles of road was resurfaced with rock. Barrow ditches were constructed, and culverts were replaced.

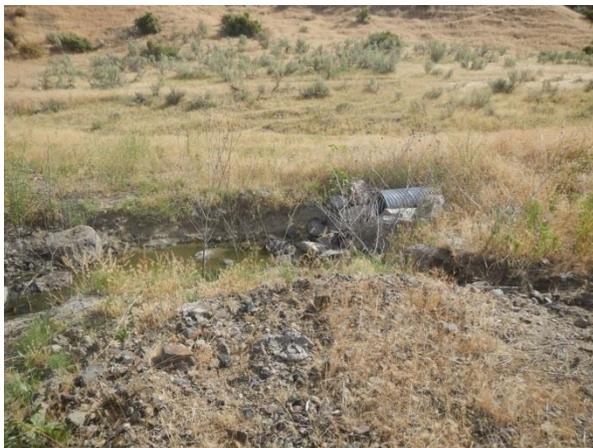
Approximately 620 feet of pipe delivers water from Cove Creek to the inlet of the sediment basin.

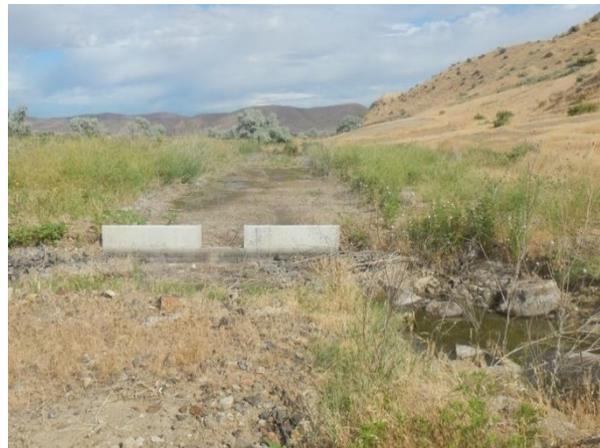
The basins are 3 feet deep and designed to collect sediment and nutrients from returned irrigation water. These basins can be easily maintained for proper operation.

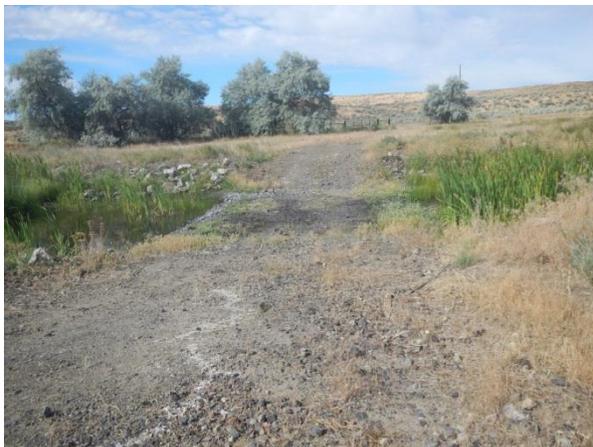
This hardened crossing on Cove Creek provides access to the constructed wetland area. A pipe buried under this road serves to deliver water from the sediment basins to the two downstream grow plots.

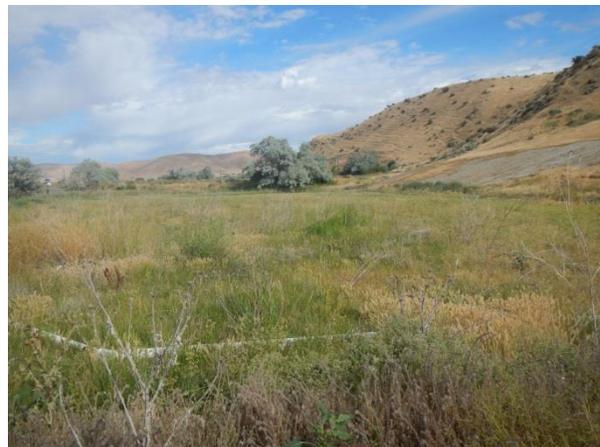
These shallow grow plots were hydro-seeded and sprinkler irrigated for the first year due to severe drought conditions. Soil from the excavation of the basins and grow plots was feathered onto the hillside. The hillside soil was seeded and plants were observed beginning to take root.

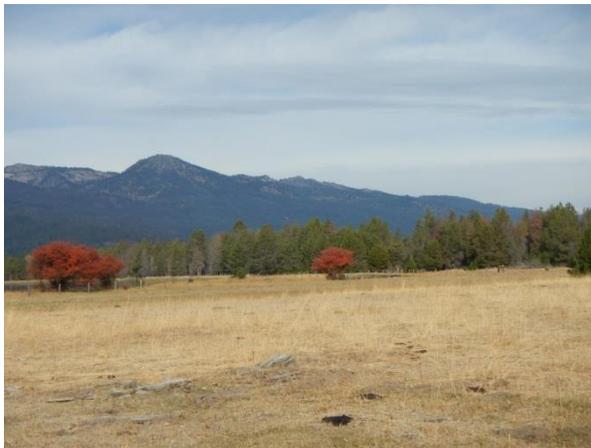
By fencing cattle from the river's edge, the banks will begin to stabilize and foliage will begin to grow.

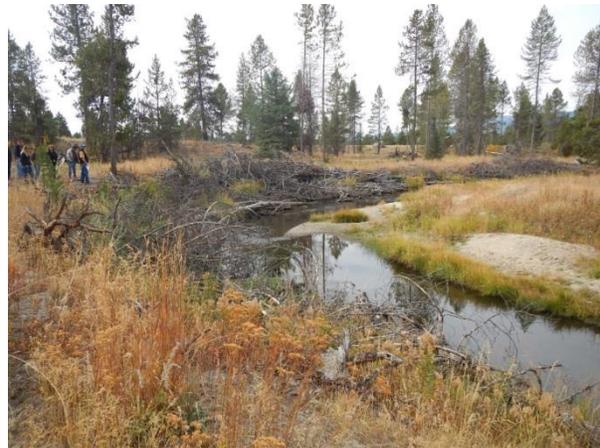
Three sections of bank along Big Creek were treated with tree revetments to slow water velocity, create areas for sediment to deposit, and provide a matrix where willows and other quick-sprouting species could establish and grow to provide permanent cover.

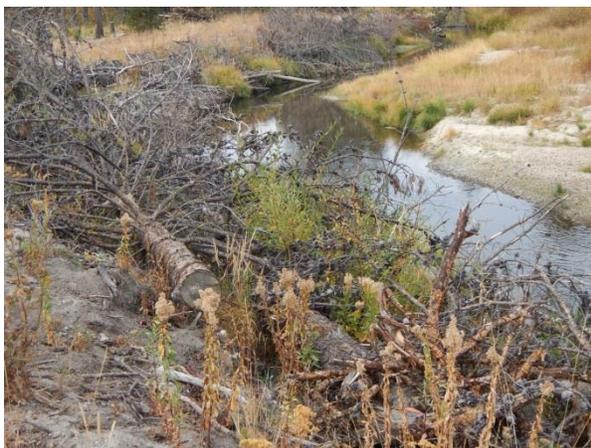
These revetments of nonsprouting trees will hold the bank in place. Willows can already be seen growing through the revetments to help stabilize the bank.

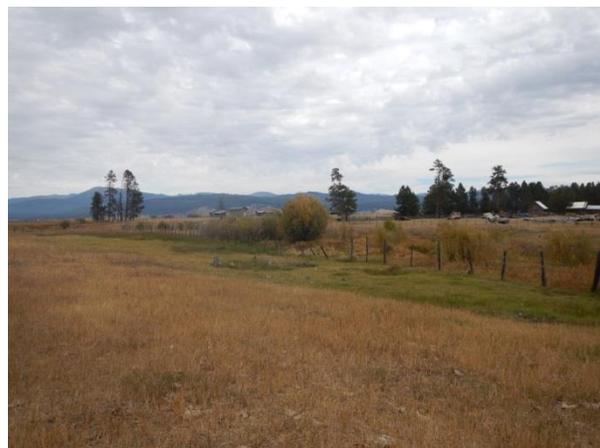
This stretch of land along Willow Creek was planted by IDFG 5-6 years ago. Funds provided for this project allowed revegetation work to continue. New riparian plantings took root to further stabilize eroding banks and provide additional shade to the creek.

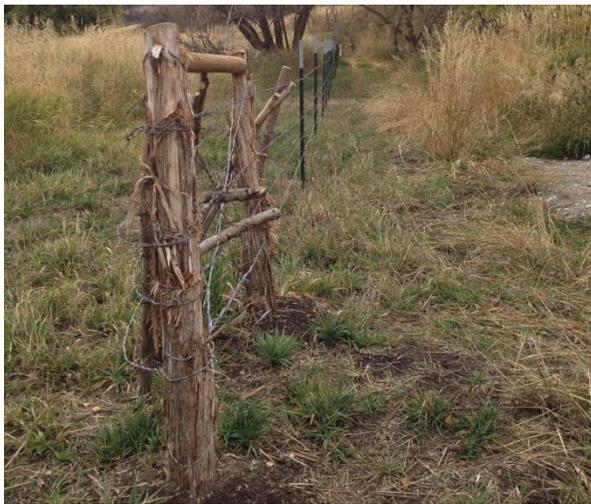
This fence was built to exclude livestock from entering the riparian area along Station Creek. Other fences installed under the project include small gates that allow wildlife to pass through when livestock are not in the area.

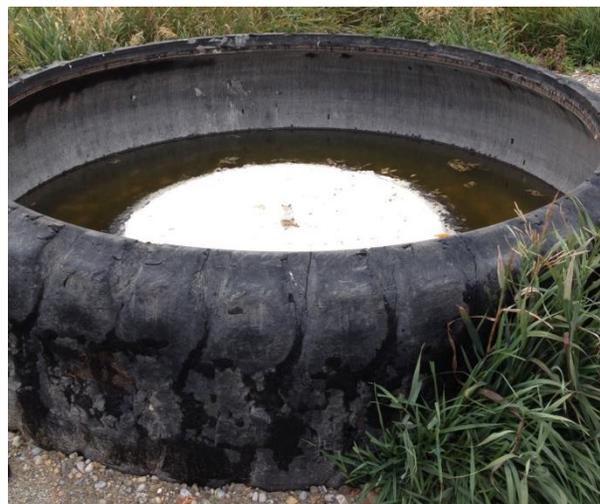
Water troughs were installed upslope from the creek to keep livestock from needing to access the stream for water.

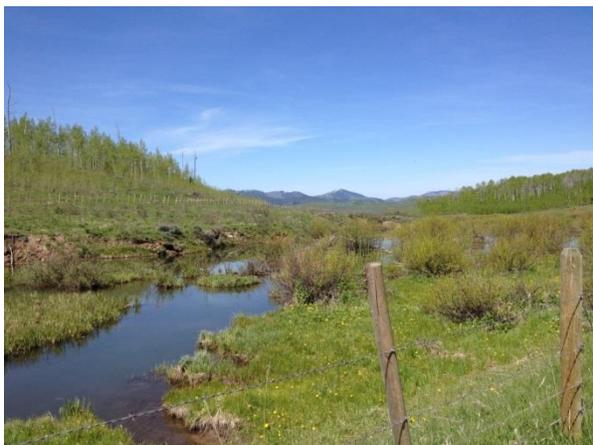
The fences seen on each side of Lanes Creek were built to exclude livestock from the riparian area. They lay flat under heavy snow to protect the fence from damage.

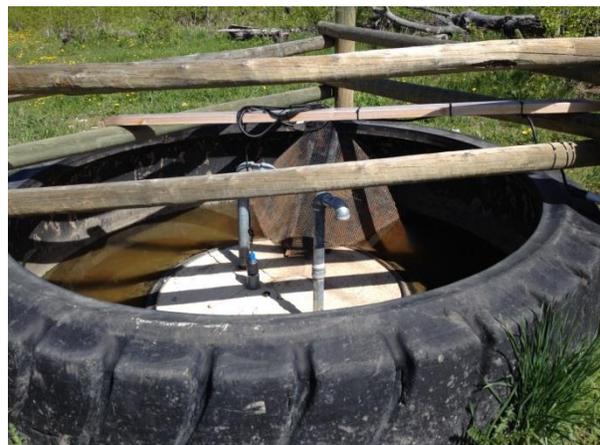
Eight troughs were installed on the project site. The inlet and drain pipes can be seen in the middle of the trough. Metal mesh extends into the trough to provide an exit for birds.

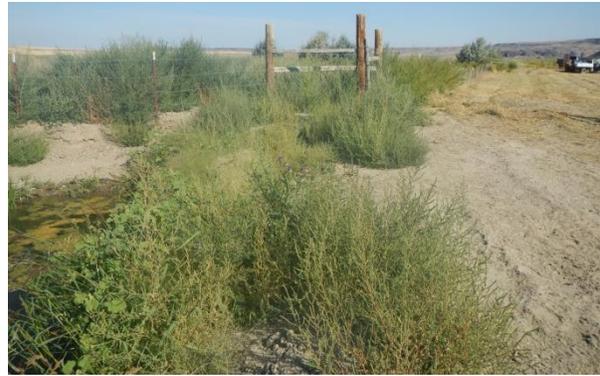
Converting to 5,000 feet of 12-inch pipe replaced the need for the open ditch system that was being used to irrigate grazing land and a wetland/wet meadow area.

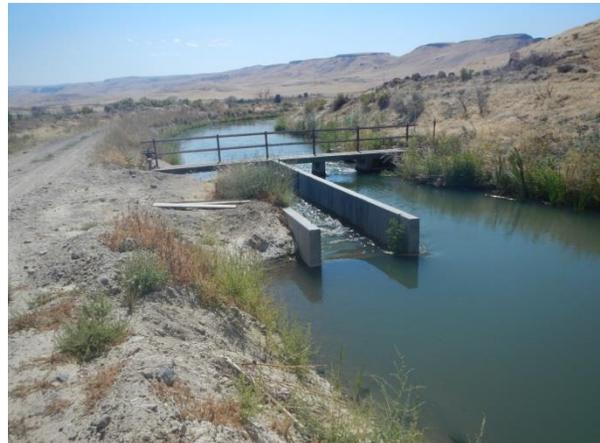
This screened inlet structure on the South Canal is the source of pressurized irrigation used on 700 acres of tier 1 cropland that is currently being furrow irrigated. This new system will improve irrigation efficiency and eliminate soil erosion and sediment discharge into Jump Creek.

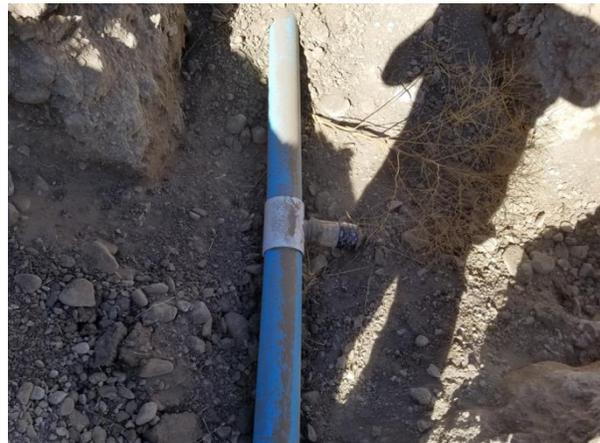
Tees fit in the water line branch off to provide water to troughs.

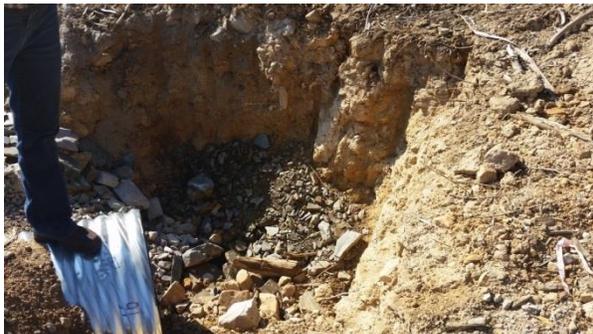
Some newly installed relief culverts had inlets that were not well stabilized, creating conditions that could lead to sediment discharge into the creek.

The Idaho Soil and Water Conservation Commission (ISWCC) provided engineering assistance. All work required under the engineering design plan and the stormwater pollution prevention plan is progressing well overall, with only minor concerns noted. The integrity of some of the relief culverts was questioned in terms of how they were installed and the potential erosion risk they created. A culvert failure could result in a major discharge of sediment entering the creeks. The ISWCC engineer agreed to re-evaluate the culvert installations and recommend mitigation, if necessary.

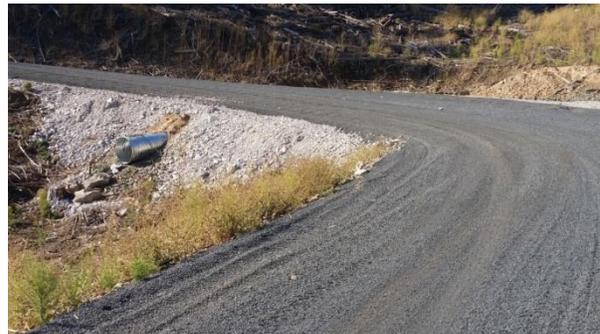
Much of the road received a new surface and improved drainage.

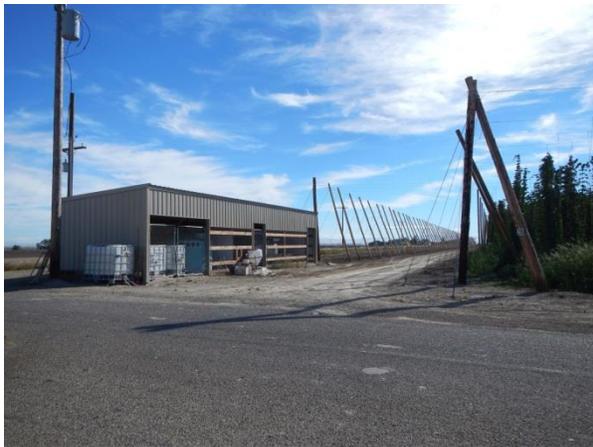
The pump and related infrastructure for the drip system is nicely housed.

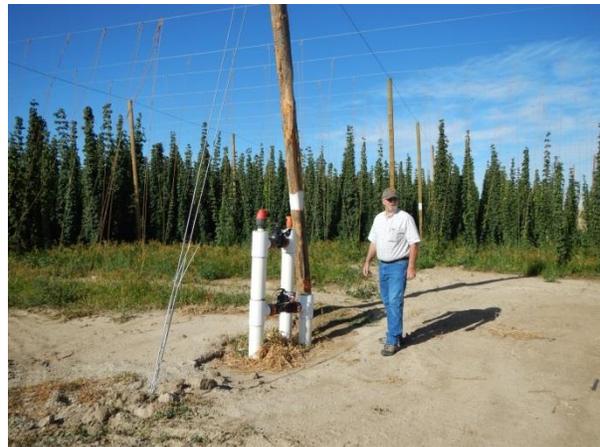
Pipes exit the pump house underground and lead to this valve system. From here, drip tape is placed into the field.

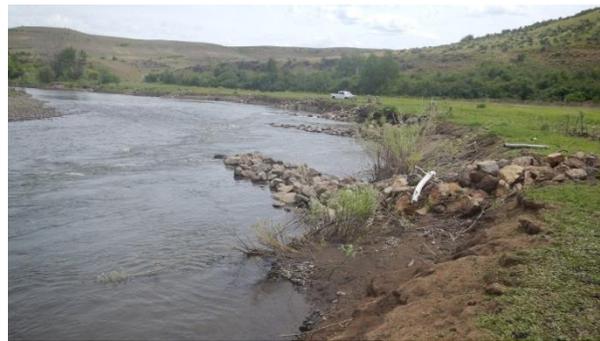
Willows installed along and between the rock barbs on this stretch of eroding streambank will increase the effectiveness of the rock by forming a living root mat at the base of the rock. The barbs and willow plantings will also help deflect flow and dissipate energy that could otherwise cause sediment to deposit along the bank.

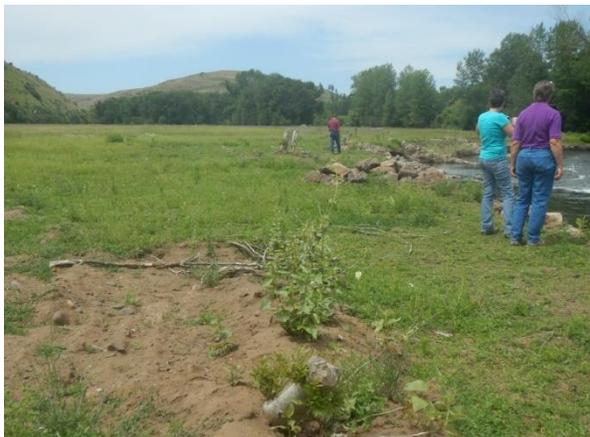
An upland willow trench pack was used to accelerate the development of a riparian buffer. Once established, the willows will help hold the soil in place and dissipate energy during periods of high flow. The current lack of vegetation in the area makes the streambank highly susceptible to erosion.

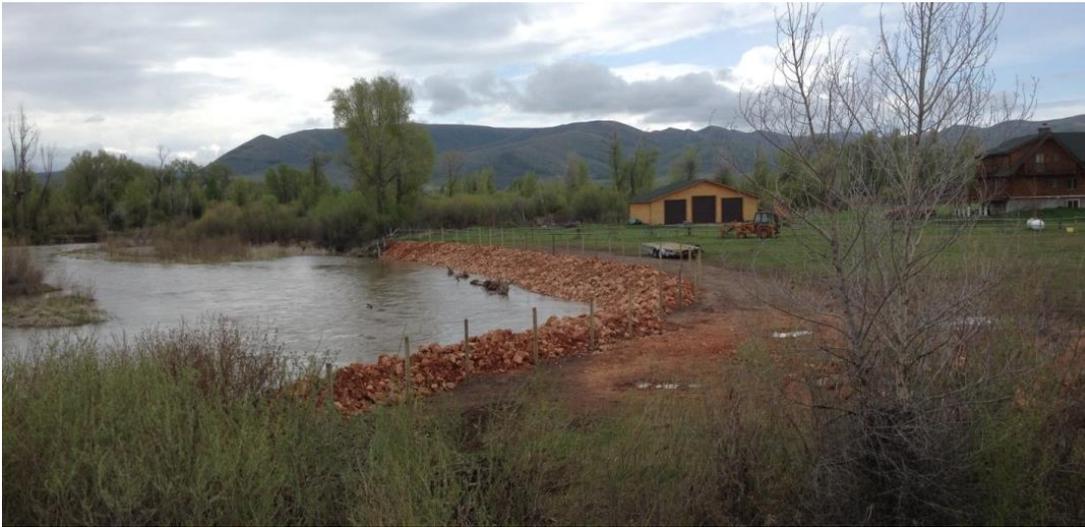
This photo shows an overview of the restoration efforts, taken from the Dingle Bridge. Note the tree root balls placed in the river along the bank. The root balls were keyed into the bank to decrease their chance of moving during periods of high water.

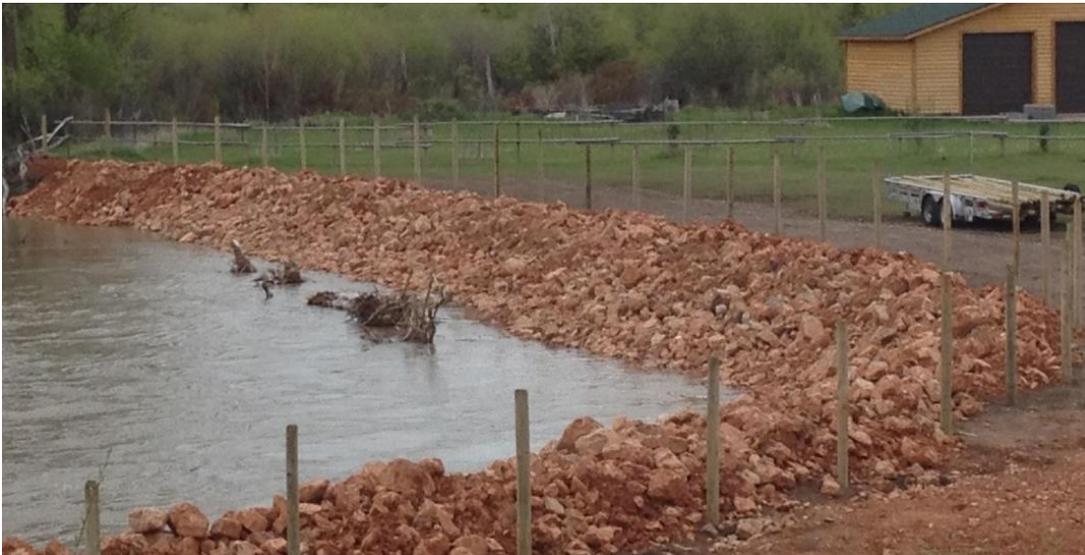
Root balls were placed to help stabilize the bank and fencing excludes livestock.

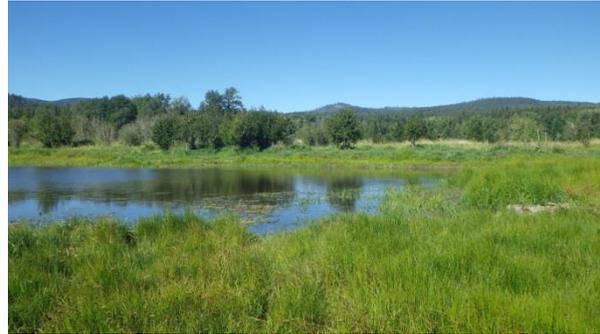
A second pond was observed following one season of native vegetation recruitment.

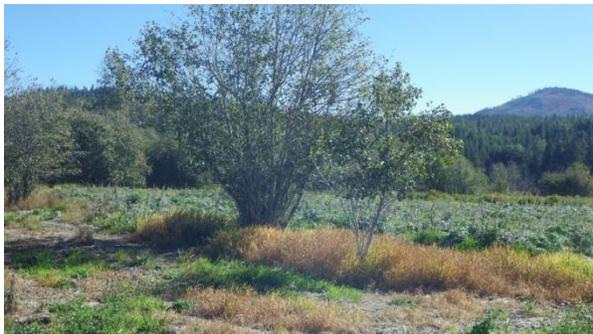
This site is pictured following an attempt to control reed canarygrass.

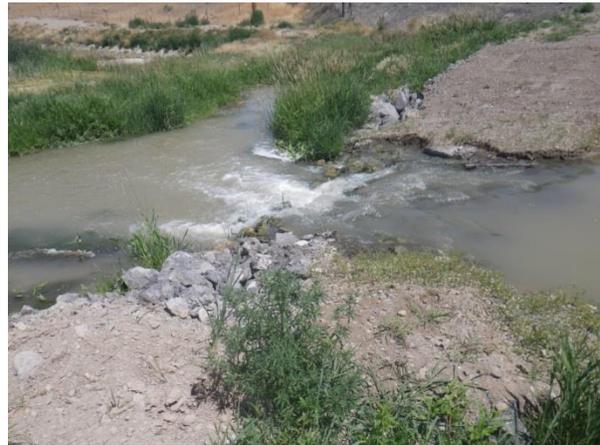
The 39A drain discharges directly into the finishing pond.

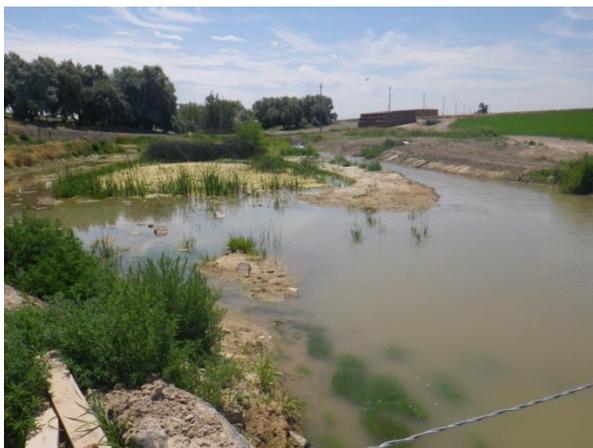
Water from this finishing pond discharges to a holding pond.

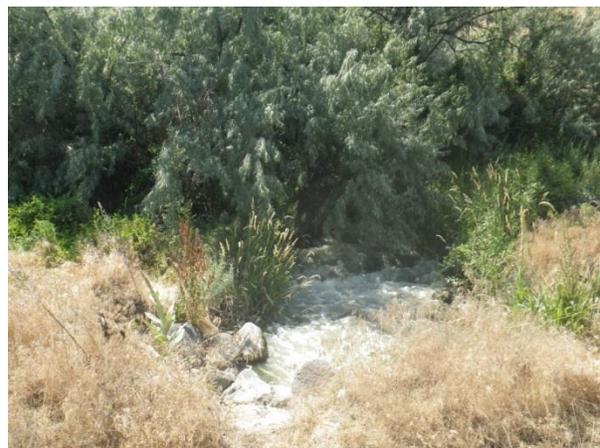
Water discharged from the hydroelectric project flows to the Snake River.

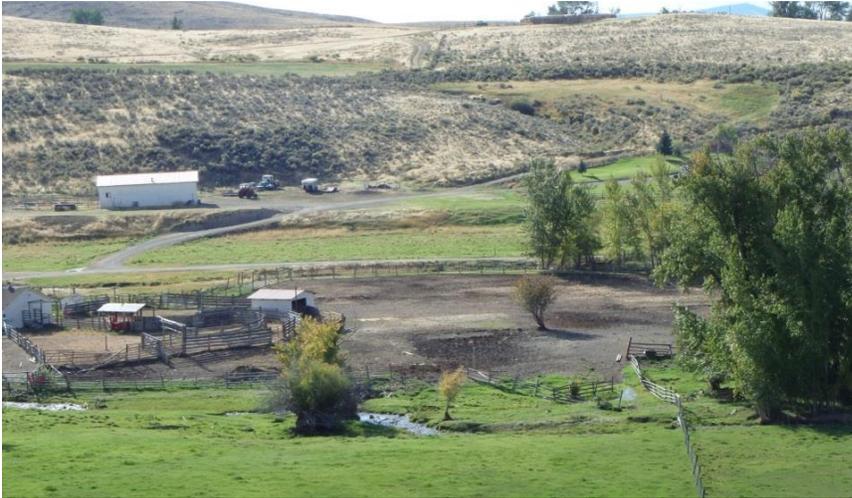
A confined animal feed lot and calving operation is located on Wimpey Creek. The manure pile that was located on this site has been removed.

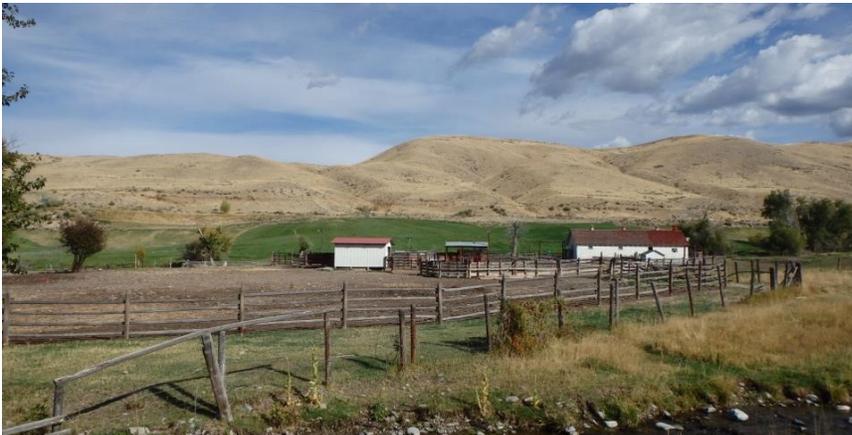
This confined animal feed lot and calving operation is located along Wimpey Creek.

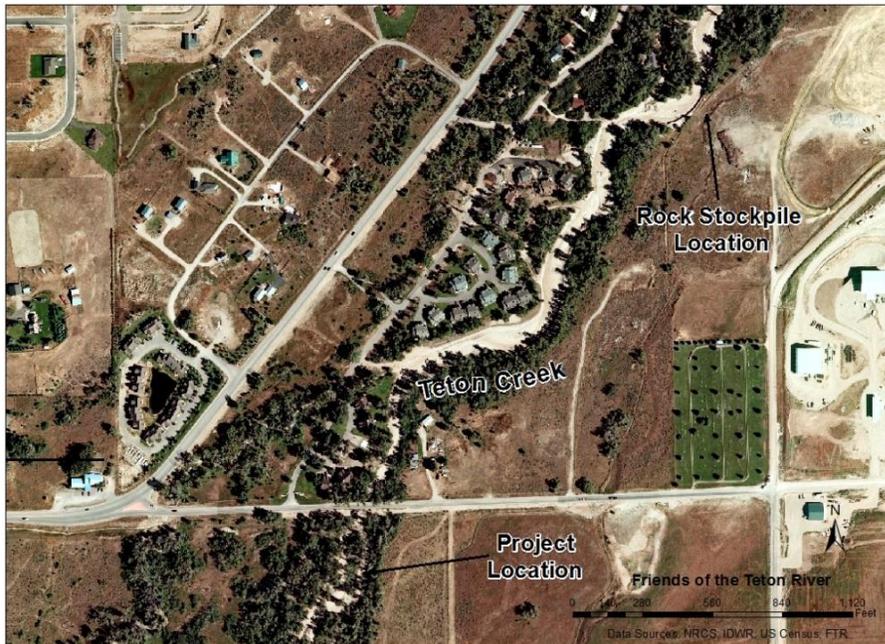
This figure provides an overview of where rock has been stockpiled for use on the project.

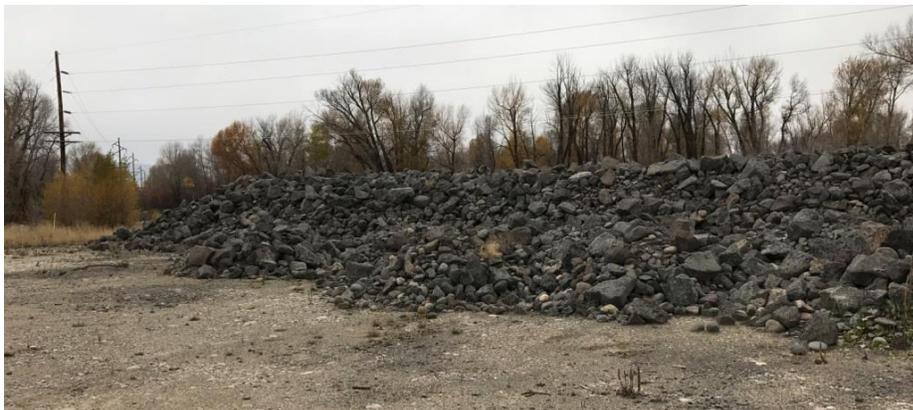
The rock stockpile was staged for use on this project.

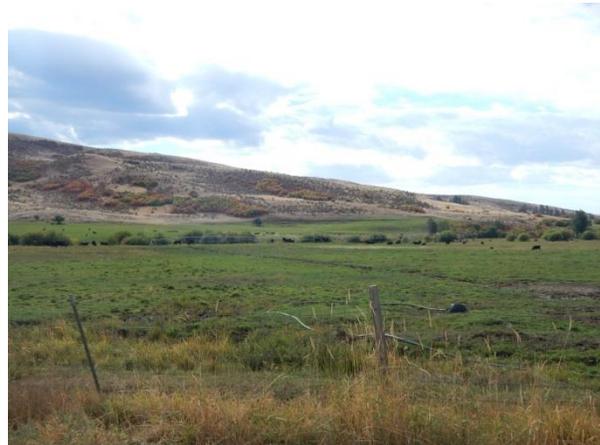
Corner pods and a pivot irrigate the lower end of this property located on the Second Fork of Squaw Creek. The creek flows in the tree line seen in the distance. The irrigation conversion helps to prevent overland flow of sediment- and bacteria-laden water from entering nearby surface waters.

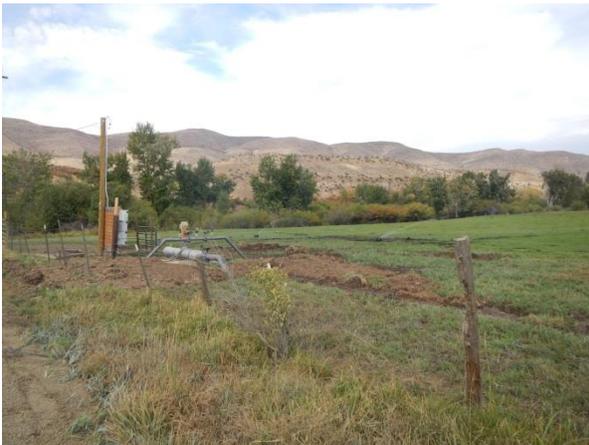
Under current conditions, cattle have open access to the creek's adjacent riparian area. The next phase of this project includes plans to fence cattle from the riparian area across the length of the property.

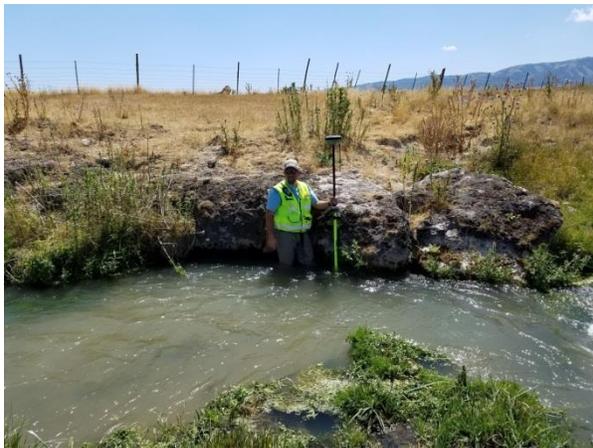
The small tributary stream is down cut in places and lacks riparian vegetation. Structures will later be installed instream and woody vegetation will be planted.

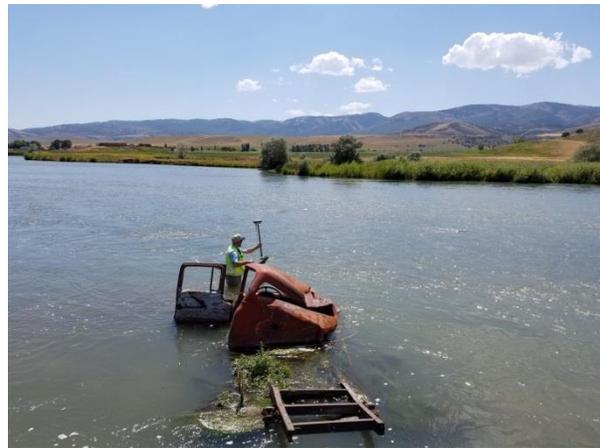
Cars that had been disposed of in the river, in some cases unintentionally, provided some level of bank protection.

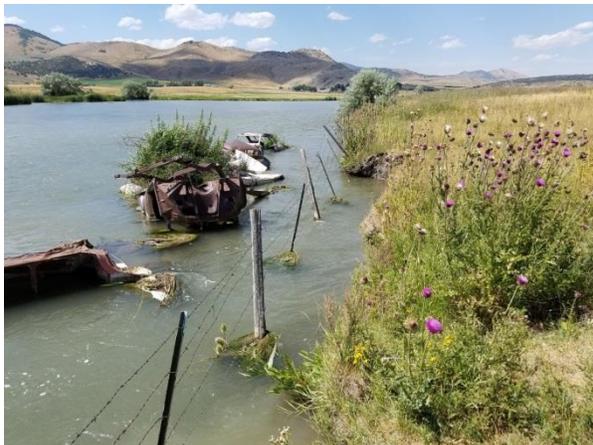
In other cases, flow was not redirected by the cars and instead the river flowed behind them to cause further erosion of the banks.
