**Watersheds
Program**

PCEI Invoice Final Report

Lindsay Creek Riparian Animal Management Project Walton, Cowger, Neilson and Canyon Crest Estate Sites

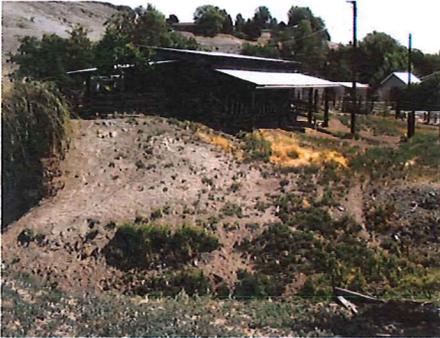
2008 Pre-restoration

Walton Project Monitoring

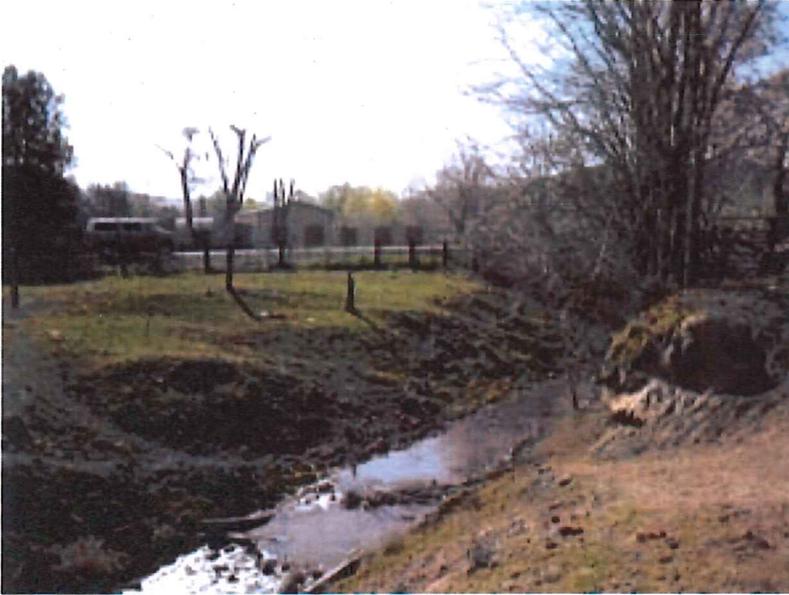
April 2008

Pre-Restoration

Steep, eroding banks and lack of native vegetation along the stream characterize this reach of Lindsay Creek.

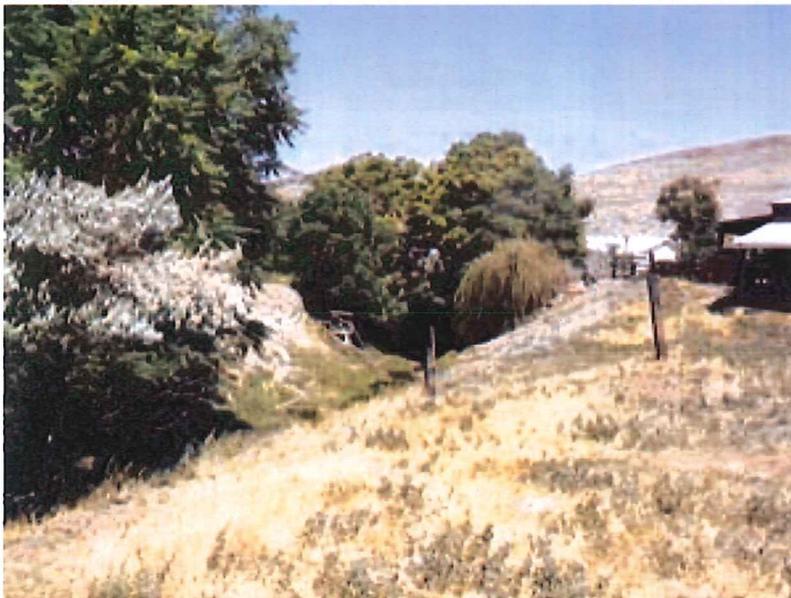
July 2008

Pre-Restoration

The lack of native vegetation and frequent soil disruption by livestock (buffalo and cattle) has led to the invasion of noxious weeds. Modifying the current livestock management practices will significantly aid in the recovery of Lindsay Creek.

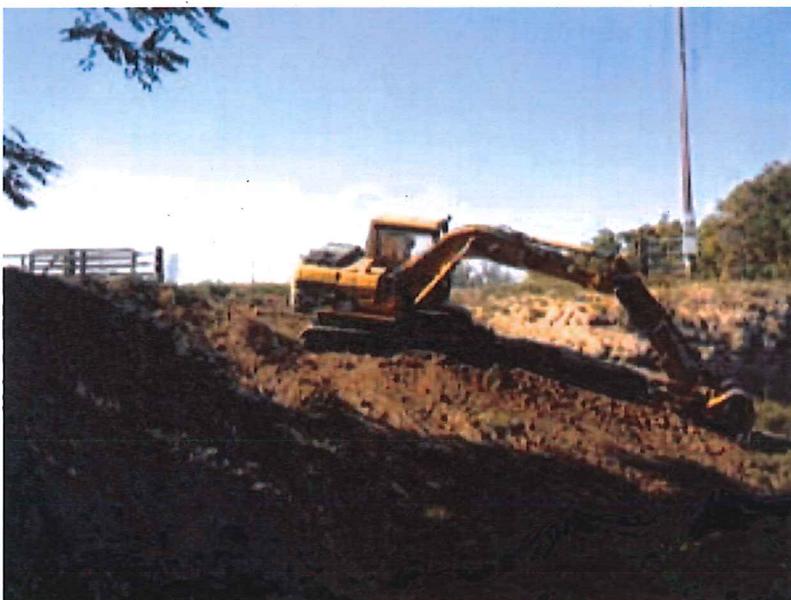
October 2008

Excavation

Both the north and south (shown here) banks were re-sloped to help stabilize the banks and remove weeds to provide suitable planting area to complete the re-vegetation of the stream banks.

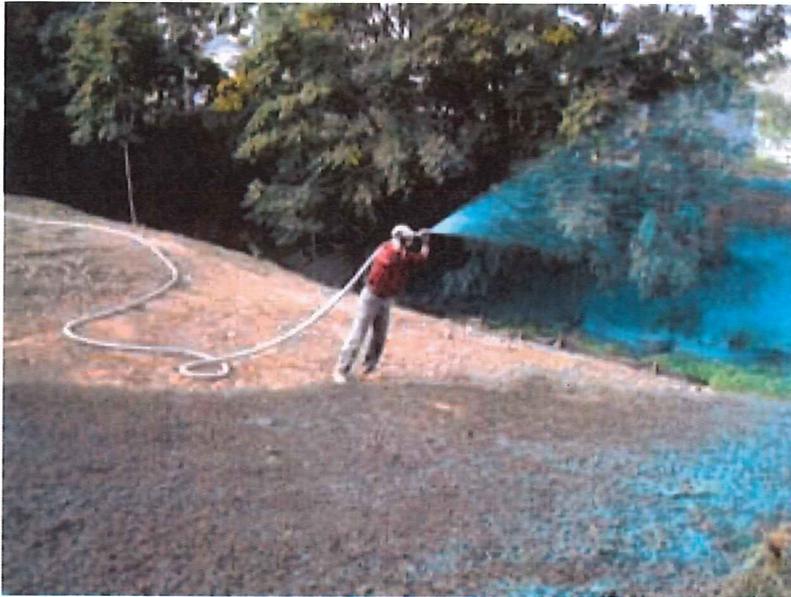
October 2008

Hydro-mulching

A hydro-mulch mixture of native and restorative grasses was sprayed throughout the site on all exposed soil. The hydro-mulched grasses will help with the stabilization of the banks and will also help to out-compete invasive species.

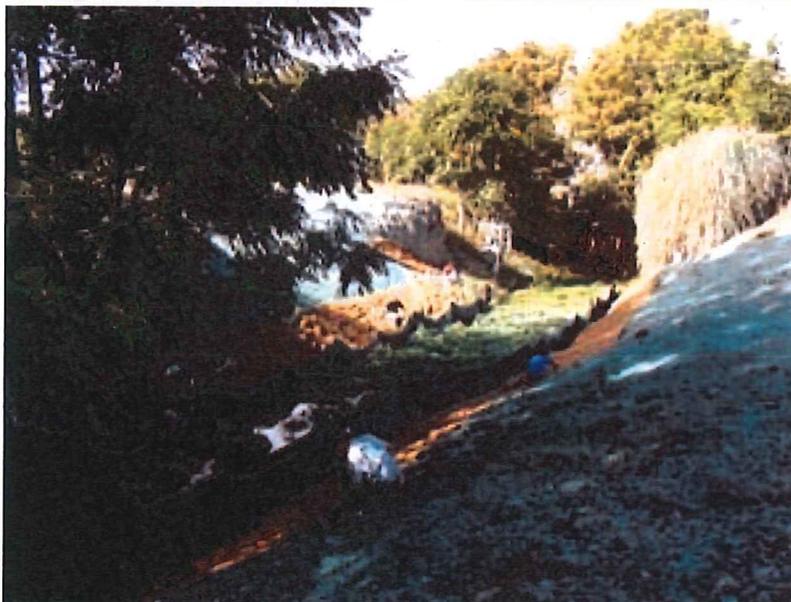
October 2008

Erosion Control Fabric

With the help of several student volunteers, over 300 feet of erosion control fabric was installed on steep stream banks to support native plant growth, protect the newly seeded native grasses, and reduce erosion. The fabric, which is composed of hemp fiber and coconut husk, will biodegrade over the course of several seasons.

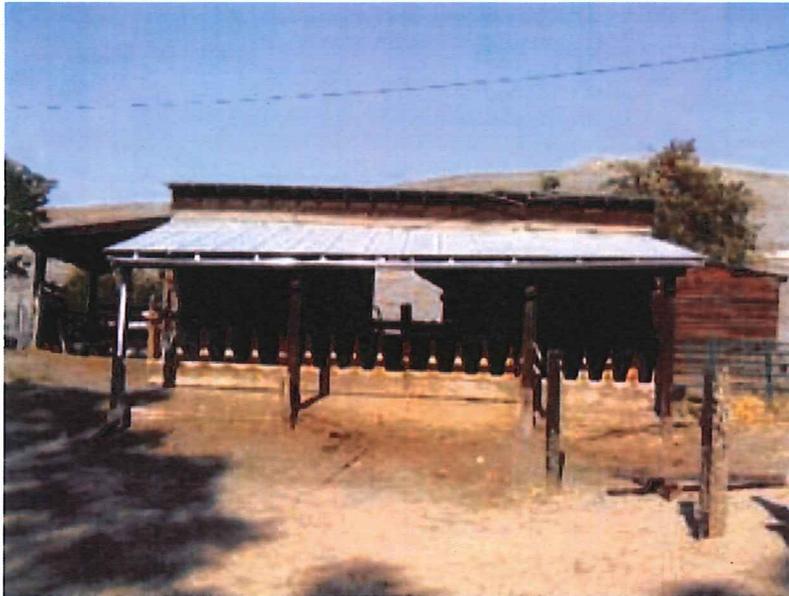
October 2008

Improved Gutter System

A new gutter system was installed to redirect rainwater from the barn roof to an outflow pipe, which drains directly into Lindsay Creek. The new gutter and pipe system prevents rainwater from running off the barn roof onto the steep banks and through the buffalo pasture reducing erosion, nutrients and bacteria from entering Lindsay Creek.

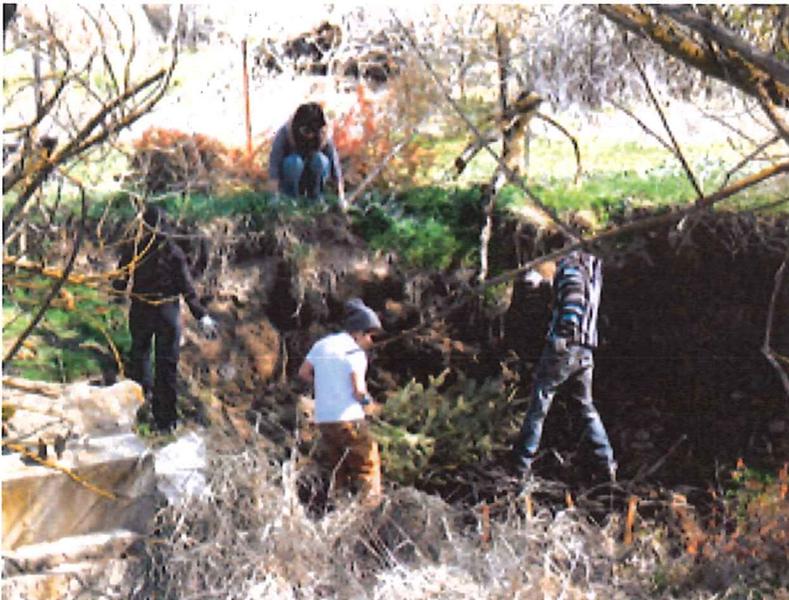
March 2010

Bank Stabilization

Waddle installation on Cowger property for bank stabilization and erosion control. Later, plants are planted along newly restored banks.

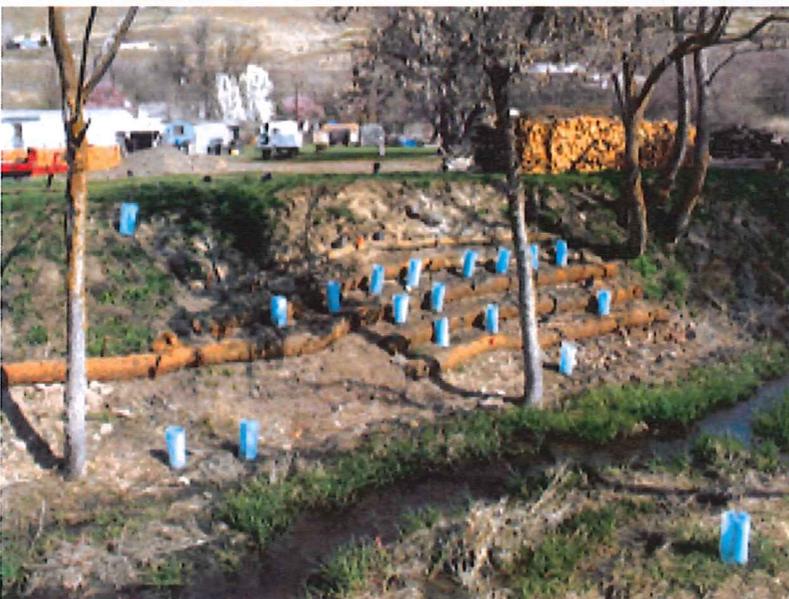
March 2010

Post Erosion Control

The end product after waddles and coirs have been placed in bank for stabilization and blue tubes set over the new plants for protection during Saturday Restoration Event.

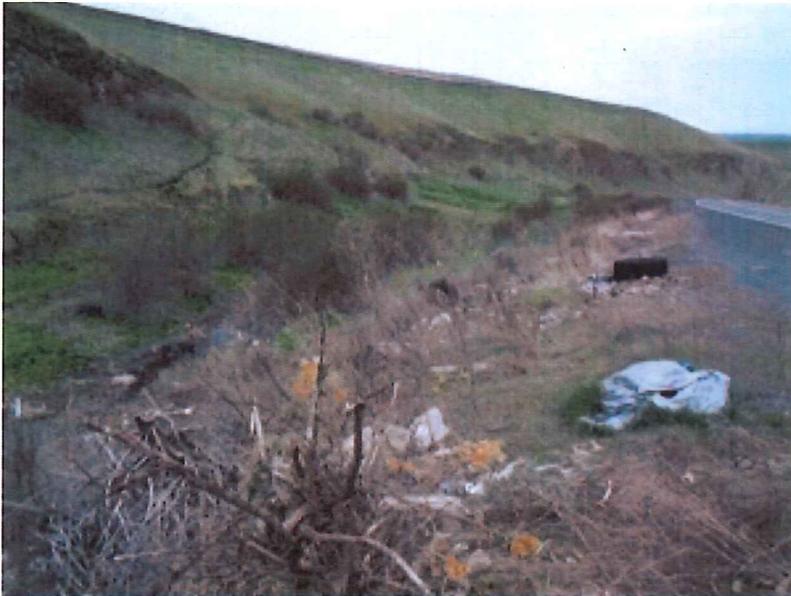
April 2011

Canyon Crest Estate Project Site

Trash accumulates on the banks of Lindsay Creek along our project site. Restoration designs will include a series of in-channel wetlands to help reduce nitrogen levels in the creek.

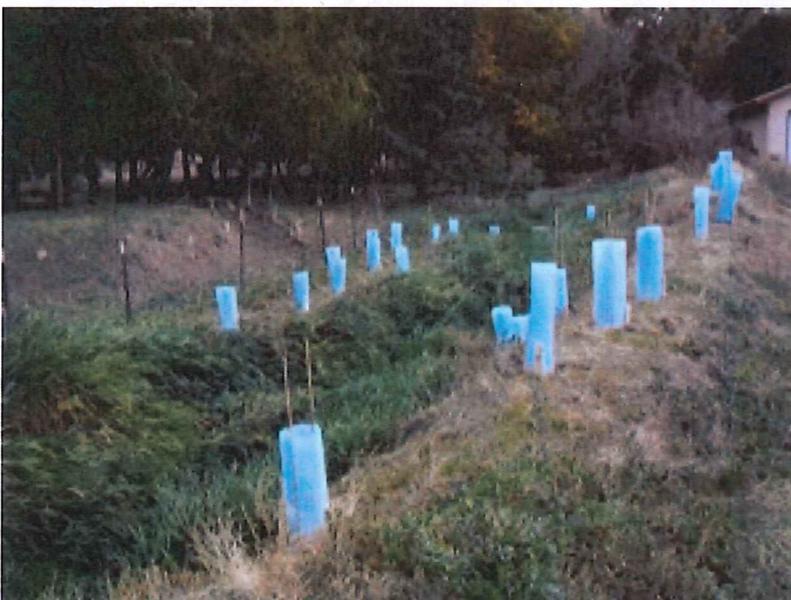
October 2011

Neilson Project Site

Native trees and shrubs were planted along Lindsay Creek. Weed control has been an ongoing challenge on all of our sites along Lindsay Creek. Poison hemlock and scotch thistle are the dominant weed on site.
