# Physical and hydraulic response of geomembrane wrinkles underlying saturated fine tailings

**REFERENCE:** Joshi, P., Rowe, R. K. and Brachman, R. W. I. (2016). Physical and hydraulic response of geomembrane wrinkles underlying saturated fine tailings. *Geosynthetics International*. [http://dx.doi.org/10.1680/jgein.16.00017]

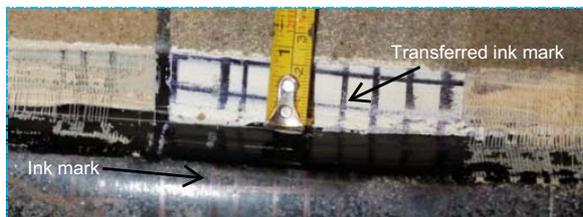
**Figure 5.** Underside of the 1 mm thick LLDPE geomembrane: (a) before test W2, with white paint on one side of the wrinkle crest line and ink marks on the opposite side. A double-sided tape is attached on one side to prevent the geomembrane from relaxing after the applied stress is removed, (b) post-test photograph showing the underside after the termination of test W2, (c) is an enlarged view of the inset in Figure 5b showing the ink marks transferred from one side of the wrinkle to the white paint on the opposite side, confirming contact between the inner sides of the wrinkle

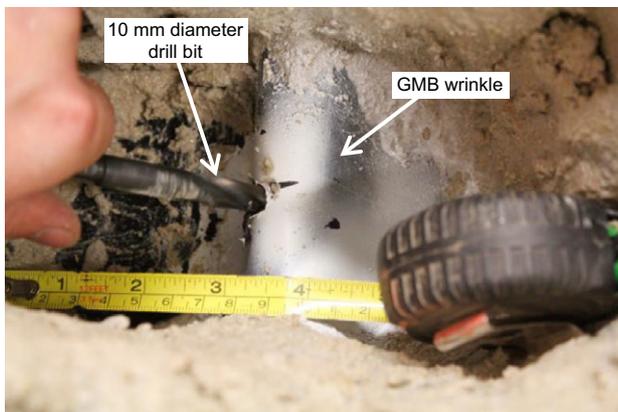
Figure 12. Hole being placed on the top side of the exposed wrinkle (test W4). The wrinkle was painted white to provide a reflecting surface for laser scanning

Initially, the 2 mm thick HDPE geomembrane wrinkle in test W4 did not have any hole. After 100 h of sustained vertical pressure of 250 kPa, the stress was removed and an observation trench excavated to allow inspection of the wrinkle (Figure 10). After the inspection, a 10 mm hole was drilled at the top side of the wrinkle (Figure 12). The observation trench was backfilled, and the backfill was consolidated as described for test W2 before starting the permeation phase of the test at  $p = 250$  kPa and  $u = 200$  kPa ( $p' = 50$  kPa; Figure 7). A steady state flow of 8.5 lpd was measured in a permeation test that lasted for 44 days. Although steady state flow conditions were attained in 20 days, the test was allowed to run for twice that time to confirm that a steady state had been reached and that there was no time-dependent effect on flow.

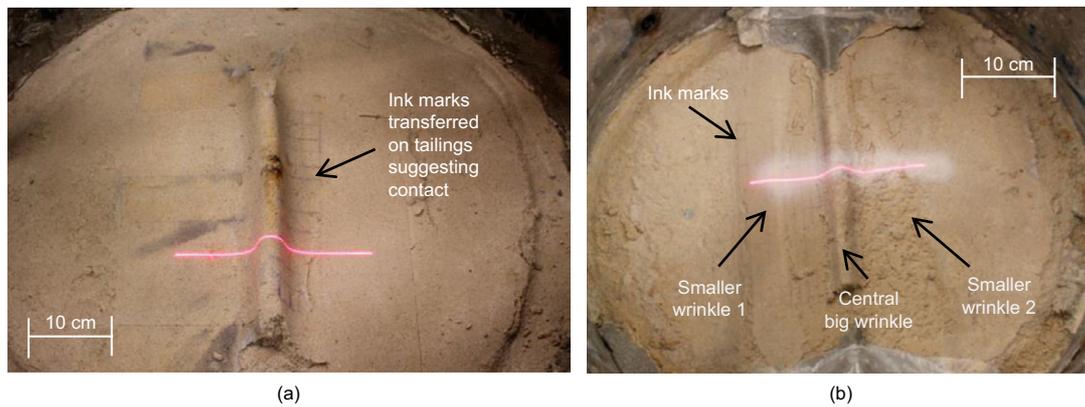
**Figure 13.** Photographs taken after removing the deformed geomembrane wrinkle followed by termination of the permeation test. (a) after test W4 with a 2 mm HDPE geomembrane where the hole was placed after tailings consolidation (see Figure 12), (b) in test W5 with a 2 mm thick LLDPE geomembrane where the hole was placed before placement of tailings
