# **Preliminary Assessment and Site Inspection Report for Bimetallic Ridge Mines**

**Catherine Mine (aka Silver Butte Mine)  
Brown Bear Mine (aka Silver Butte Mine, Silver Hill, Erickson)  
Hope and Faith Shaft  
Iron Mask Mine**

Bonner County

**January 2013**

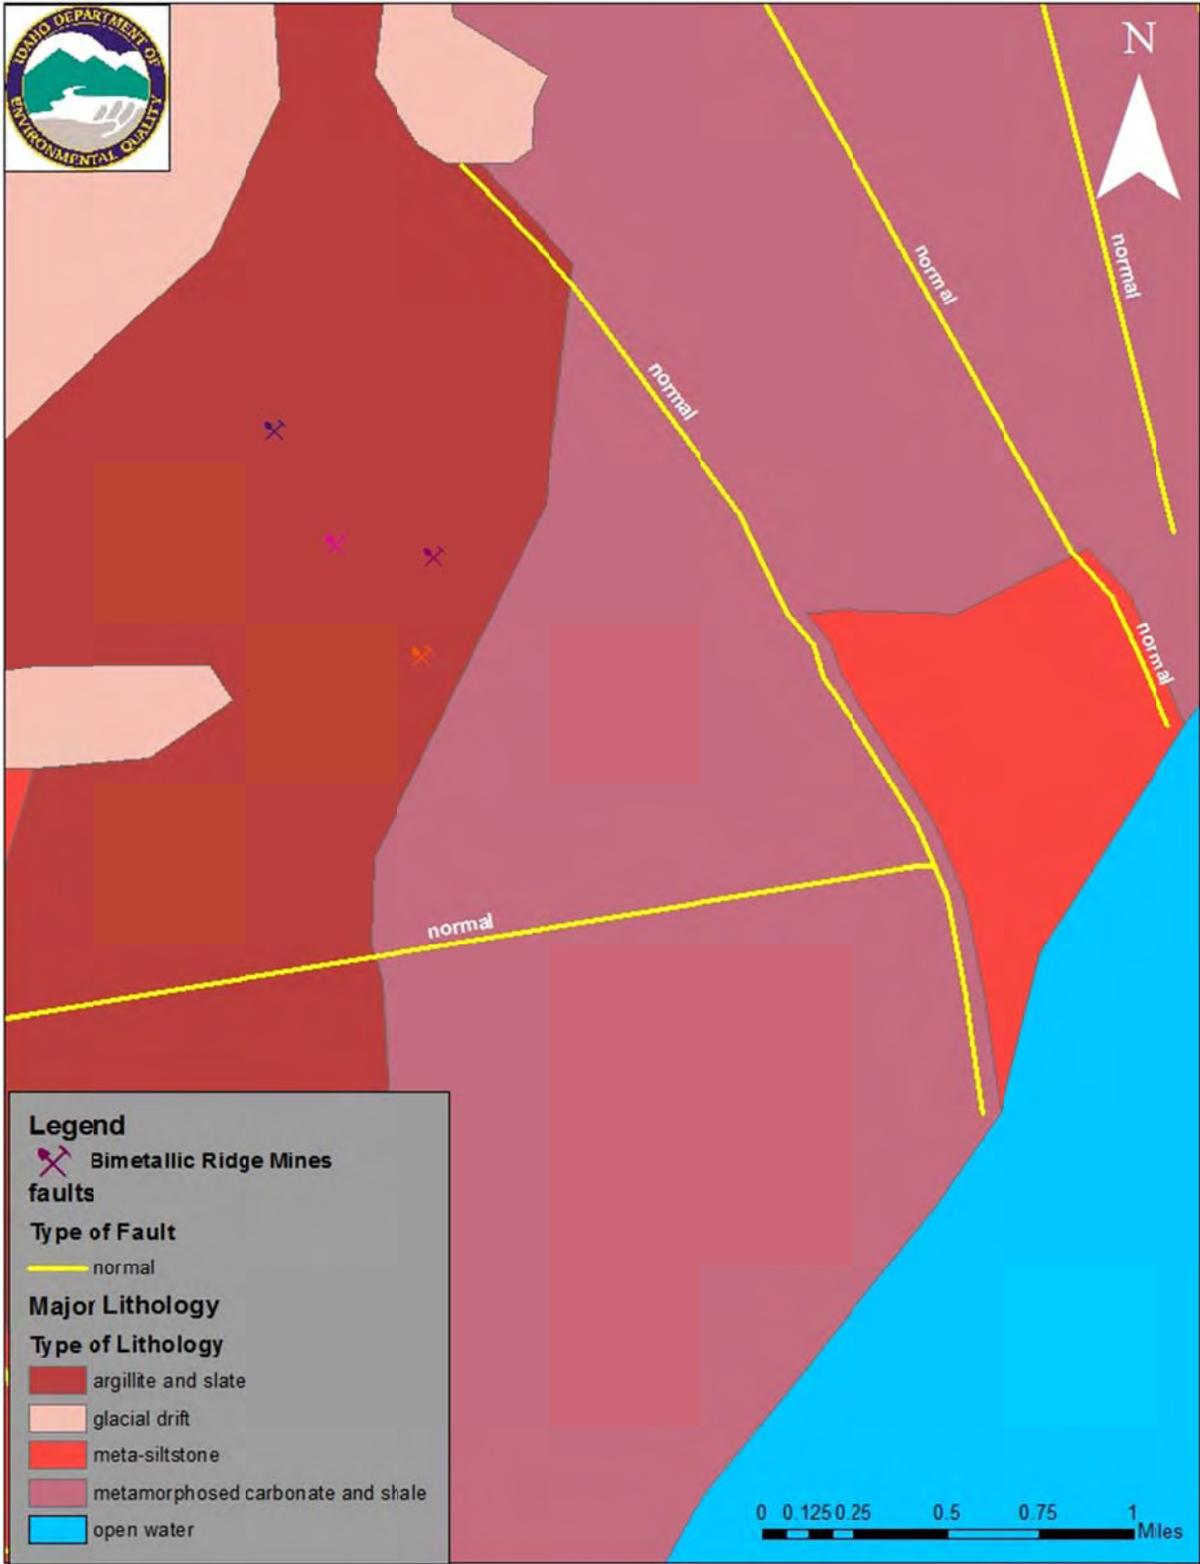
Figure 3 is a map of the major lithology in the vicinity of the Bimetallic Ridge mines.

Figure 3. Map of major lithology in the vicinity of the Bimetallic Ridge Mines.

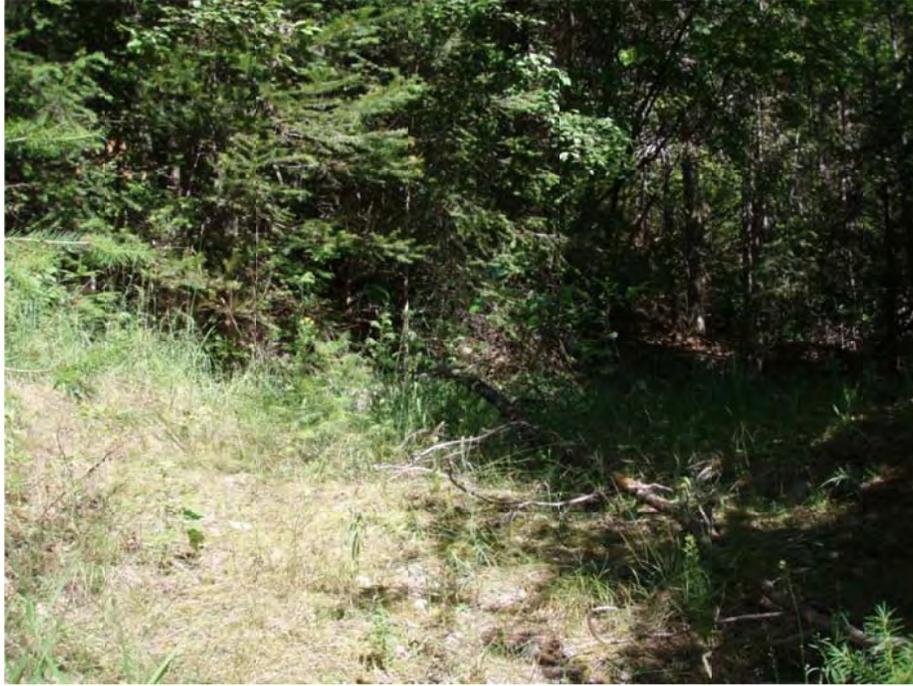
identified. The waste dump has been modified by bulldozer work. This area is referred to as CAAD1 on the sample location map (Figure 5 in Section 9).

**Photo 1. View of area on the north side of the road where Catherine Adit 1 was located.**

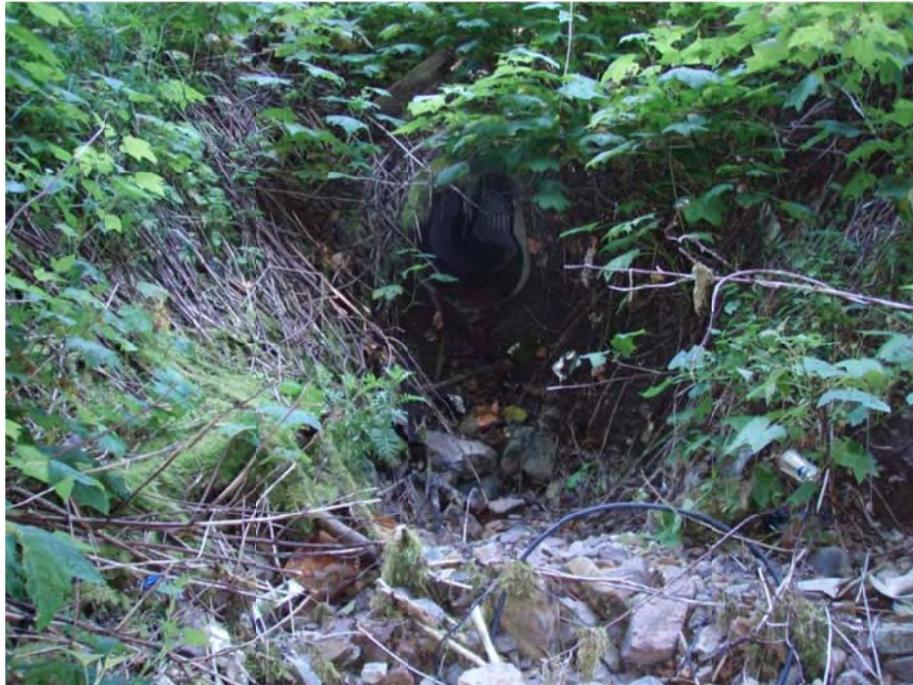
DEQ was unable to locate Catherine adit 2 (Photo 2) as identified by the IGS. This area is still identified as CAAD1 on the sample location map (Figure 4 in Section 9).

**Photo 2. View of area on the south side of the road where Catherine adit 2 was located.**

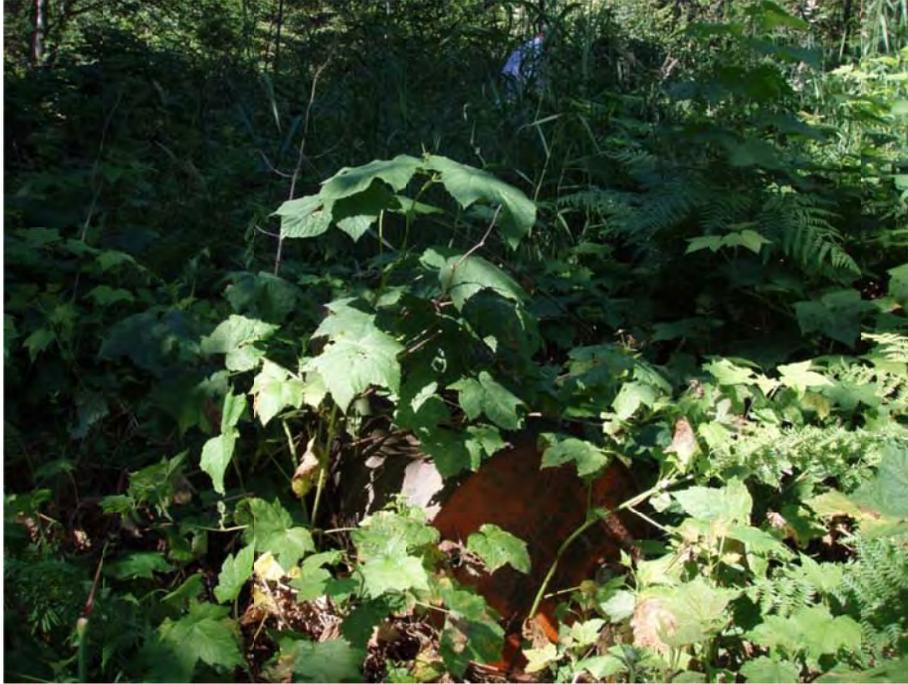
Photo 3 shows the area where Catherine waste dump 2 was identified by the IGS. The whole area above the unnamed creek has been modified by bulldozer work. The area below the road into the creek drainage contains a large amount of debris. The debris appears to range in age from 1950s to 1980s. There is a substantial amount of junk in the creek bed. The debris includes numerous 30-gallon barrels, old cars, gas cans, car parts, chairs, sinks, old heaters, 5-gallon cans, and other type of scrap (metal and plastic).

**Photo 3. View of area on the south side of the road where Catherine waste dump 2 was located.**

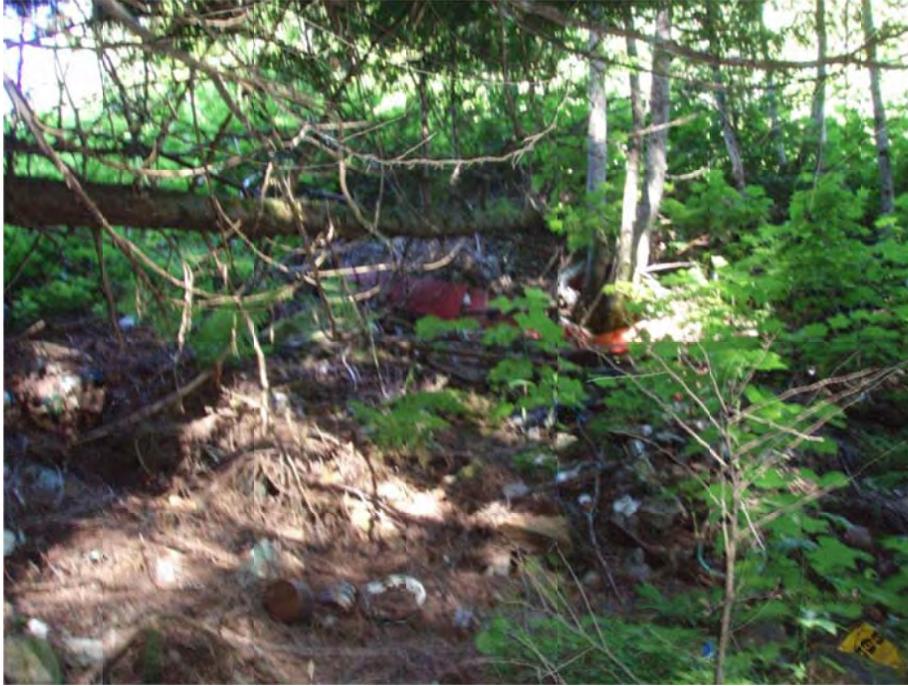
The disturbed area where the Catherine waste dumps were located is heavily overgrown (see vegetation above car body in Photo 4). The road is located approximately 30 feet above the car body. The whole disturbed area covers several acres.

**Photo 4. Car body appears to be stabilizing the bank of the unnamed creek.**

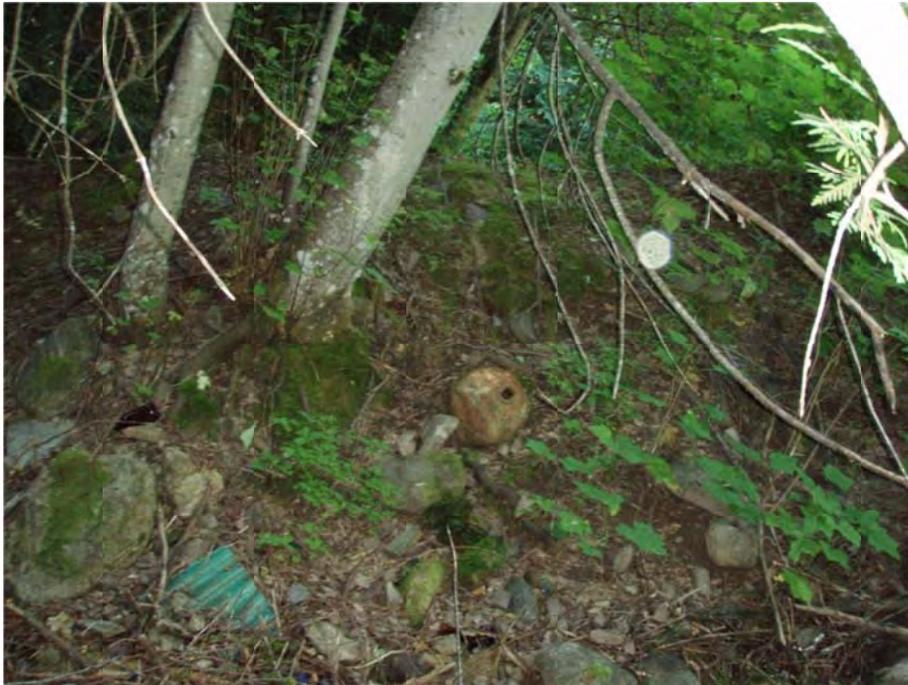
The area in Photo 5 is labeled as CAAD1 and CAAD2 on the sample location map (Figure 4 in Section 9). In the IGS site inspection report (Kauffman et al. 2003) the area is referred to as Catherine adits 1, 2, and 3.

**Photo 5. Debris on the creek bank below Catherine adits 1, 2, and 3.**

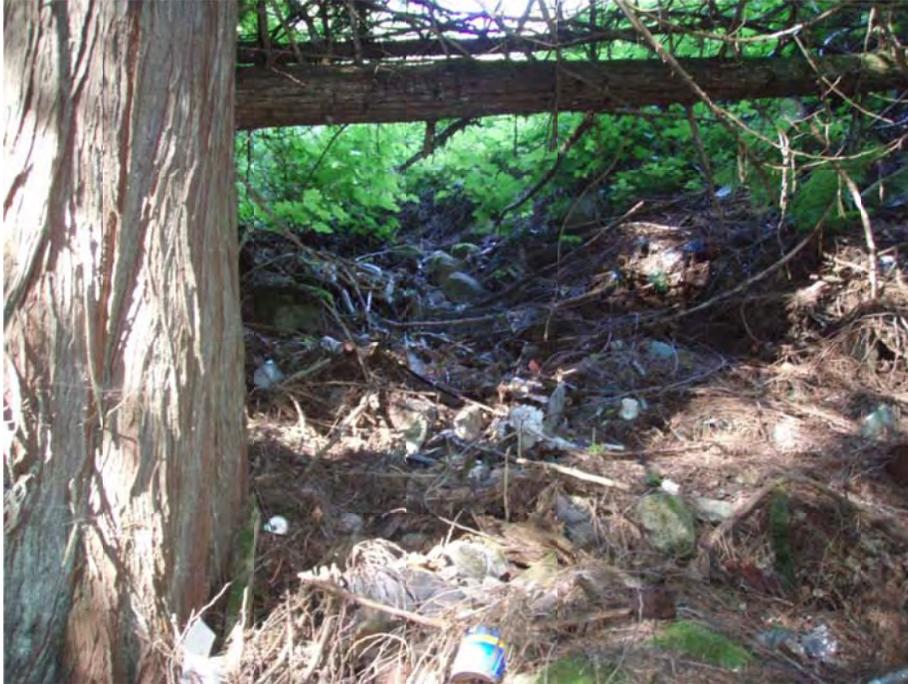
It appears that trash may be mobile during heavy rain events (Photo 6). There is evidence of rilling from the creek bank to the creek.

**Photo 6. Trash near the unnamed creek.**

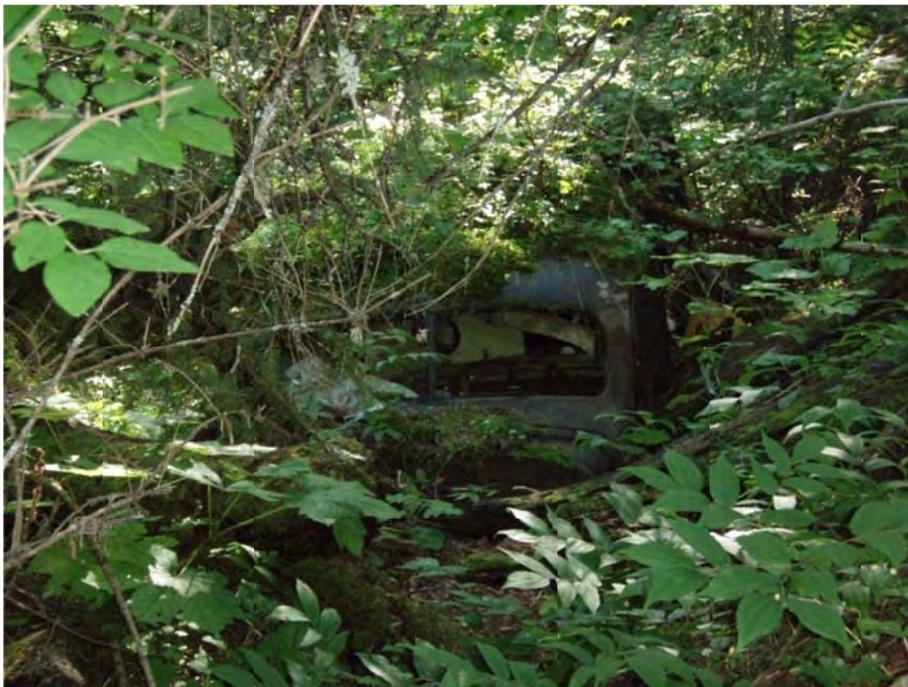
**Photo 7. Car body in floodplain of unnamed creek.**

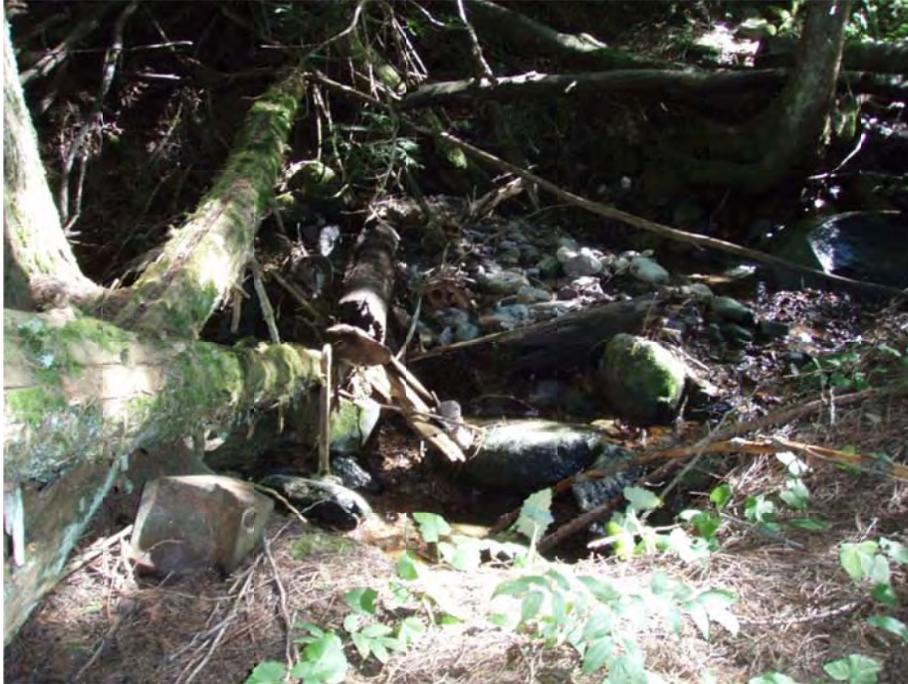
**Photo 8. Debris in the unnamed creek.**

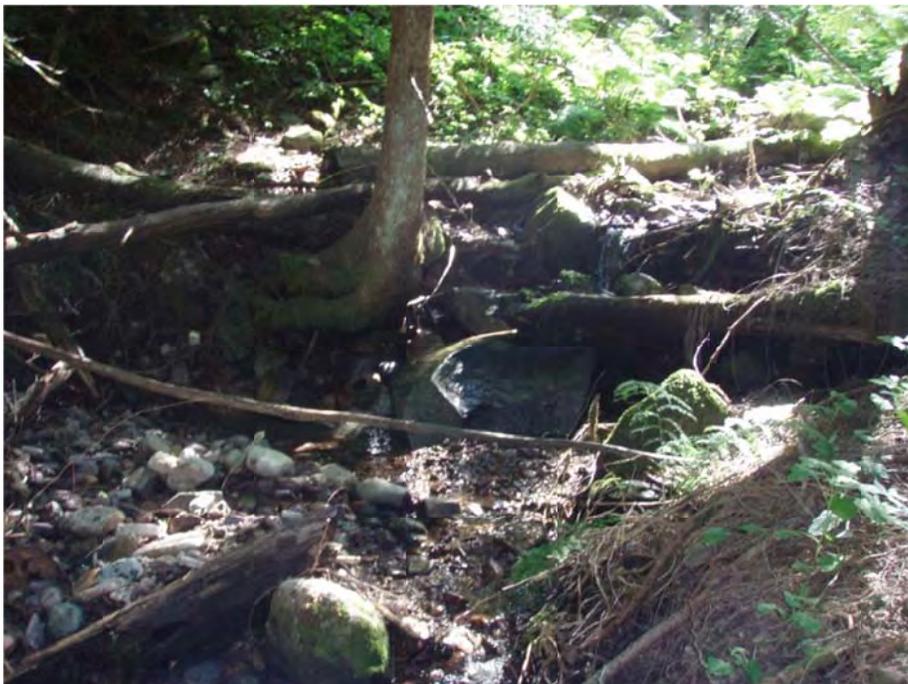
Surface water sample BBPPE1SW1 and sediment sample BBPPE1SD1 were collected from this unnamed creek (Photo 9) below the majority of mine workings. Parameters were also collected from the creek. The sample location was selected in an area away from where most of the debris was concentrated. There was still a minor amount of debris around the sample area.

**Photo 9. Samples BBPPE1SW1 and BBPPE1SD1 were collected from this unnamed creek.**

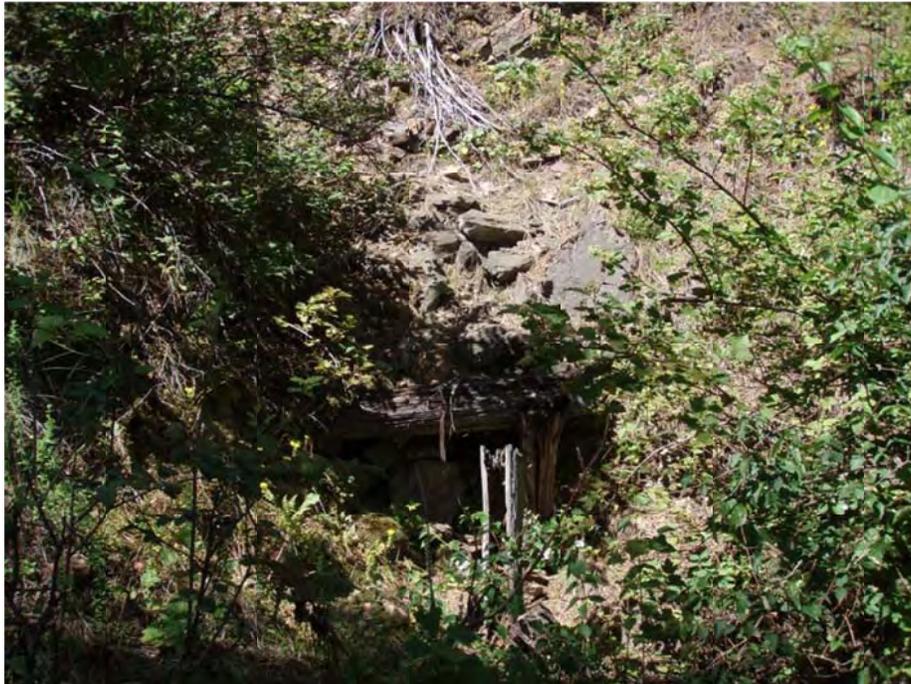
The following adits are located in a gully on the northwest side of the main access road west of Catherine adits 1 and 2 and north of adit 3. The workings observed were relatively minor. DEQ refers to the adit in Photo 10 as CAAD3 on the sample location map (Figure 4 in Section 9). The IGS site inspection report calls it adit 4.

**Photo 10. View of partially collapsed Catherine adit 4.**

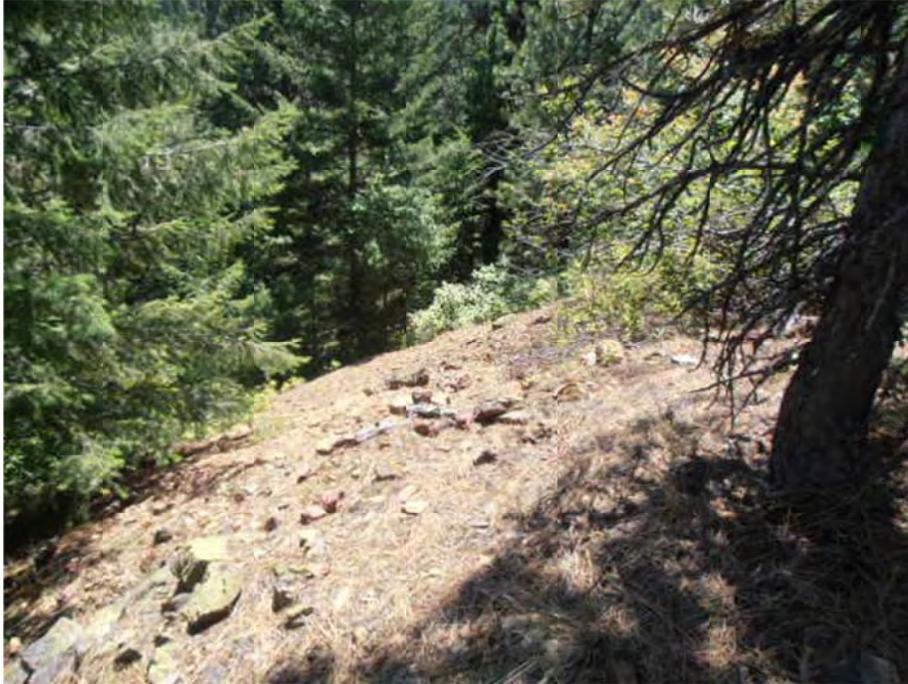
Soil sample CAWD6XRFSS1 was collected for QA/QC from the waste dump shown in Photo 11.

**Photo 11. View from the southwest of CAAD3 waste dump.**

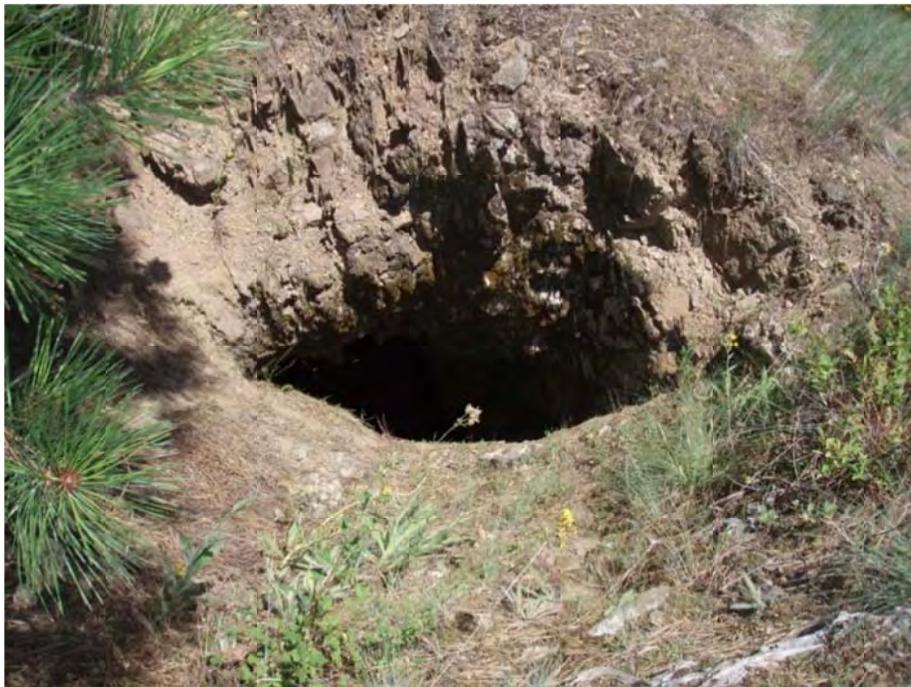
DEQ named the adit in Photo 12 CAAD4 on the sample location map (Figure 4 in Section 9). The IGS site inspection report (Kauffman et al. 2003) refers to it as Catherine adit 5 or 6. The adit is open and located on a steep hill.

**Photo 12. View of Catherine adit 5 or 6.**

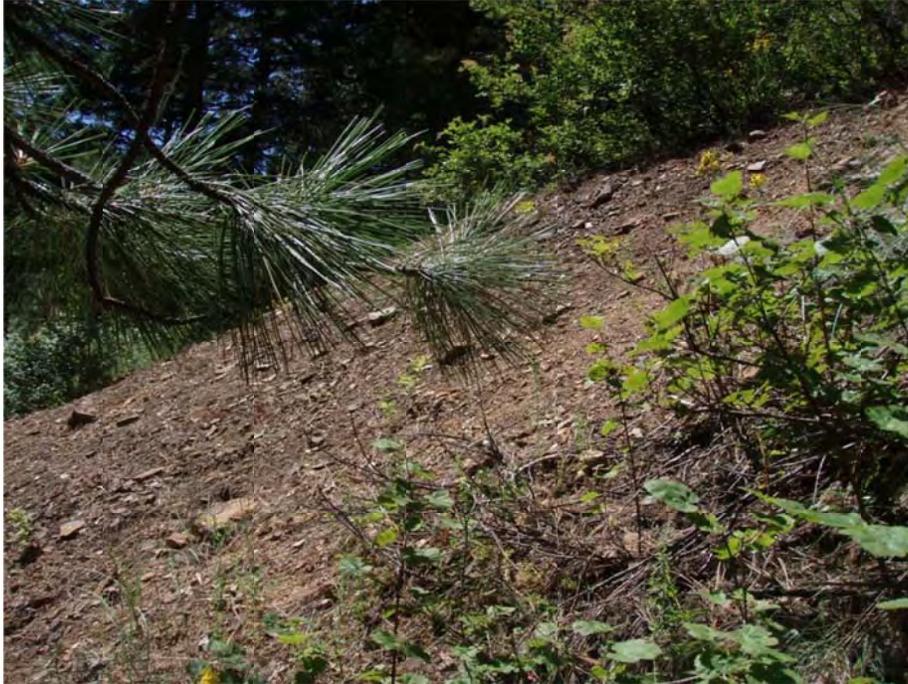
Because an arsenic value greater than 200 mg/kg on the FPXRF reading triggered collection of a sample, soil sample CAWD5SS1 was collected from the waste dump in Photo 13.

**Photo 13. CAAD4 adit waste dump.**

Metals and arsenic concentrations assessed above the FPXRF screening levels were found only at Catherine adit 5 of the five remaining Catherine adits. An arsenic value larger than 200 mg/kg on the FPXRF reading triggered the collection of soil sample CAWD5SS1 for chemical analysis. The analysis demonstrated that both lead and arsenic are above levels of concern.

However, an estimated 333 cubic yards of waste rock is present. The Catherine adit 5 waste dump is isolated from any road or trail and must be actively sought out. Since the lead and arsenic exceedance are one and a half and three times the risk levels, respectively, on a steep area of loose rock with no vegetation and covering less than three hundredths of an acre, little human health or environmental protection would be gained by capping this single remote waste pile.

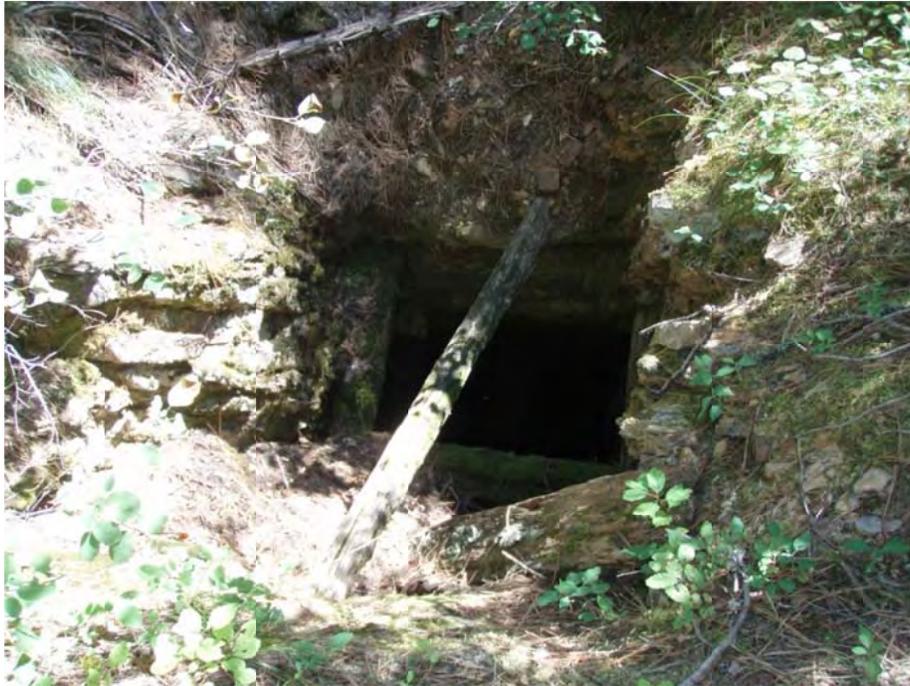
The Hope and Faith Shaft is a single feature located just to the south of the center of Section 36. The shaft dips into the earth at a greater than 45 degree angle. It is open which poses a fall risk to an unwary individual approaching it. However, the shaft is isolated and well off an ATV trail to its north and likely seldom visited. A second prospect feature or possibly a building dugout is located immediately north of the shaft.

**Photo 14. Hope and Faith Shaft.**

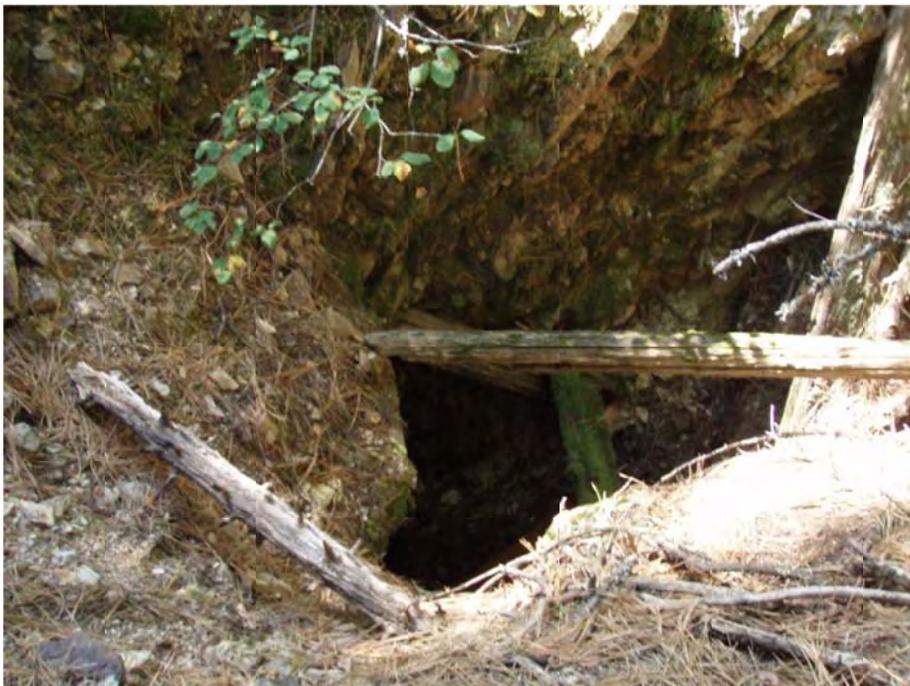
At the time of the assessment no water was observed in the shaft. There were no indications of water traveling from the shaft, from the surface, or in the area down gradient in the form of seeps. The area is located at a higher elevation than the rest of the workings where there are no surface water features.

**Photo 15. Close-up of Hope and Faith Shaft.**

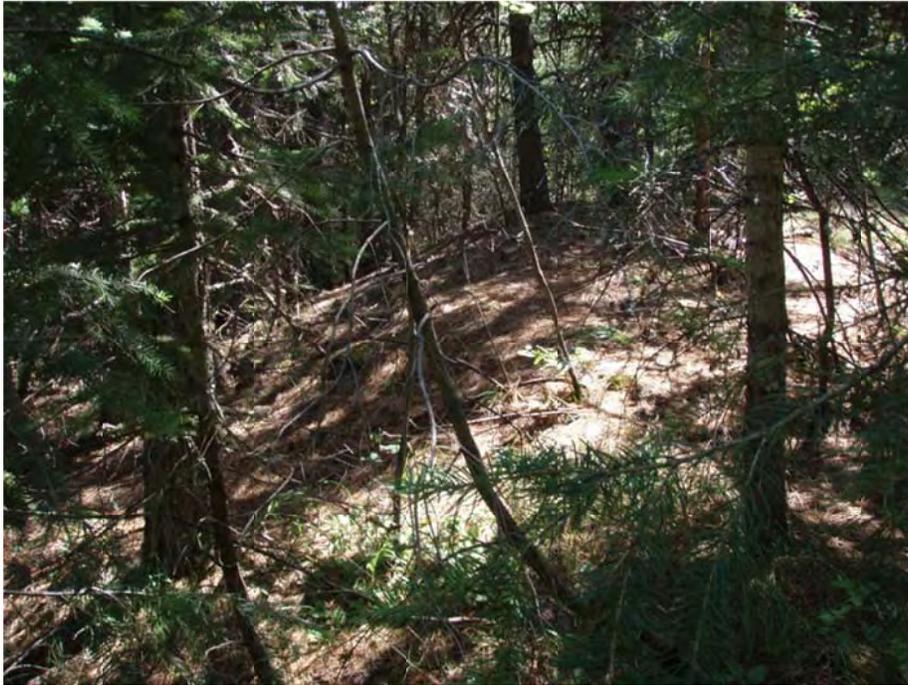
Very little waste rock is located around the shaft (approximately 37 cubic yards [cy]). The lack of waste rock suggests the shaft does not penetrate too deep into the ground. All mine wastes associated with the Hope and Faith Shaft are waste rock. No evidence of milling operations and associated tailings were found on the site.

The FPXRF assessment of the waste rock yielded average readings on three tests of 106 mg/kg lead, 24 mg/kg arsenic, and 79 mg/kg zinc. Based on this screening level assessment, the mine waste at the Hope and Faith Shaft is not a risk to human health or the environment. However, the open shaft is a potential safety risk to a hunter or some other area user that might unwittingly stumble into it.

**Photo 16. Hope and Faith Shaft waste dump.**

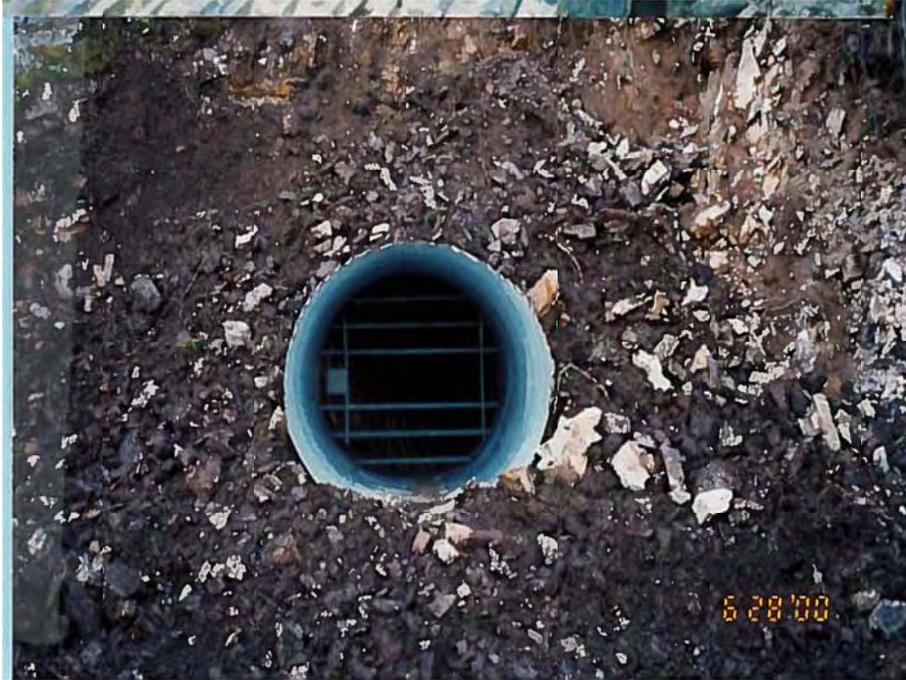
No water was observed at Iron Mask adit 1 at the time of DEQ's site assessment and the gate appeared in good condition.

**Photo 17. Iron Mask adit 1 (IDL photo 6/28/2000).**

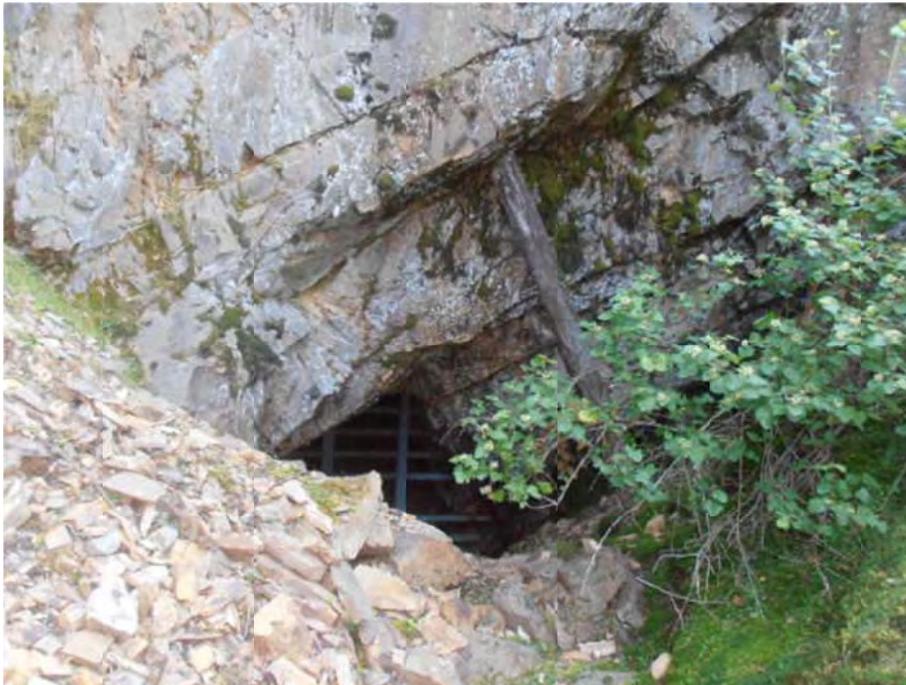
No water was observed in the upper Iron Mask adit. It was also fitted with a bat gate.

**Photo 18. View to the south of the upper Iron Mask adit.**

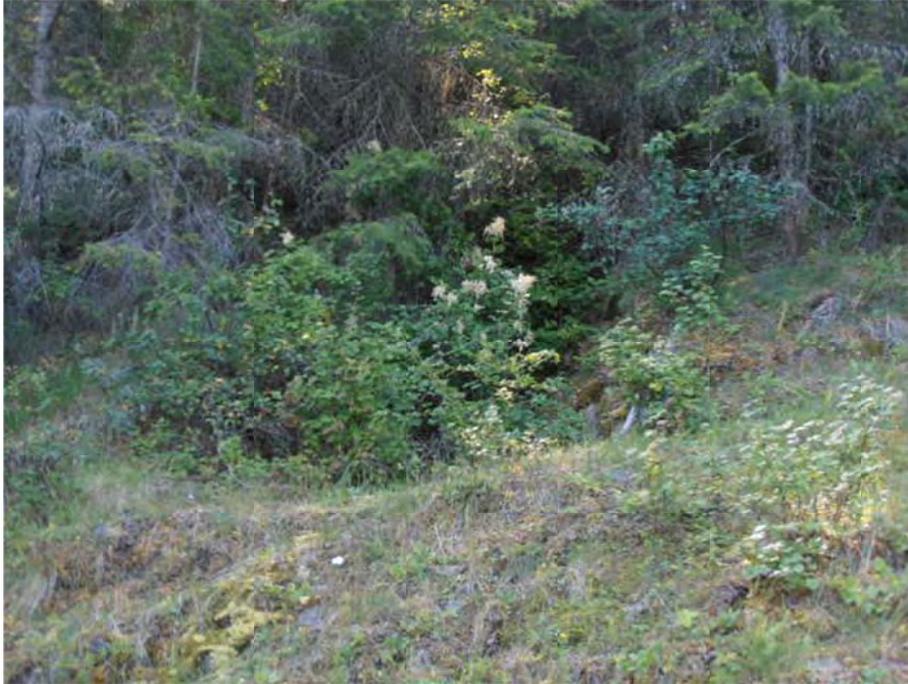
Photo 19 shows a prospect cut is located approximately 50 feet east of the lower Iron Mask adit.

**Photo 19. View to the west of the Iron Mask Mine prospect cut.**

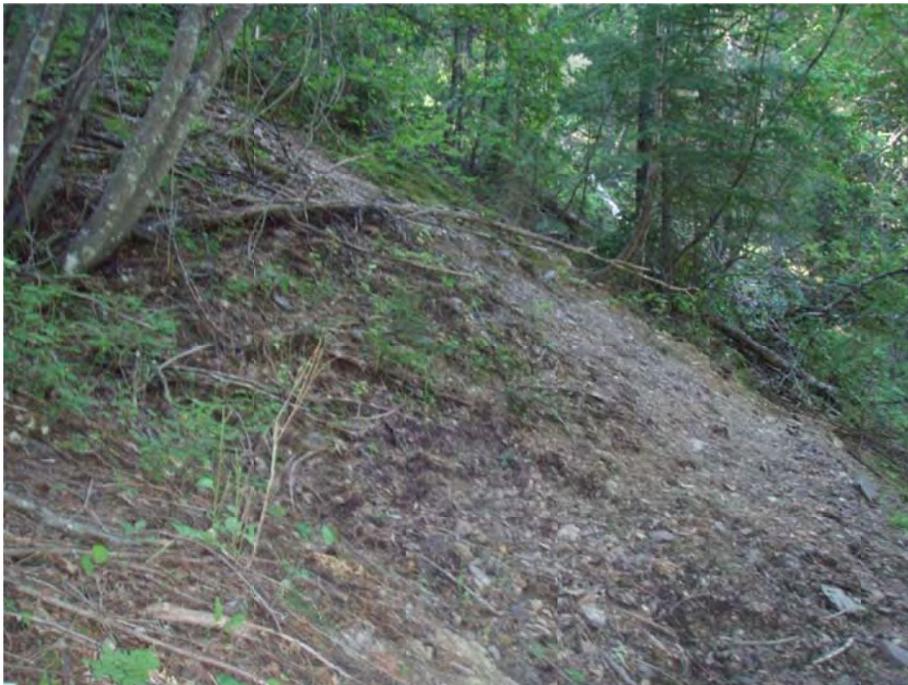
As shown in Photo 20, the Iron Mask Mine waste dump associated with the upper adit is well vegetated.

**Photo 20. Iron Mask Mine upper adit waste dump.**

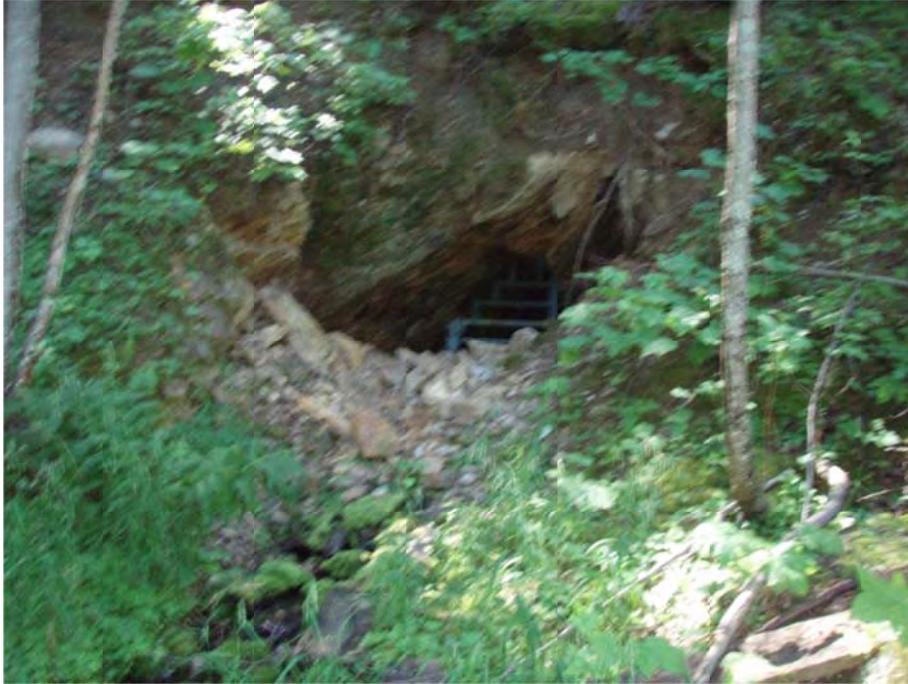
The Brown Bear Mine is located in the southeast quarter of Section 36. Brown Bear adit 1, located to the south of Catherine adits 1 and 2, is the most northerly mine feature. Brown Bear adit 1 is open with a bat gate.

**Photo 21. Brown Bear adit 1.**

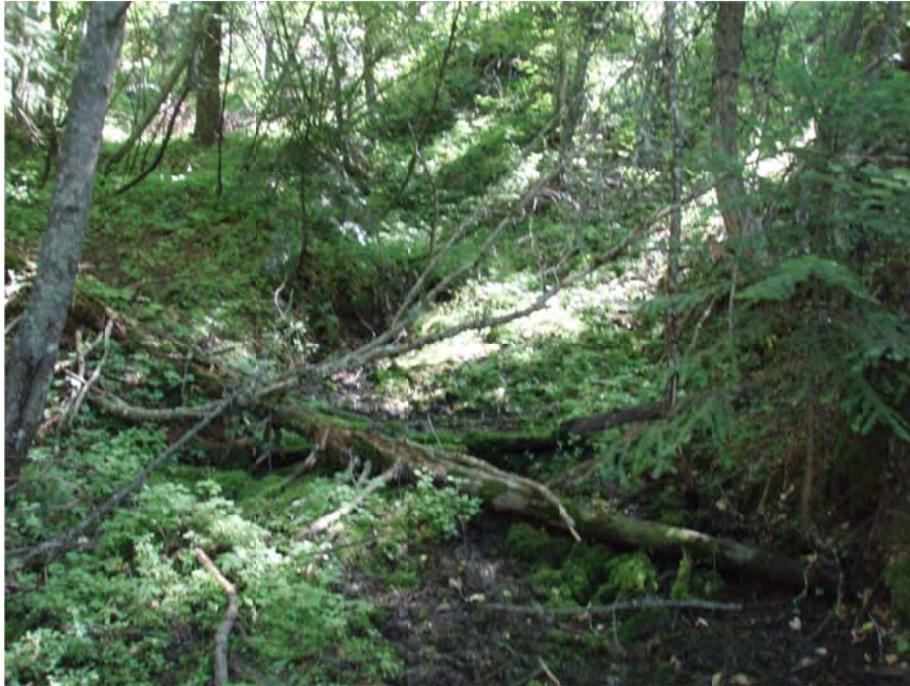
Brown Bear adit 2 (BBAD2 on Figure 5 in Section 9) is collapsed with water flowing at a rate of approximately one gallon per minute (gpm). The area is well vegetated and shows signs of hunting. Surface water sample BB2AD1SW1 was collected from the adit drainage. A duplicate water sample BBDUPSW1 was collected and water parameters were also collected.

**Photo 22. View to the south of Brown Bear adit 2.**

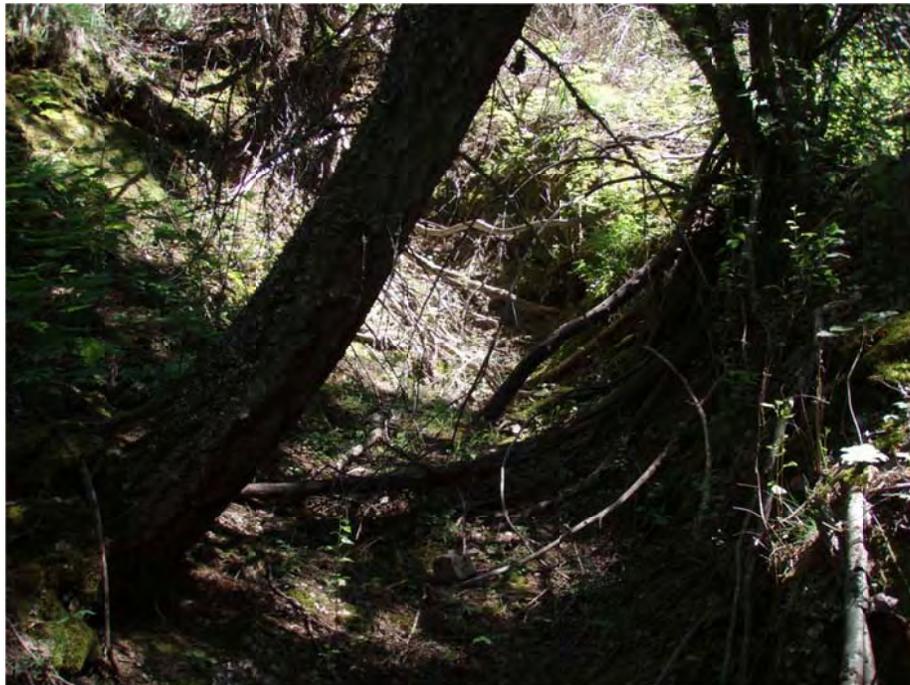
Brown Bear adit 3 (BBAD3 on Figure 5 in Section 9) is collapsed with no evidence of flowing water.

**Photo 23. View to the south of Brown Bear adit 3.**

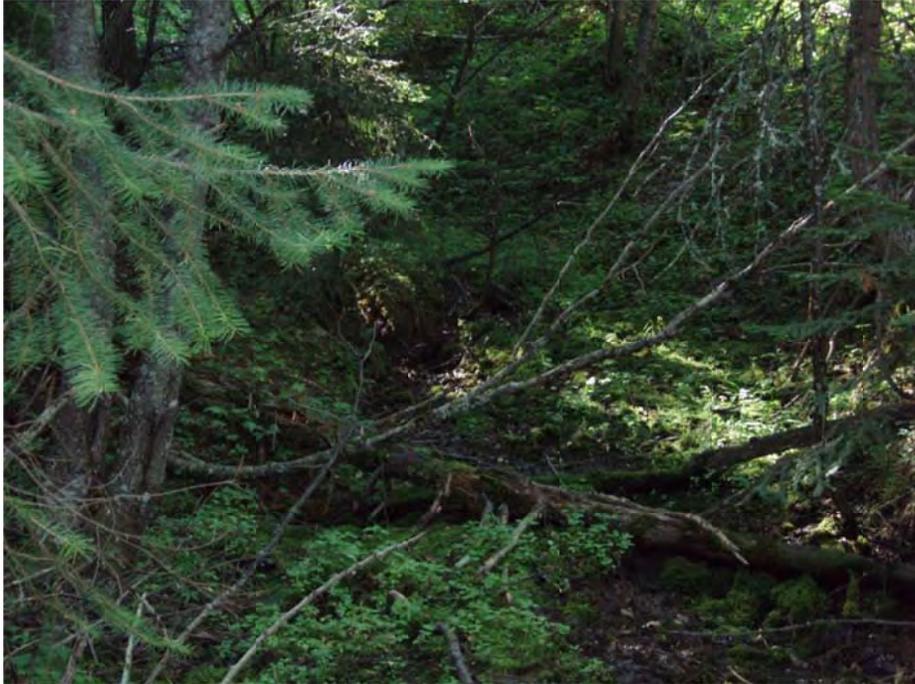
The area between Brown Bear adit 3 and waste dump 3 is heavily vegetated and signs of animals bedding down can be seen (Photo 26). Waste dump 3 (Photo 27) contains approximately 5,185 cubic yards of waste rock. Given the size of the waste dump, a composite soil sample BBWD3SS1 was collected.

**Photo 26. View facing southwest of top of Brown Bear waste dump 3.**

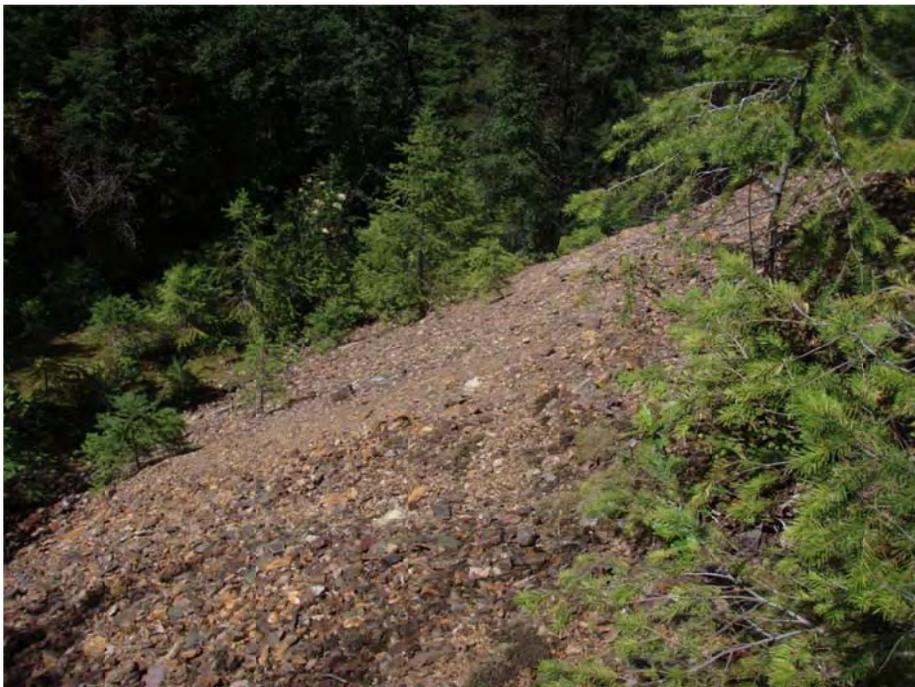
**Photo 27. North facing view of slope of Brown Bear waste dump 3.**

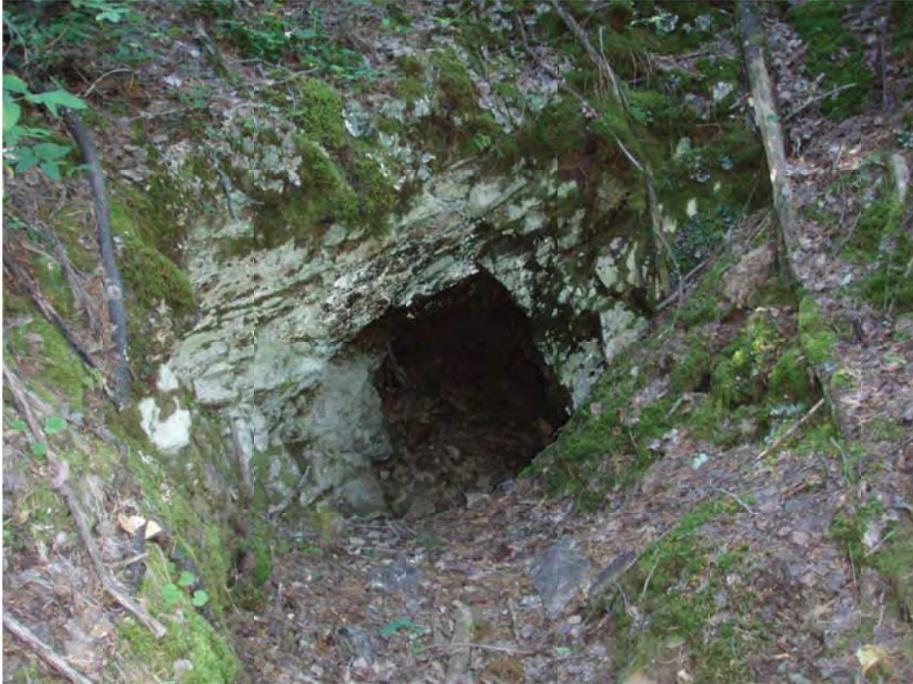
As shown in Photo 28, Brown Bear adit 4 (BBAD4 on Figure 5 in Section 9) is open with no evidence of water.

**Photo 28. View facing south of Brown Bear adit 4.**

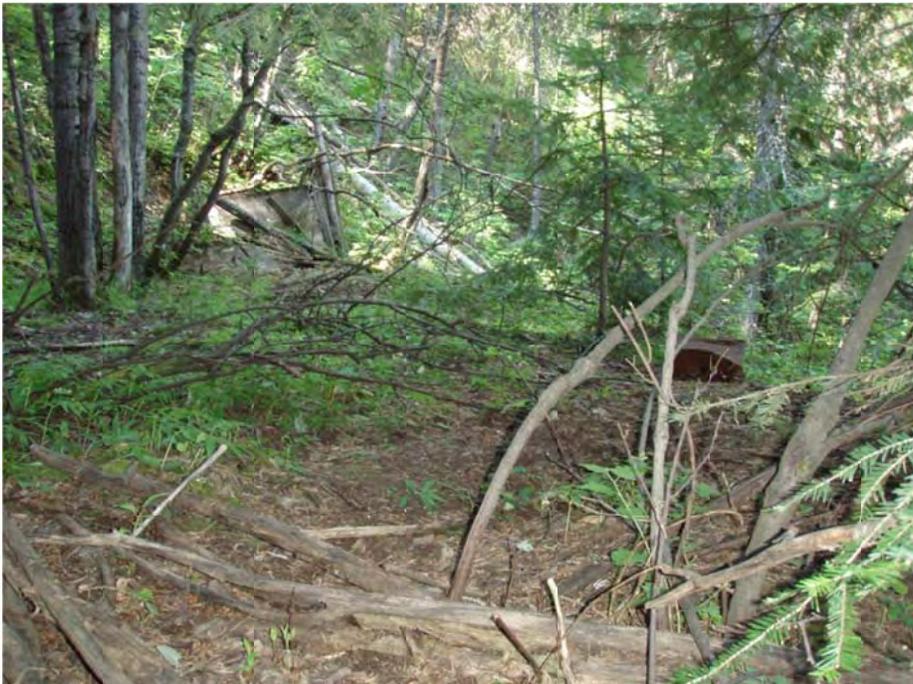
Brown Bear waste dump 4 is approximately 200-300 cubic yards of mainly country rock. The top and toe of the waste dump (Photo 29) are heavily vegetated with mature trees and a layer of more than two inches of duff. No sulfides were observed. No water was observed on or around the waste dump.

**Photo 29. View facing east from the top of Brown Bear waste dump 4.**

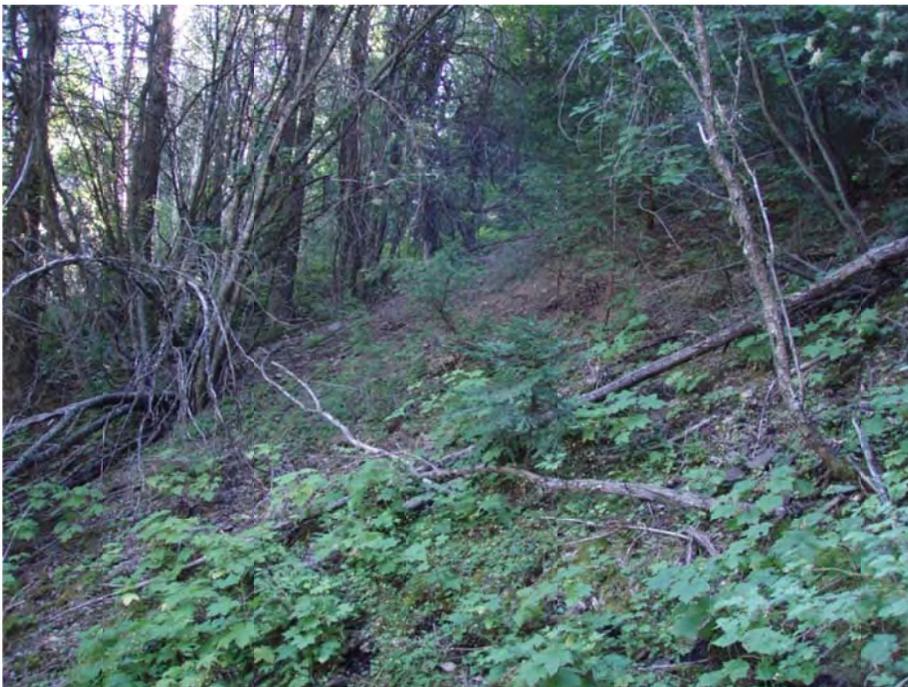
**Photo 31. View facing northwest of the slope of Brown Bear waste dump 4.**

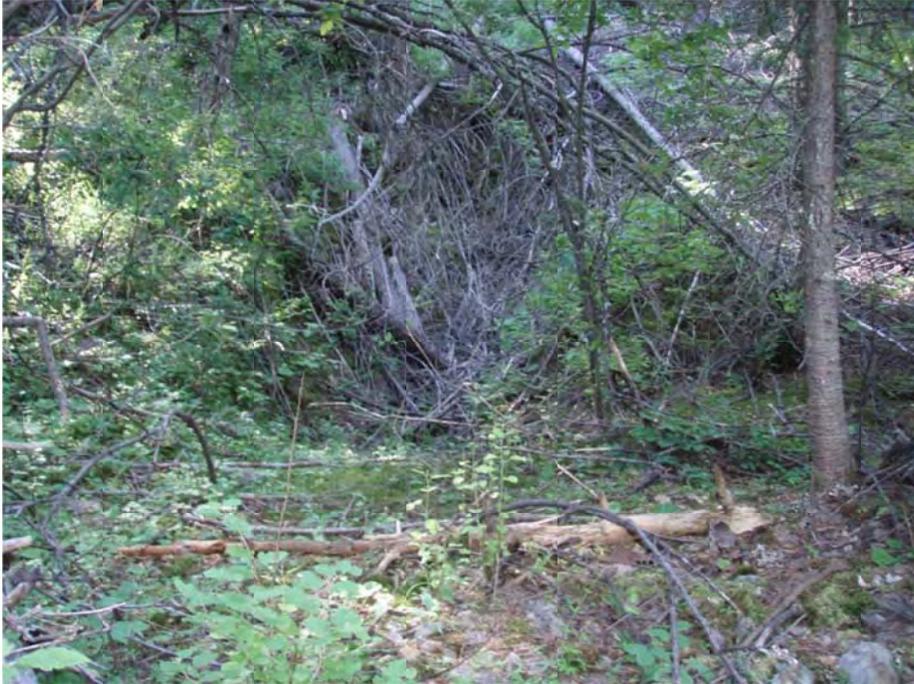
As shown in Photo 32, no water was observed at Brown Bear adit 5 (BBAD5 on Figure 5 in Section 9). The adit opening is very small and right below a tree (Photo 33).

**Photo 32. View to the south/southwest of Brown Bear adit 5.**

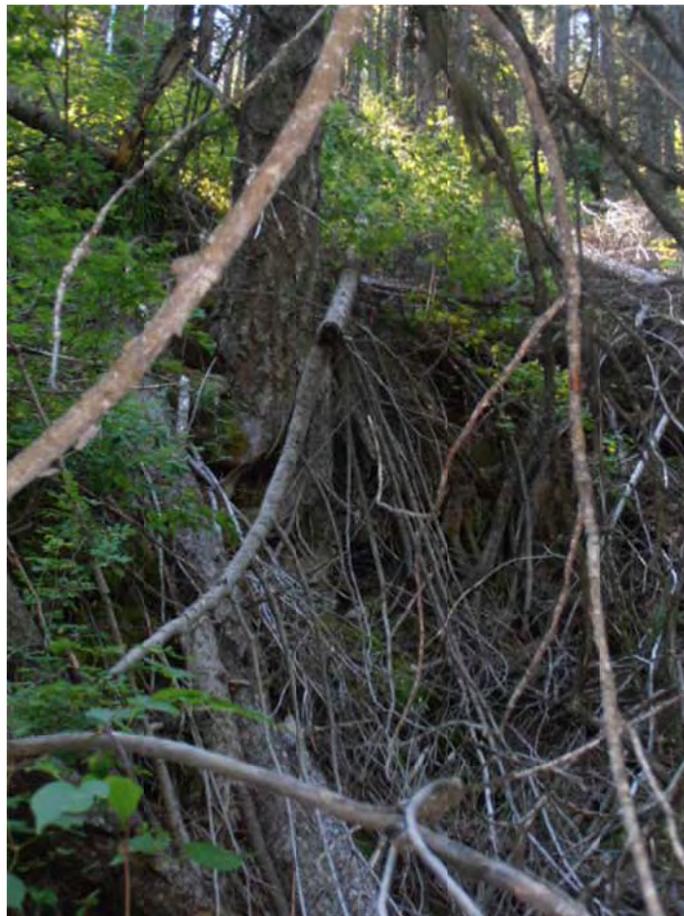
**Photo 33. Close-up view of Brown Bear adit 5.**
