# **Preliminary Assessment and Site Inspection Report for Bimetallic Ridge Mines**

**Catherine Mine (aka Silver Butte Mine)  
Brown Bear Mine (aka Silver Butte Mine, Silver Hill, Erickson)  
Hope and Faith Shaft  
Iron Mask Mine**

Bonner County

**January 2013**

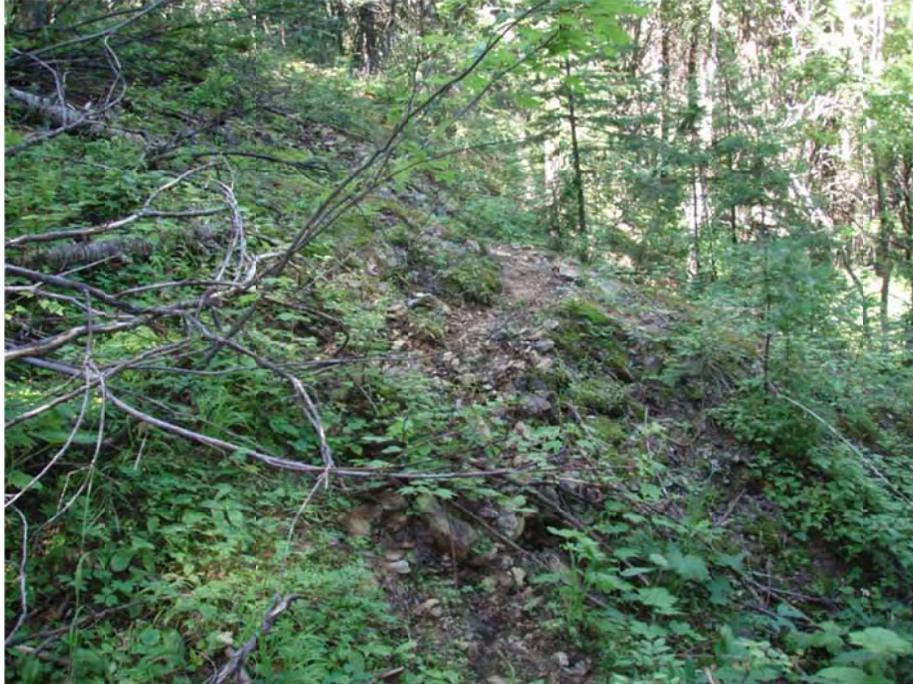
Photo 34 shows Brown Bear waste dump 5 which contains less than 50 cubic yards of waste rock and is heavily vegetated.

**Photo 34. View facing southeast of Brown Bear waste dump 5.**

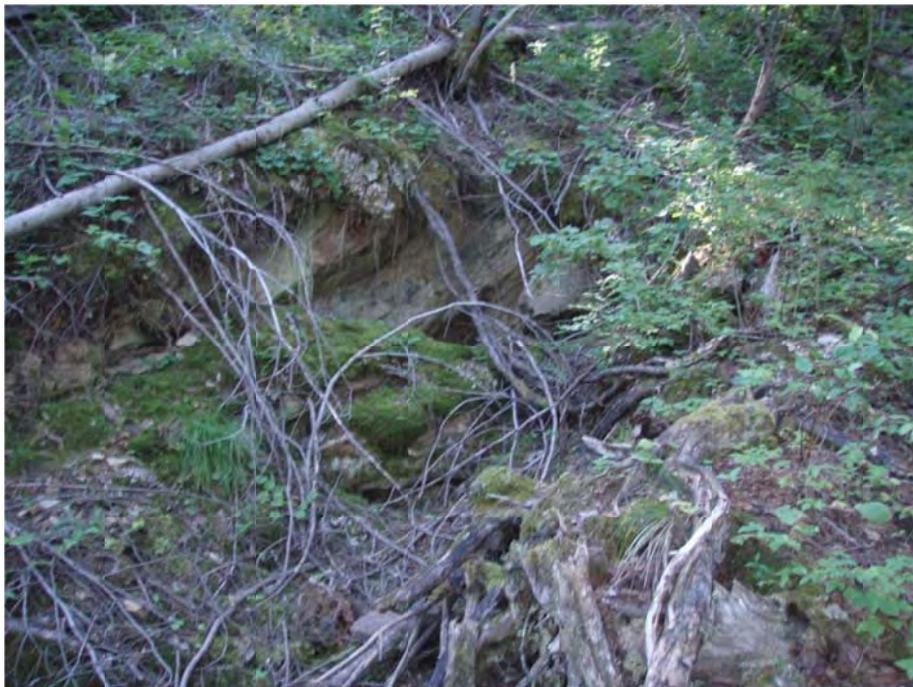
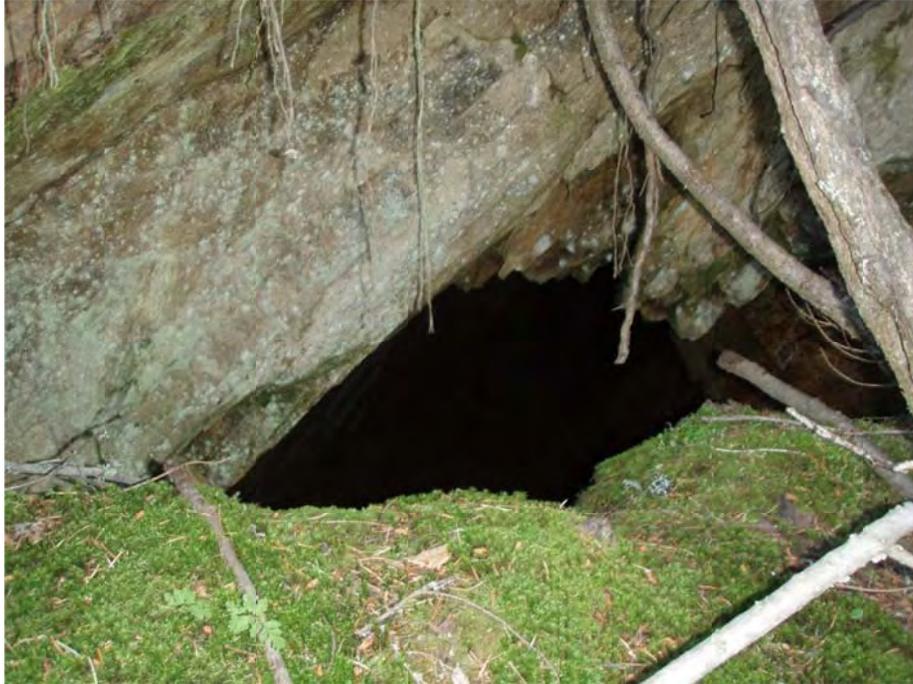
As shown in Photo 35 and Photo 36, Brown Bear adit 6 (BBAD6 on Figure 5 in Section 9) appears to be collapsed. There is a small opening along the outcrop and shallow workings. Boulders have slumped in front of the adit opening limiting access. No water was observed.

**Photo 35. Brown Bear collapsed adit 6.**

**Photo 36. View to the south of Brown Bear adit 6.**

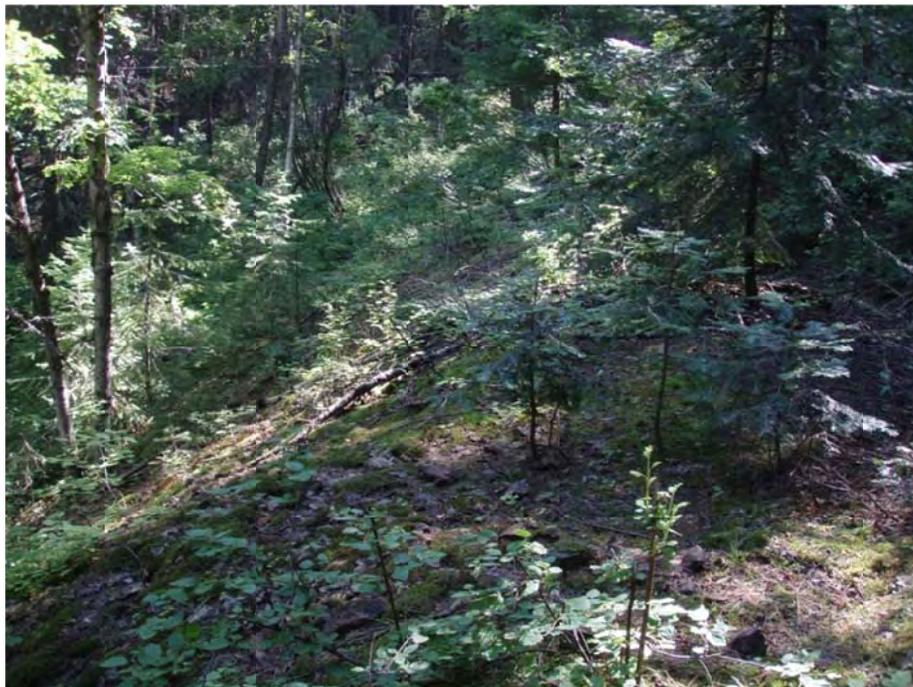
Brown Bear waste dump 6 is spread out and appears to be the waste dump for adit 6 and also a pair of adits labeled BBAD7 on the sample location map (Figure 5 in Section 9). The total area encompasses less than 3,000 feet and is heavily vegetated with mature trees on top (Photo 37). There is lush vegetation with moss and duff on the top and the toe of the waste dump. It also looks like a road may have ran along the top of the waste dump.

**Photo 37. Brown Bear waste dump 6.**

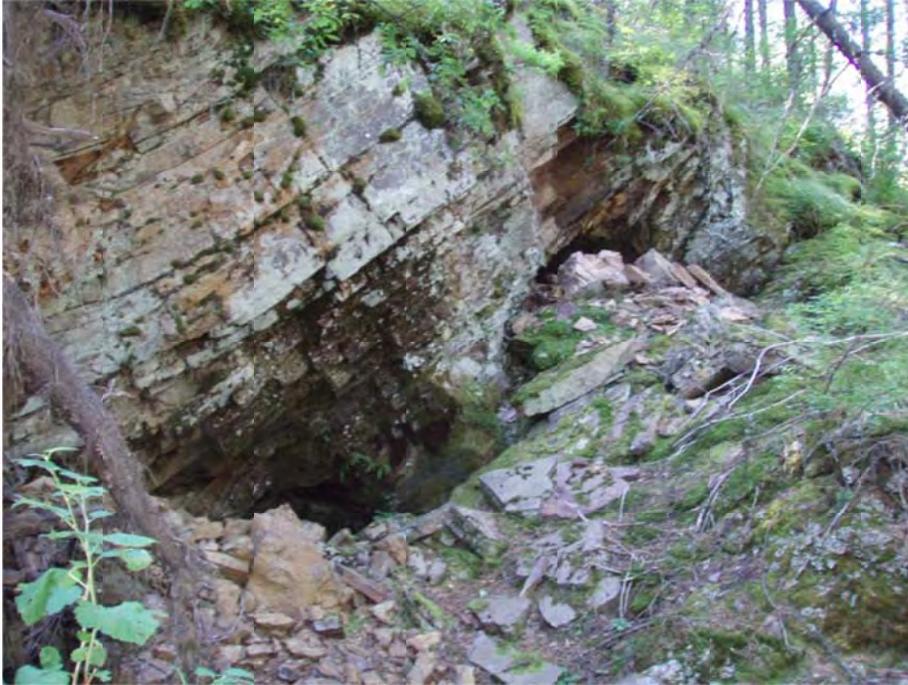
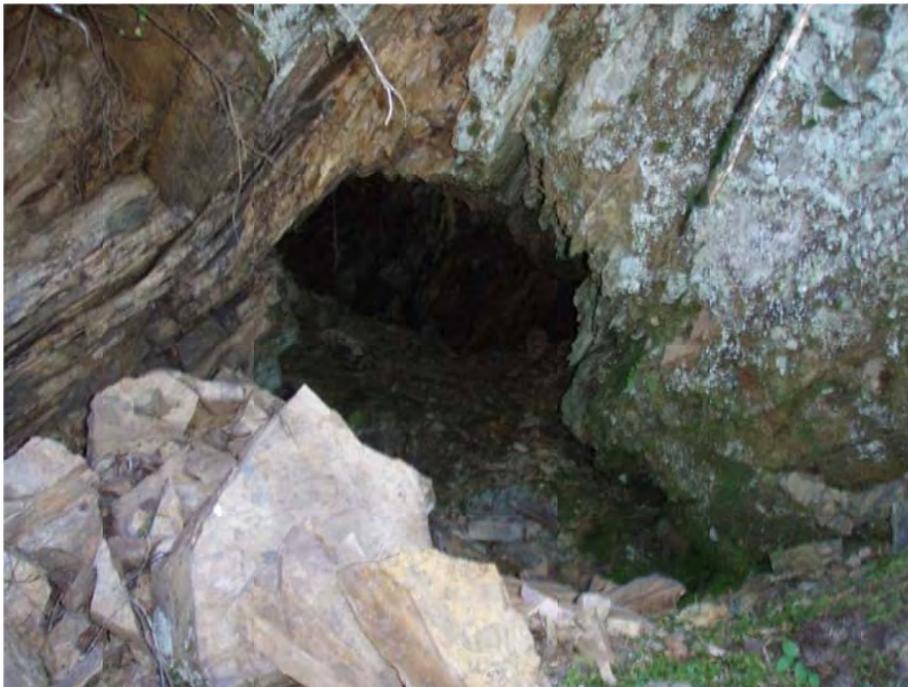
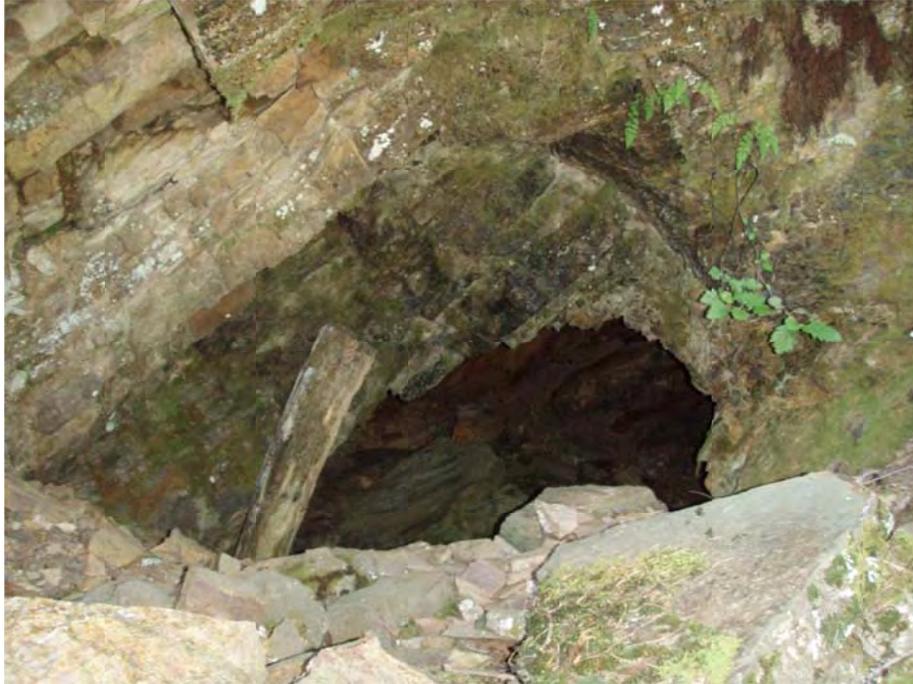
Brown Bear adit 7 (BBAD7 on Figure 5 in Section 9) is the uppermost set of adits in this drainage. There are two short openings along a vein or shear parallel to the bedding. The upper right adit appears to be a stope (Photo 38 and Photo 39). The lower opening appears shallow and caved in after approximately three feet (Photo 40).

**Photo 38. View to the south of the lower collapsed Brown Bear adit 7 and possible stope (upper right of photo).**

**Photo 39. View facing south of lower Brown Bear adit 7.**

**Photo 40. View to the south of the upper opening of Brown Bear adit 7.**

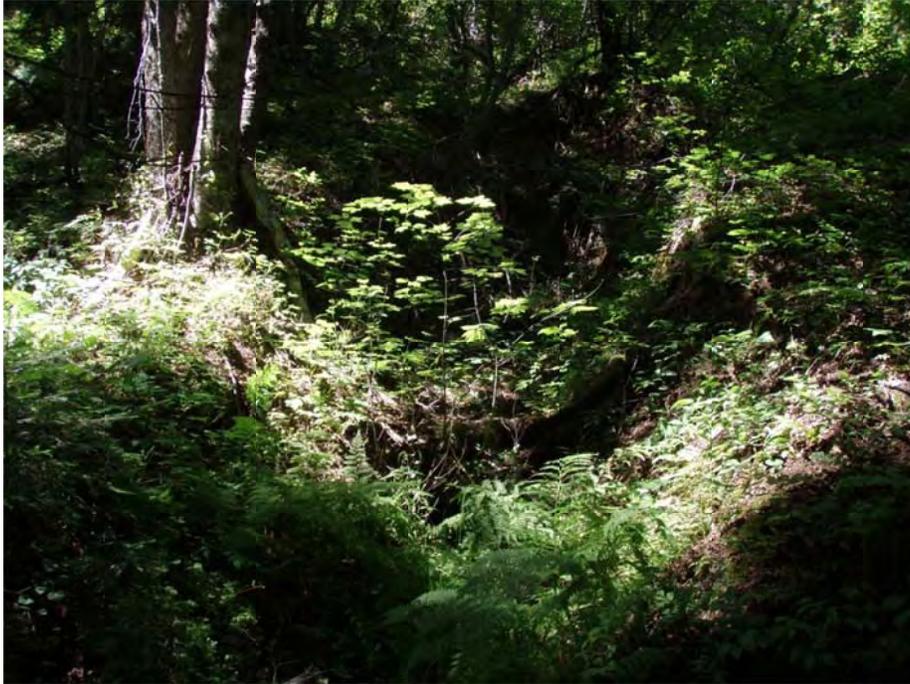
Photo 41 shows collapsed Brown Bear adit 8 (BBAD8 on Figure 4 in Section 9) which has less than one gpm of discharge flowing from it. Surface water sample BB8AD1SW1 was collected from the seep. Parameters were not collected from the seep.

**Photo 41. View to the west of collapsed Brown Bear adit 8.**

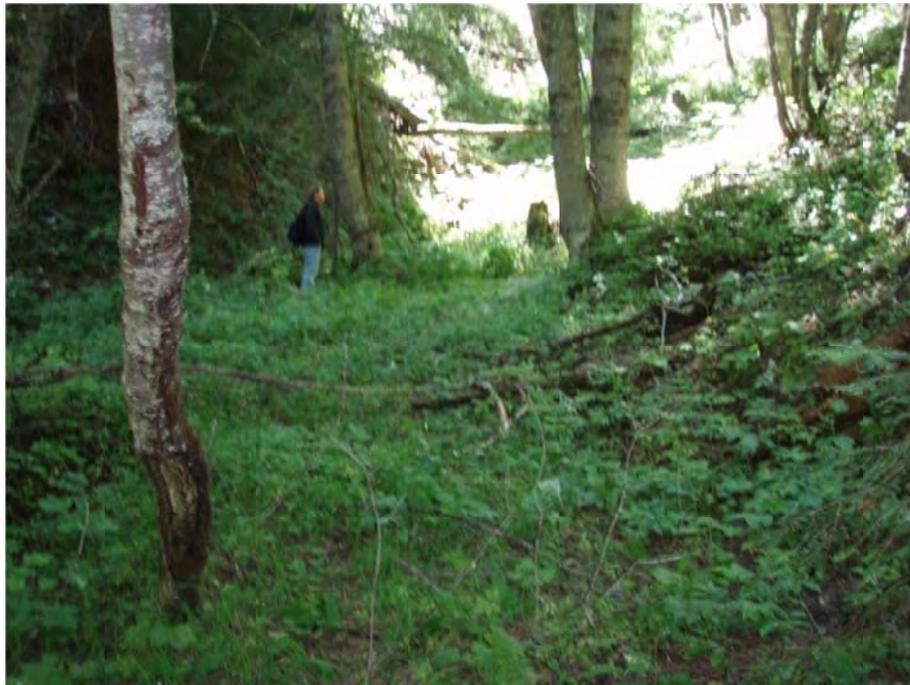
Brown Bear waste dump 8 associated with adit 8 contains less than 50 cubic yards of waste rock. The disturbed area encompasses less than 0.1 acre and is heavily vegetated (Photo 42).

**Photo 42. View facing northeast on top of Brown Bear waste dump 8.**

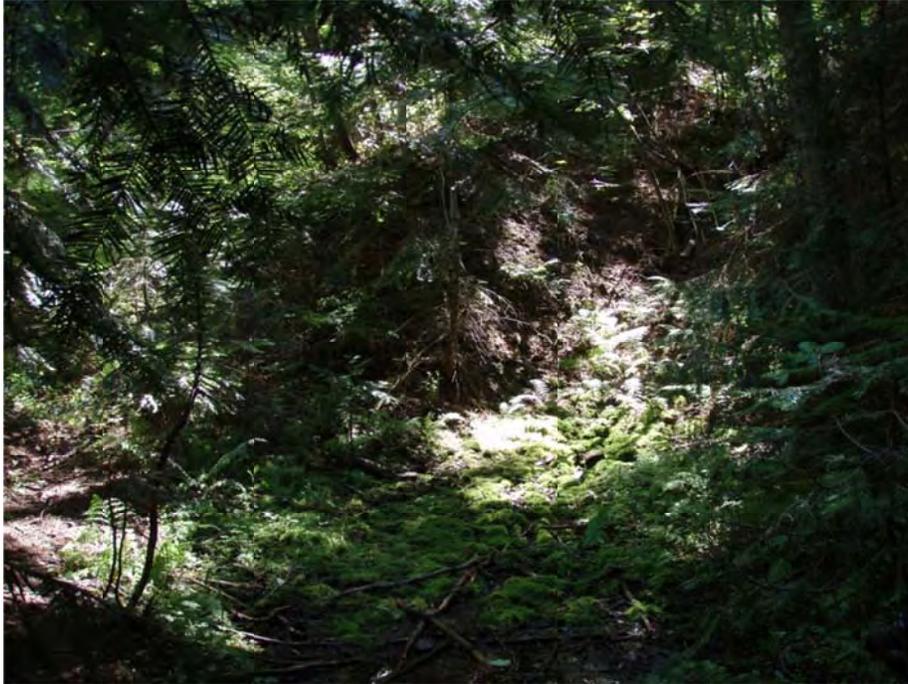
Approximately 200 feet further up the drainage and west of Brown Bear adit 8 is another adit which DEQ identified as Brown Bear adit 9 (BBAD9 on Figure 4 in Section 9). The adit is collapsed and a trickle of water was observed. Surface water sample BBAD9SW1 was collected from the seep. Parameters were not collected from the seep. Background soil sample BBBGSS1 was collected from above the adit approximately 20 feet further west and in an area where there were no signs of disturbance.

**Photo 44. View facing south of Brown Bear adit 9.**

Adit 9 is collapsed with a seep. This seep went subsurface within a few feet of the adit. The seep may contribute to the pond located next to the adit. No waste dump was found associated with adit 9 and very little with adit 7.

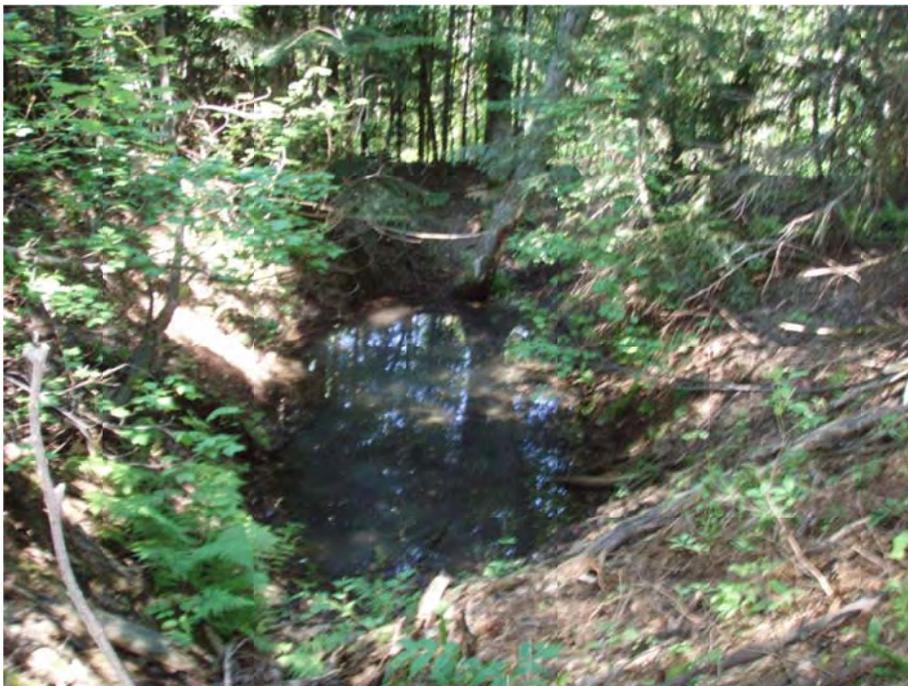
A pond is located approximately 10 feet northeast of Brown Bear adit 9 (Photo 45). A waste dump or some type of dam feature allows the pond to exist. Surface water sample BBBGSW1 and sediment sample BBBGSD1 were collected from the unnamed creek that feeds this pond. Parameters were also collected from the creek.

**Photo 45. Pond northeast of Brown Bear adit 9.**

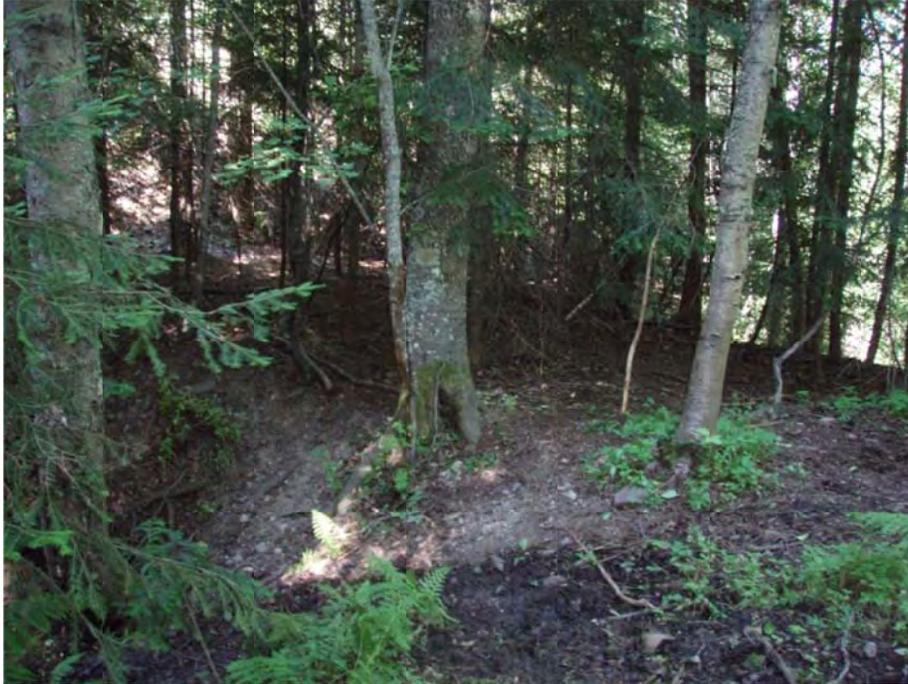
Northeast of the dam for the pond the FPXRF readings were below levels of detection for arsenic and lead. Zinc levels were negligible.

Photo 46. View facing northeast of the dam for the pond near Brown Bear adit 9.

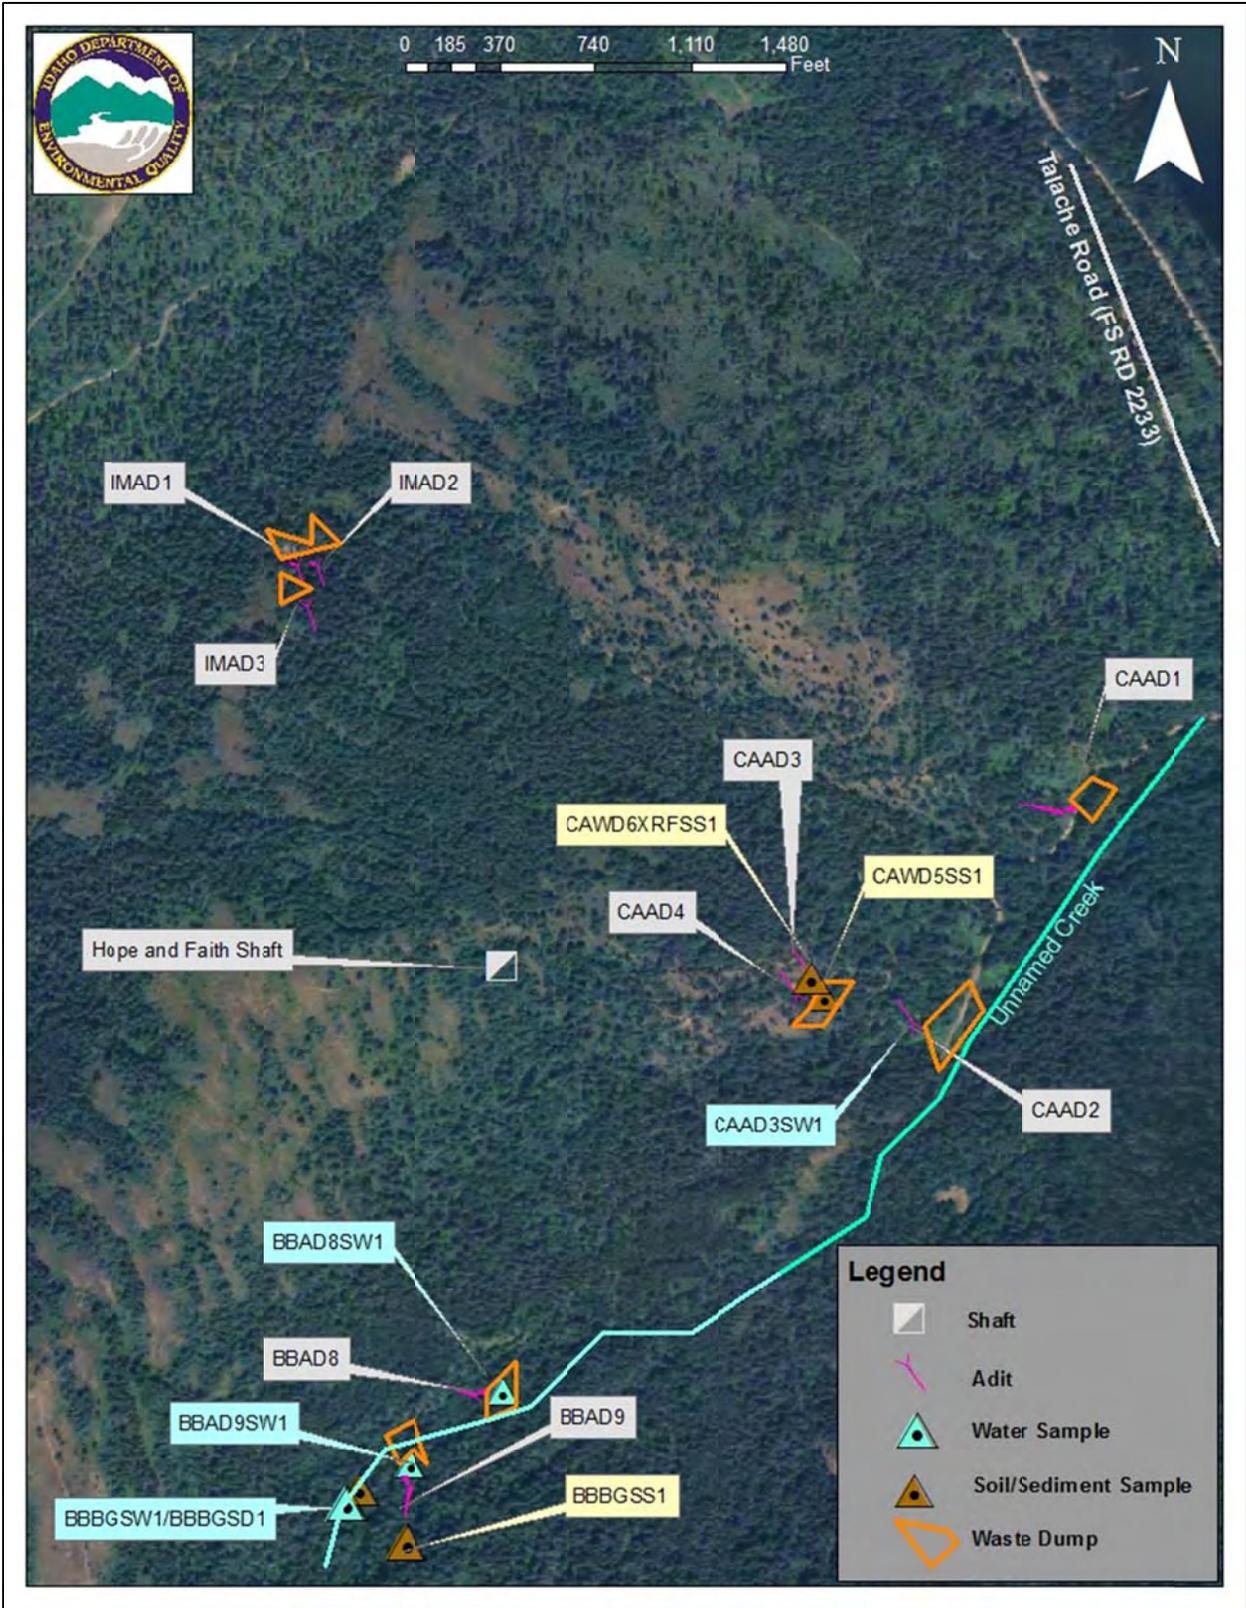
Figure 4. Sample locations and features of the Iron Mask (IM) adits, Hope and Faith Shaft, Brown Bear (BB) adits 8 and 9, and Catherine (CA) adits.

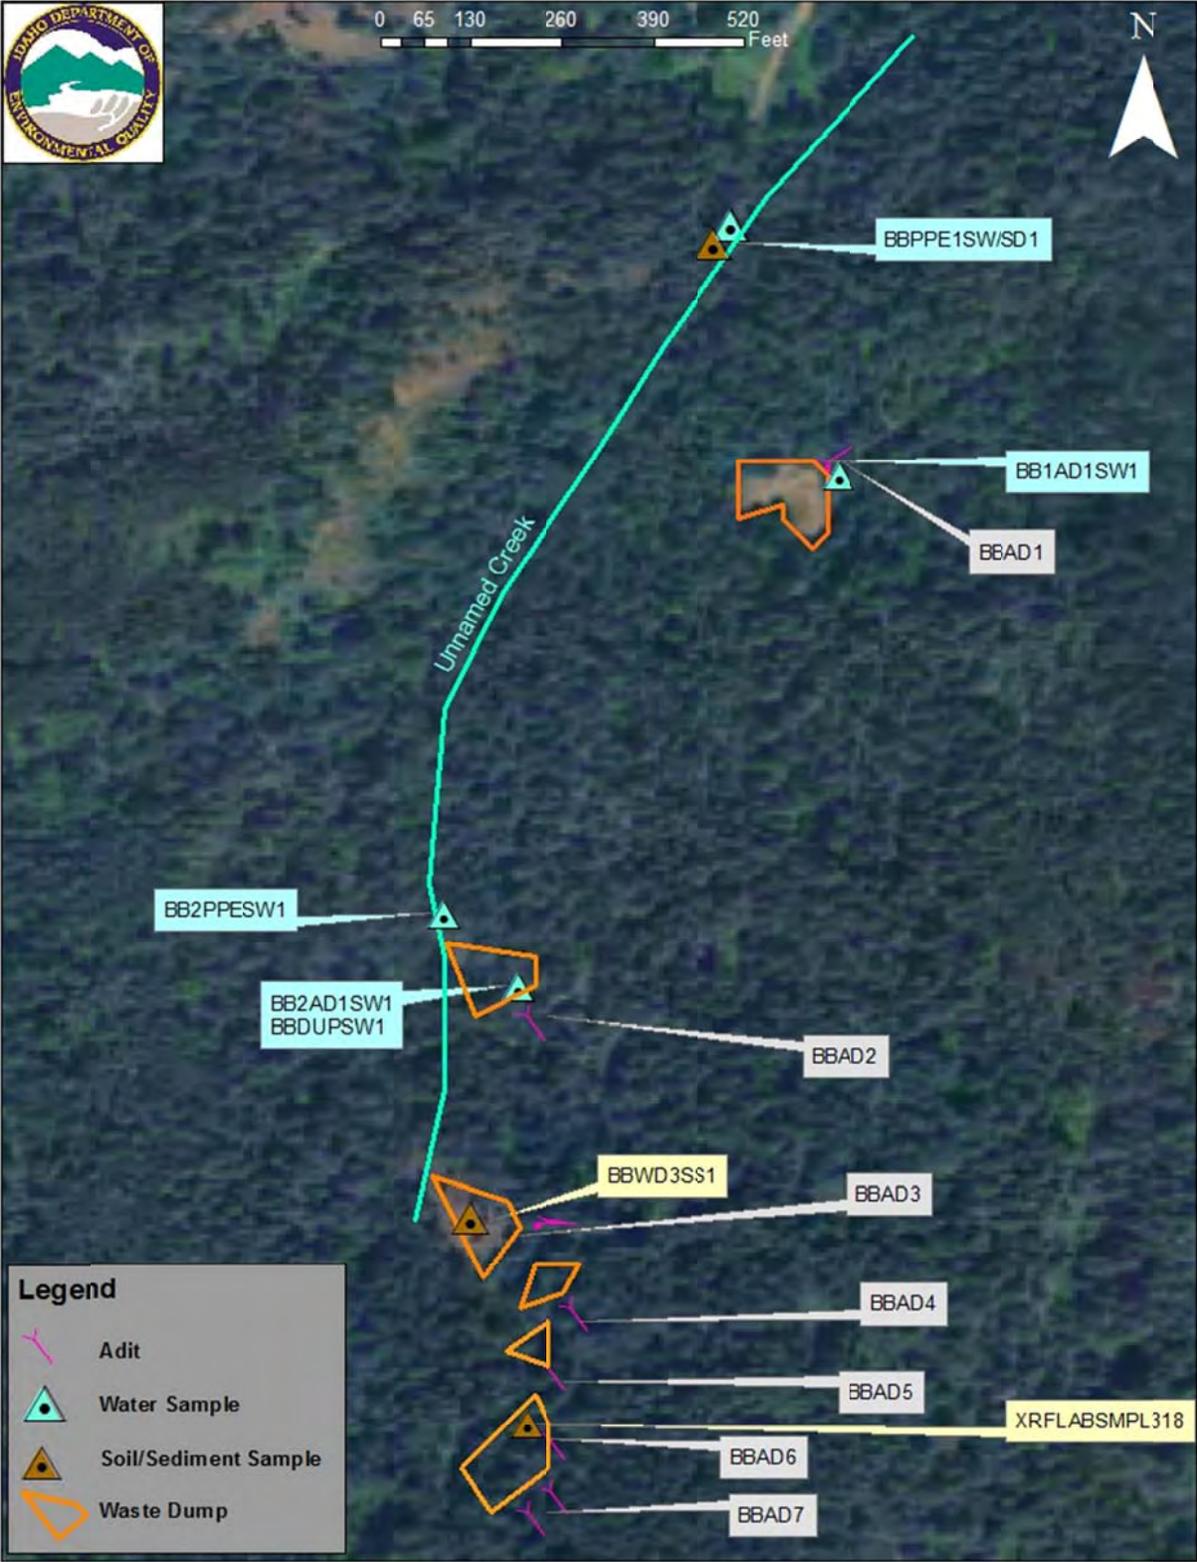
Figure 5. Sample locations and features of Brown Bear (BB) adits 1 through 7.
