Subject: Abbreviated Preliminary Assessment for Hayfork Mine, Boise County, Idaho

**Abbreviated
Preliminary Assessment for
Hayfork Mine
(aka Humming Bird, Gold Bug Group, Switzerland,
Hercules, Black Eagle Group)**

September 2016

Date of Site Inspection: 6/2/2016

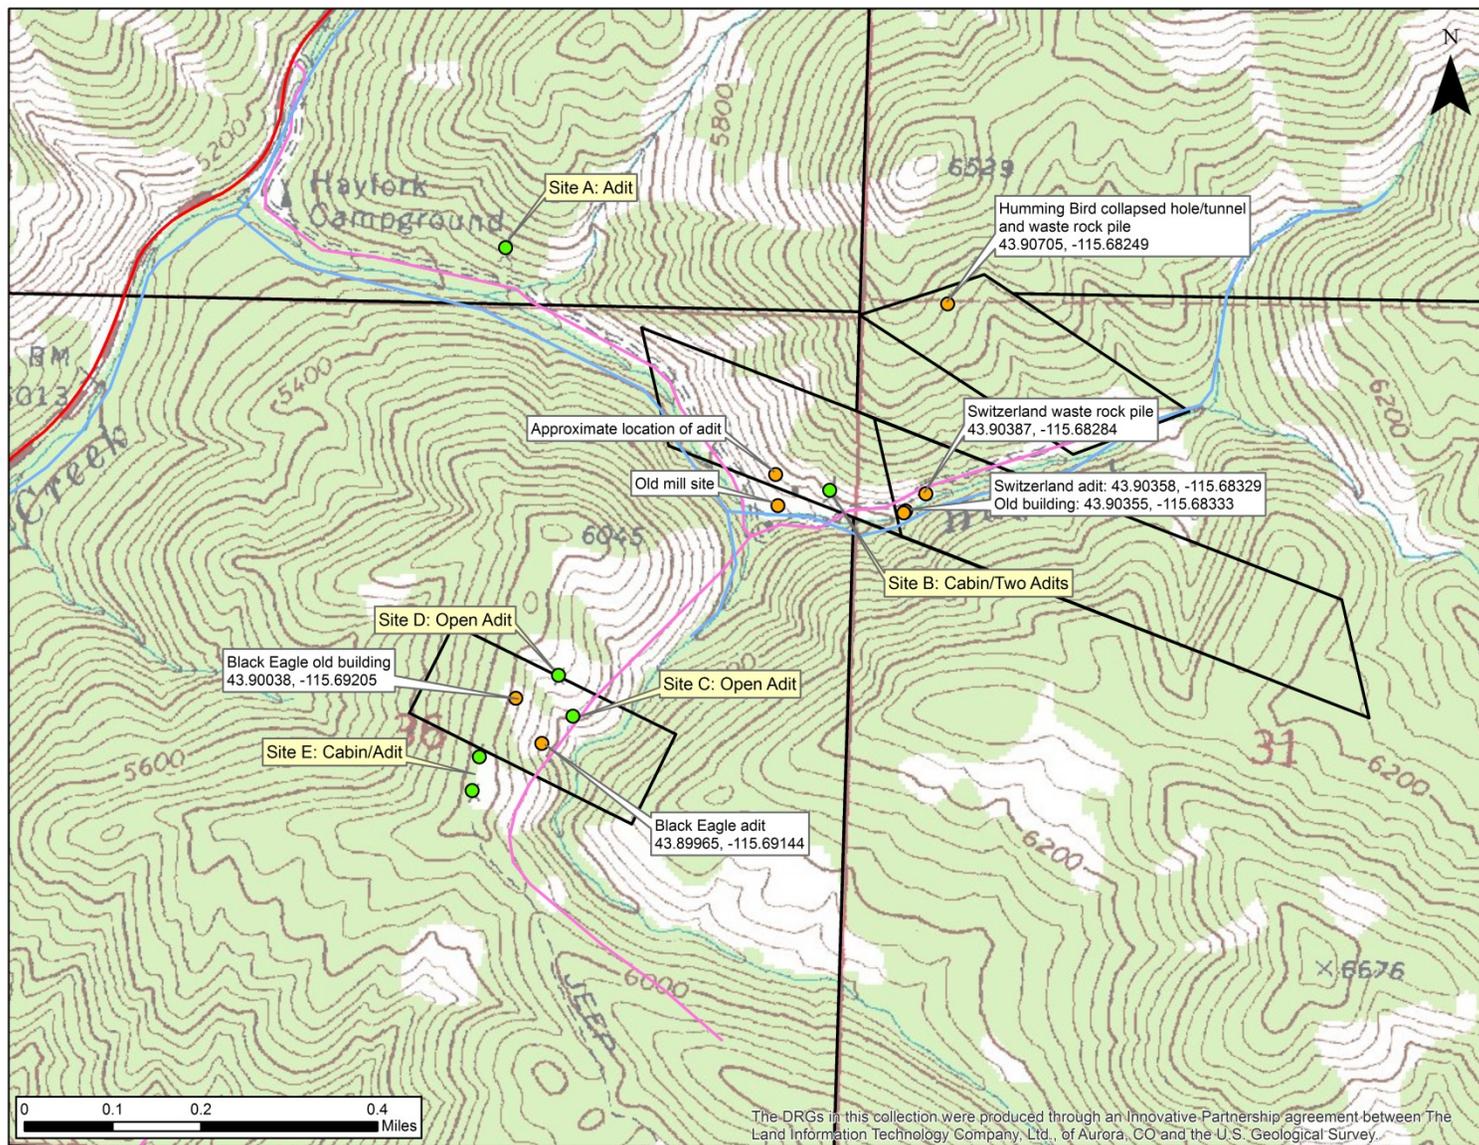
Figure 2. Approximate locations of site features; green points from 1995 IGS Report, orange points from June 2, 2016 DEQ site visit.

The Hayfork Mine area has numerous locations of small mining-impacted areas. The landowner accompanied and directed DEQ to locations with evidence of past mining on June 2, 2016 (Figure 2). During this site inspection, DEQ collected site observations and photographs. Soil and waste rock samples were not collected because waste piles were either not present or relatively small (did not appear to exceed 1,500 cubic yards in volume). In addition, the small waste rock piles were not actively eroding into nearby surface water and/or were well vegetated and not creating fugitive dust. Surface water and sediment samples were not collected because all, except for one adit located on the Gold Bug claim, had no drainage. The small amount of water draining from this adit showed no evidence of acidity (consistent with the calc-alkaline nature of the bedrock in this area); in addition, no rock staining was observed and dense, healthy vegetation was present. Numerous locations were visited; however, the list of locations is not exactly the same as the locations visited by IGS in 1995 (IGS 1995). Sites visited are summarized in this section.
