Preliminary Assessment and Site Inspection Report for the Gilmore Townsite Common Use Areas and Surrounding Lands

Lemhi County

**State of Idaho
Department of Environmental Quality**

February 2017

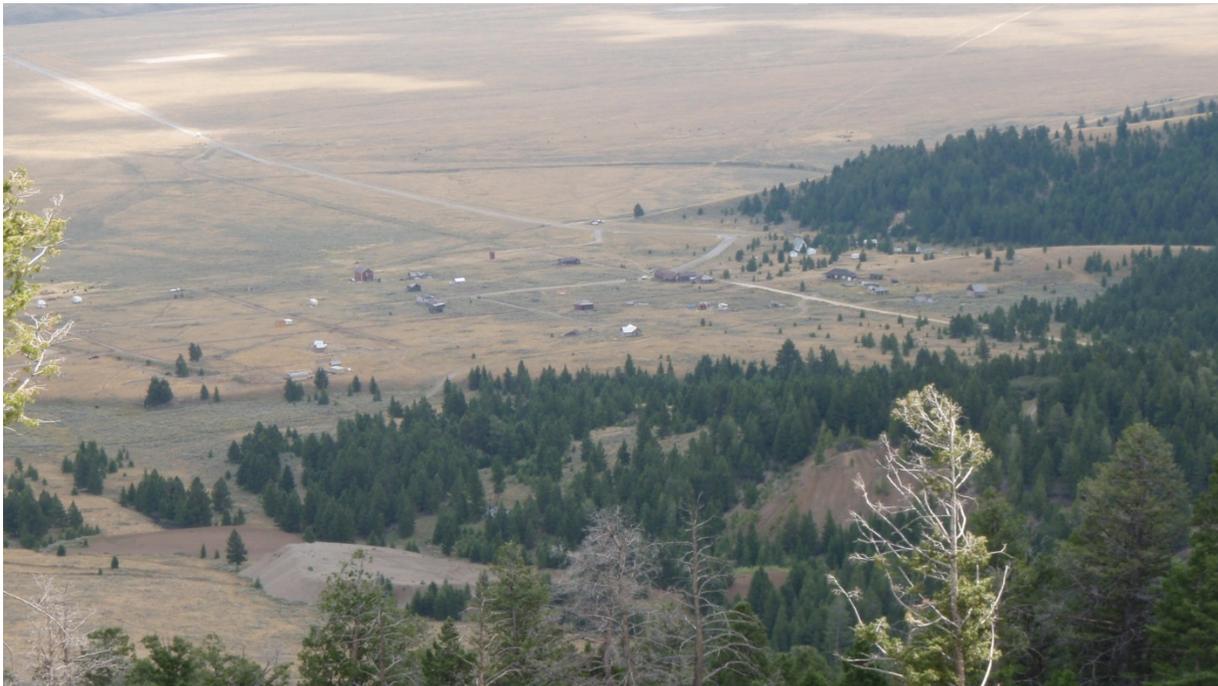
Residential dwellings are present within the Gilmore townsite; however, the overall number of residences and duration of occupancy is unknown. Since multiple parcels within the Gilmore townsite (Photo 1) are currently for sale, continued and possible increases in residential living and recreational visits is likely.

Photo 1. Overview of the Gilmore townsite. Photo taken from hillside to the west of the townsite, looking to the southeast.

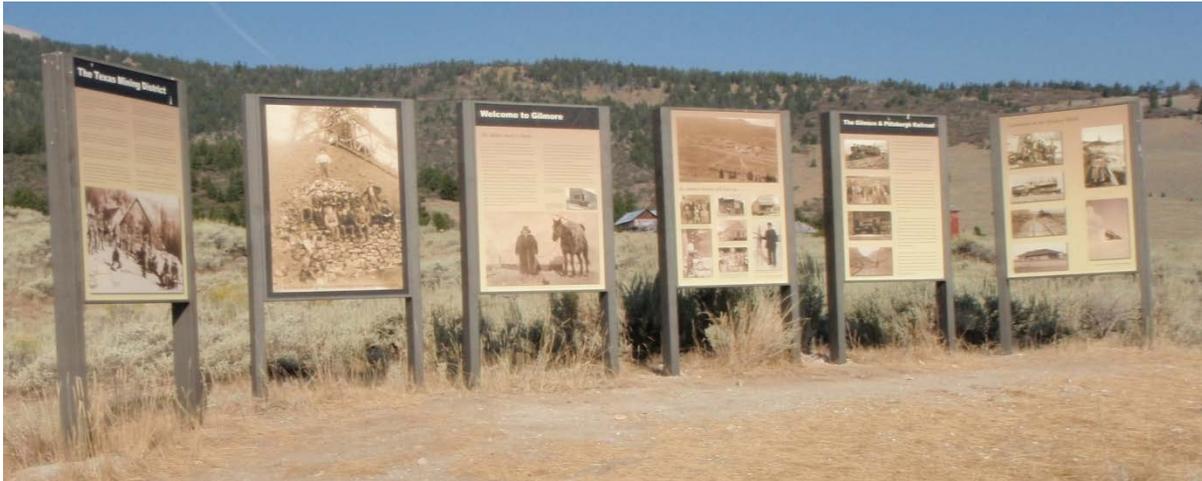
Recreationalists may visit the townsite when traveling to Meadow Lake Campground. Interpretive mining history signage is present in the townsite (Photo 2). Open holes (shafts, adits, etc...) and accessible roads and paths to historic mining sites are present along the main road as visitors travel to the Meadow Lake Campground. The abandoned mines in the Gilmore area are located on private property.

Photo 2. Interpretive mining history signage at the Gilmore townsite in 2015.

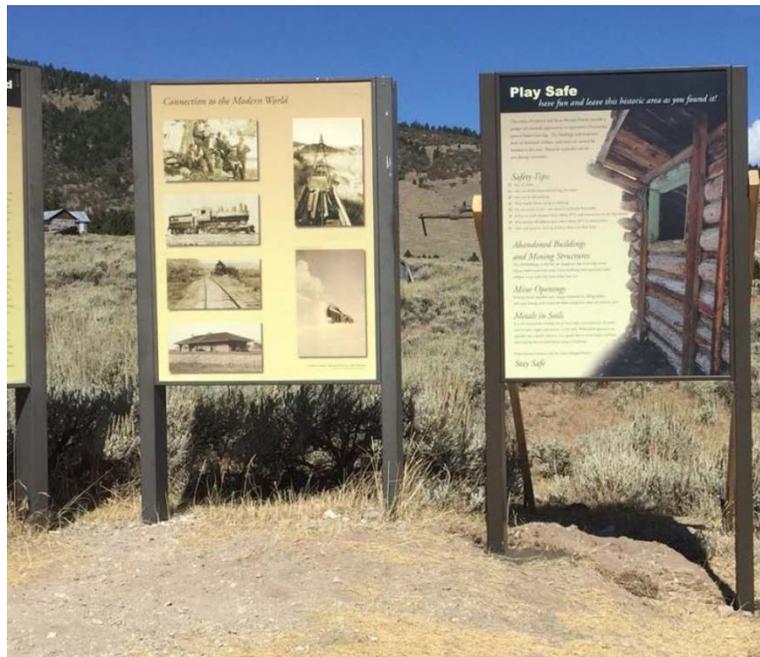
As an effort to make visitors aware of the physical hazards and metals in soil within this area, a panel with 'Play Safe' messaging has been added to the display in the Gilmore townsite (Photos 3 and 4). Funding and creation of this panel was possible through collaboration with IDHW, BLM (BLM 2014), and the Lemhi County Historical Society (Lemhi County Historical Society and Museum 2016).

Photo 3. Play safe signage added at the Gilmore townsite in 2016.

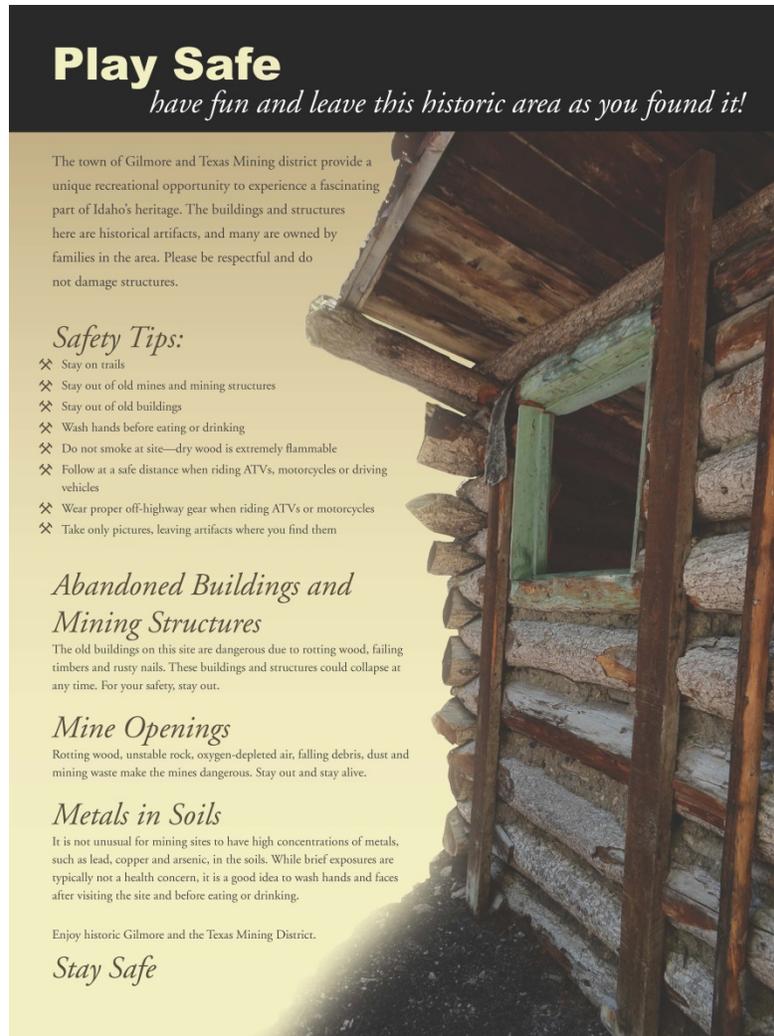
Photo 4. Play safe messaging.

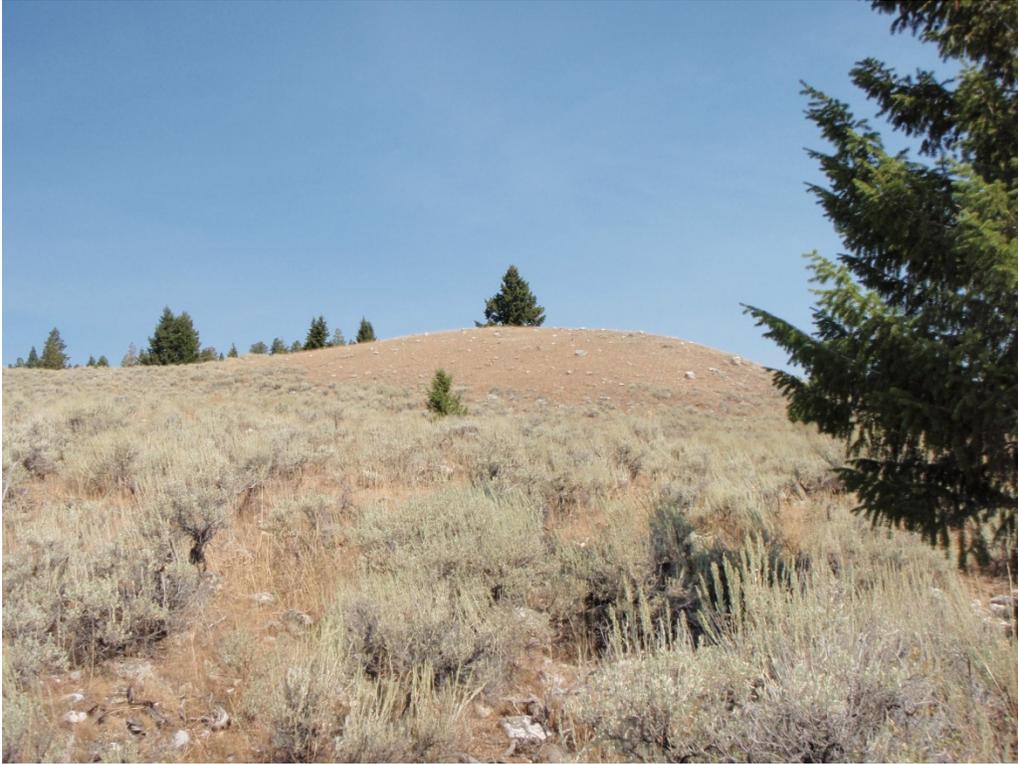
Upstream Sediment within North-South Ditch	BLM-SS6	Grab sample of sediment from dry creek bed located northwest of the townsite. Sample was collected upstream of where the creek cuts across an old ditch line (Appendix A, Photo 12).
Background	BLM-SS7	Background grab sample collected from the top of a rocky knob located northwest of the townsite (Appendix A, Photo 13).

Photo 13: Background sample BLM-SS7 collected from top of knob (looking northwest).
