Pend Oreille Lake and River Tributaries

TMDL Five-Year Review

**State of Idaho
Department of Environmental Quality
April 2017**

**Prepared by
Coeur d'Alene Regional Office
Department of Environmental Quality
2110 Ironwood Parkway
Coeur d'Alene, ID 83801**

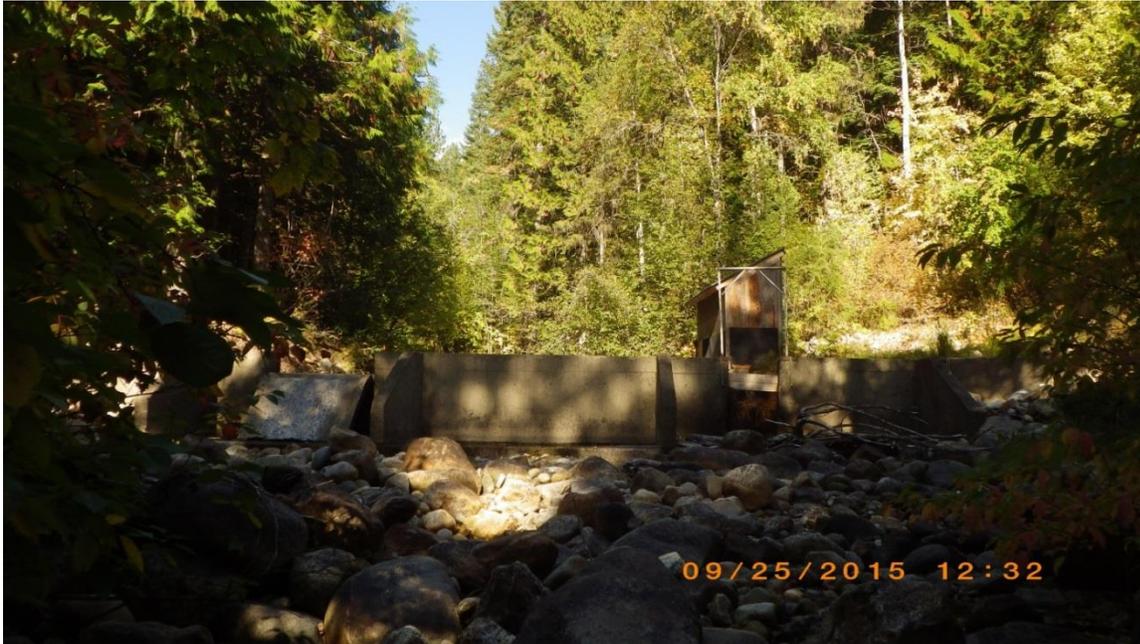
At the upstream boundary of the study reach was the city of Colburn dam, used for storage of domestic water for the city (Figure 11). The dam spans the entire width of Berry Creek obstructing movement of aquatic life and causing downstream flow alteration. A man-made ditch

running from the storage structure provides some water to the creek downstream of the structure. On September 25, flow in the creek upstream of the dam was 1.0 cubic feet per second (cfs). The flow below the dam was 0.03 cfs. A qualitative evaluation of stream conditions upstream of the dam is also provided below. Extremely low base-flow conditions existed on the creek on the date of evaluation due to low spring runoff, lack of spring moisture, and high (greater than 100 °F) summer temperatures.

Figure 11. Dam for the City of Colburn’s public drinking water system.

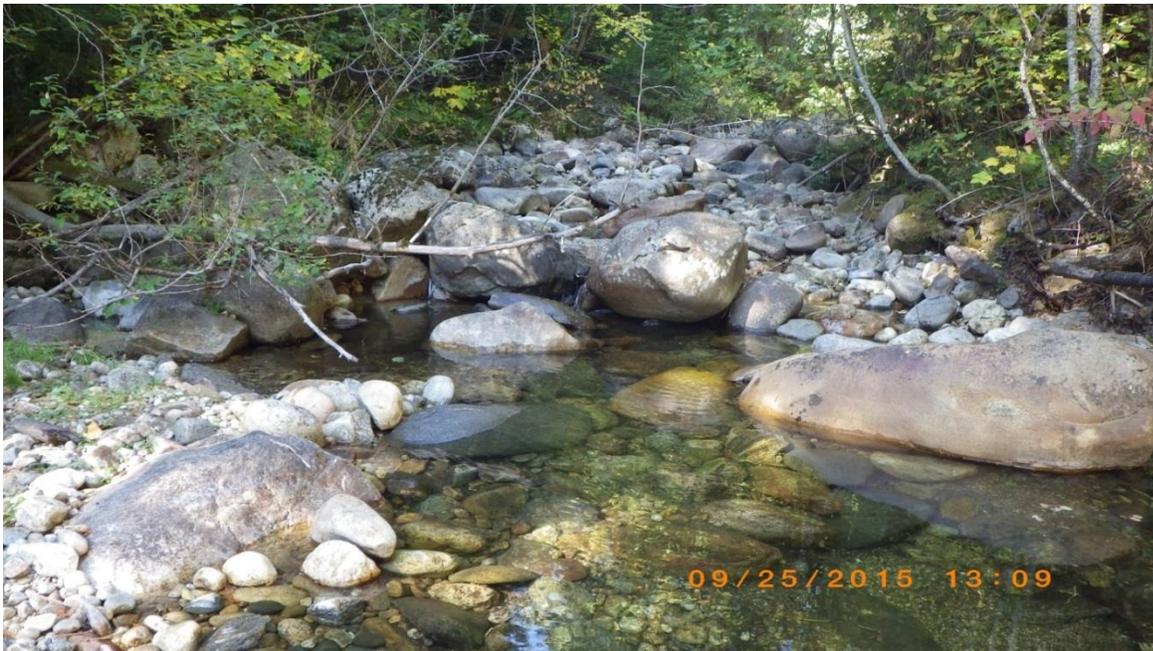
Upper Berry Creek is a step-pool stream type dominated by large alluvial substrate both above and below the Colburn Dam (D_{50} = large cobble to small boulder or 128–512 mm). Pool and pool-margin embeddedness showed a minor departure from reference conditions due to the upstream dam entrapment of fine sediment and scour downstream of the dam from the lack of sediment. In the channel below the Colburn Dam, excessive large cobble and suboptimal sediment transport capacity was evident with mobility and lack of sorting of the large-cobble substrate (Figure 13). Excessive cobble substrate is also above the dam with evidence of substrate mobility and lack of sorting (Figure 14).

Figure 14. Excess cobble in upper Berry Creek (above Colburn Dam).

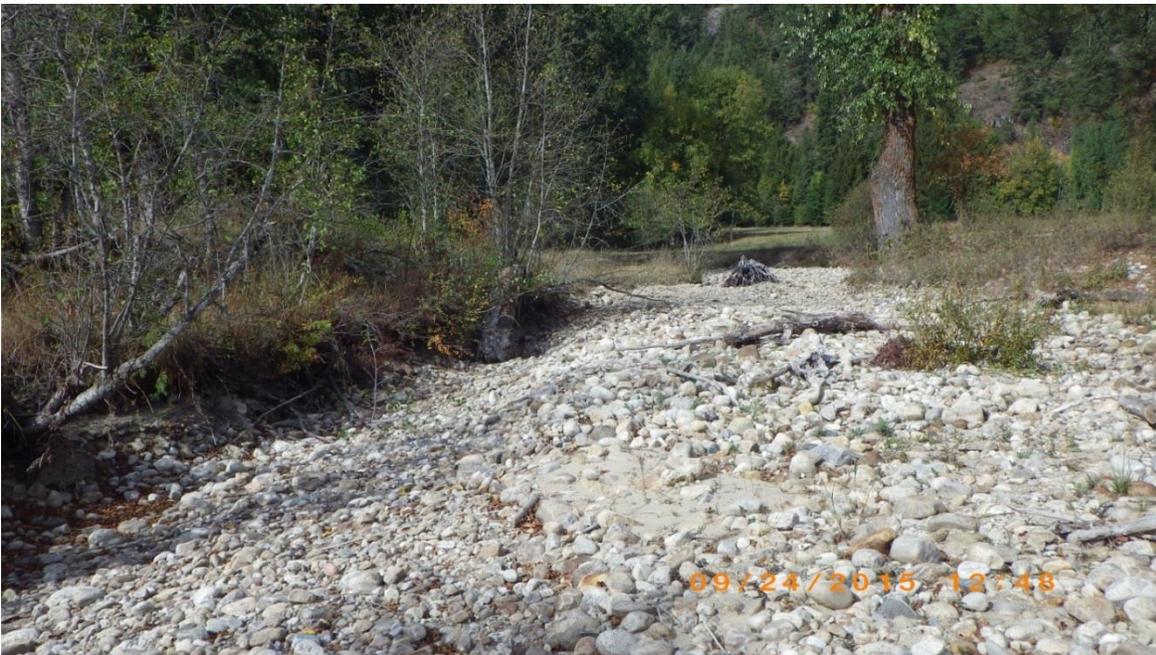
Scour and depositional features were in fair-good condition due to the excessive bedload limiting the stream's transport capacity. Due to bedload mobility, unstable point bar and mid-channel bar features were common, and a meandering thalweg was only moderately identifiable (Figure 21). Although the stream historically was straightened, the stream had good sinuosity. Pool formation on lower Berry Creek was evident, with pool size substantial in many cases. Some pools had water providing some refuge for fish (Figure 22). Cutthroat Trout and Brook Trout in various age classes (including young-of-the-year) were alive in these pools. Also observed were abundant caddisfly casings throughout the stream. Riffle formation appeared to be limited.

Figure 21. A meandering thalweg in lower Berry Creek.

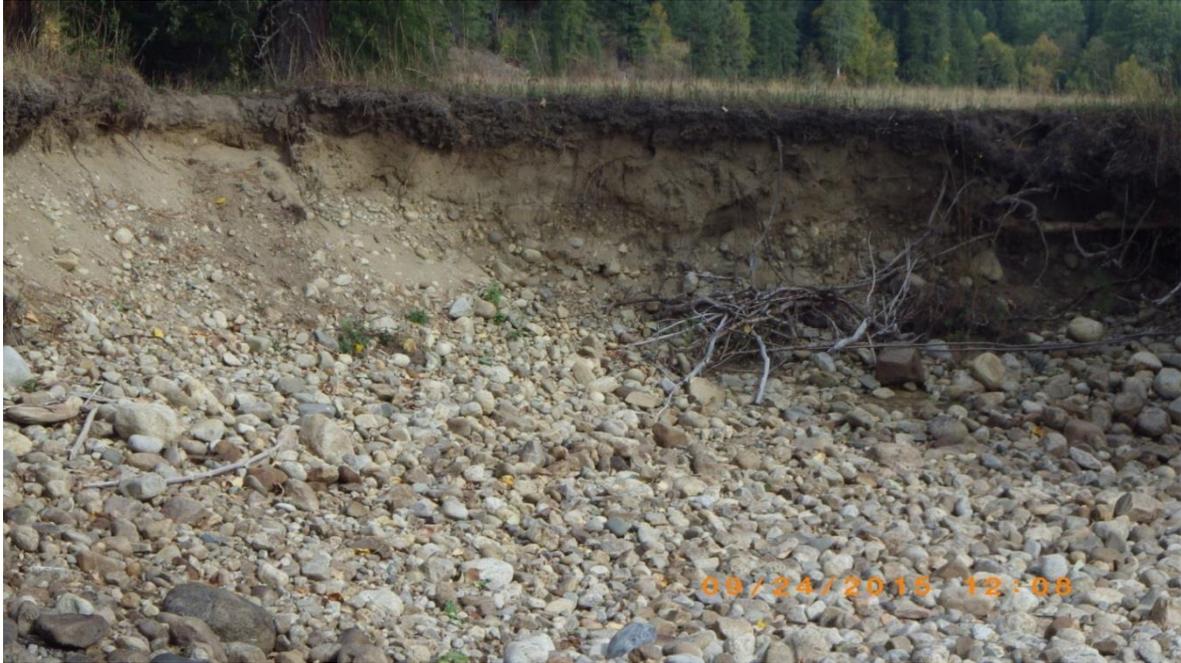
Lower Berry Creek was severely over-widened and entrenched, providing limited floodplain access (Figure 23), due to the lack of riparian vegetation and historic channelization. As such, the stream channel lacked habitat complexity that would result in refuge during high and low flow regimes. A major obstruction upstream was a very large pond that was built on the stream, which could limit longitudinal movement of aquatic species.

Figure 23. Channel incision and eroding banks, lower Berry Creek.

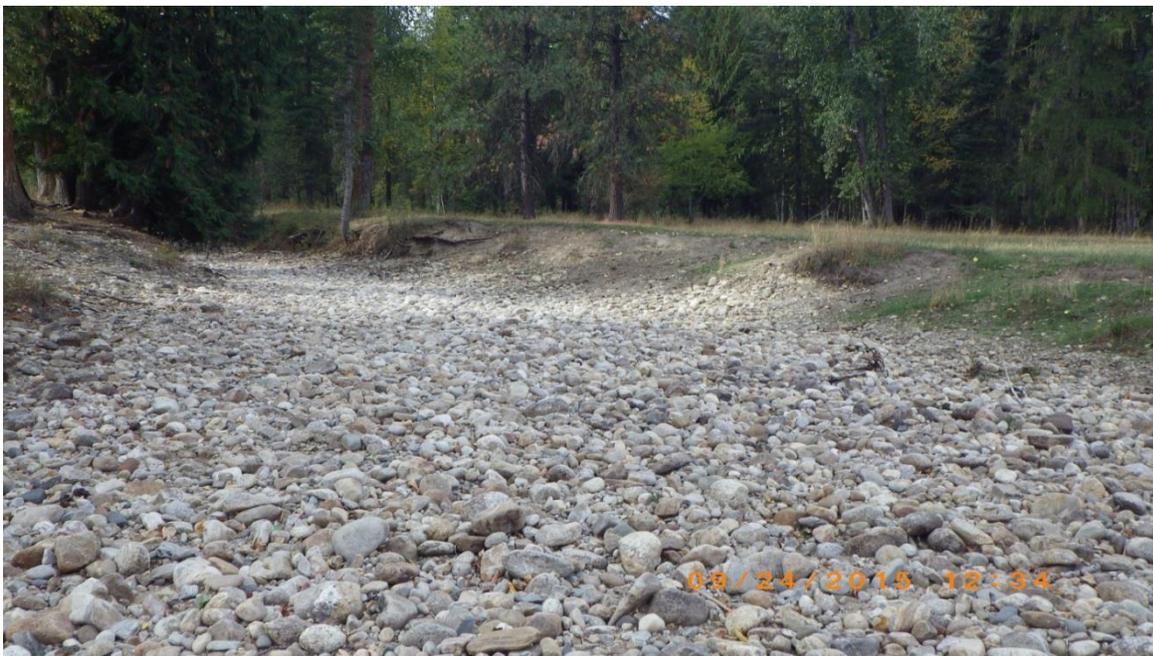
Streambank erosion was significant in the upper 50 meters of the study reach due to sparse riparian vegetation and livestock trampling (Figure 24). Undercut banks were evident; however, some undercuts lacked stability due to the loss of riparian vegetation. The undercuts nevertheless would be important habitat for fish in this creek. Bank sloughing was common within the study reach of Berry Creek (Figure 25).

Figure 24. Trampled banks, lower Berry Creek.

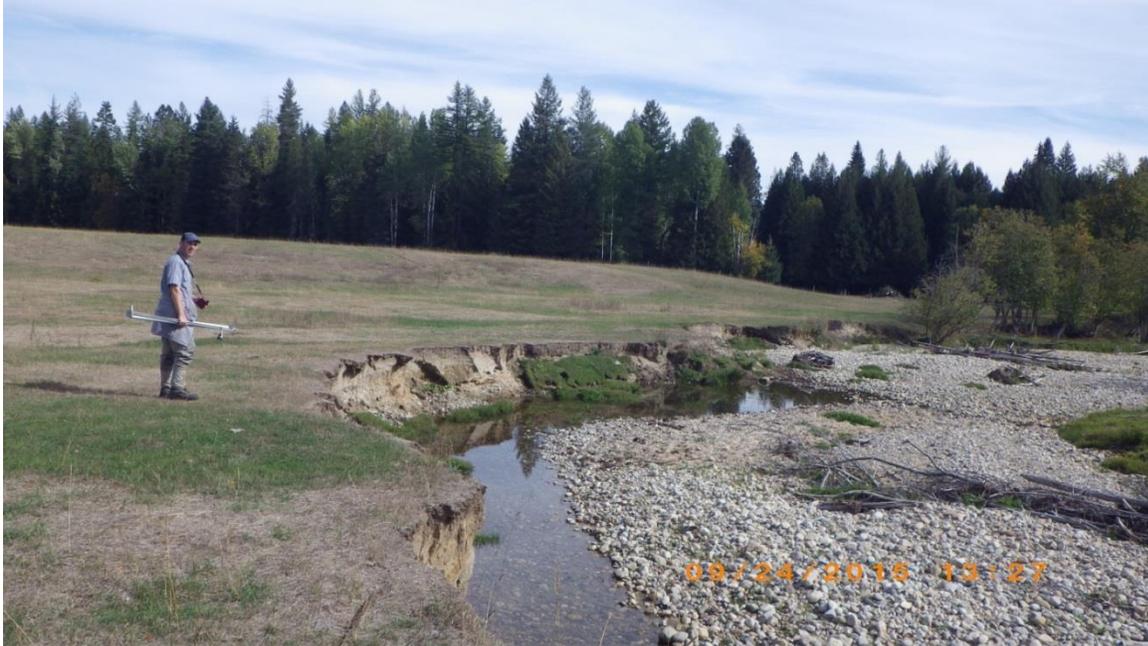
Figure 25. Lack of riparian vegetation leading to bank instability, lower Berry Creek.

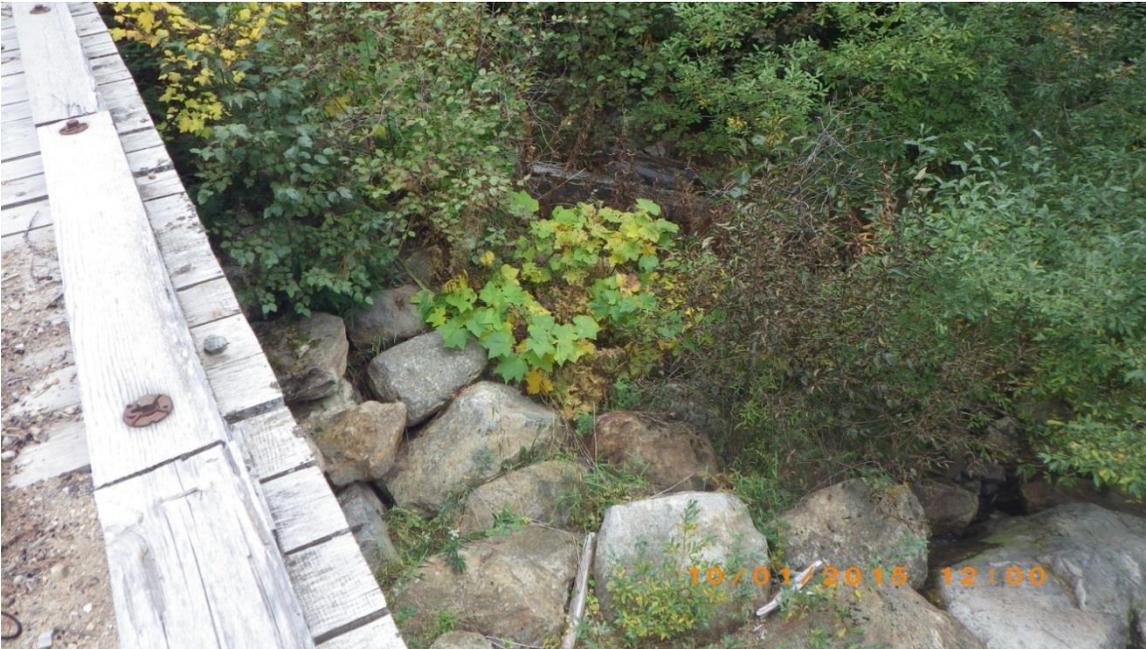
Figure 29. Bridge with minimal erosion potential, upper Berry Creek.

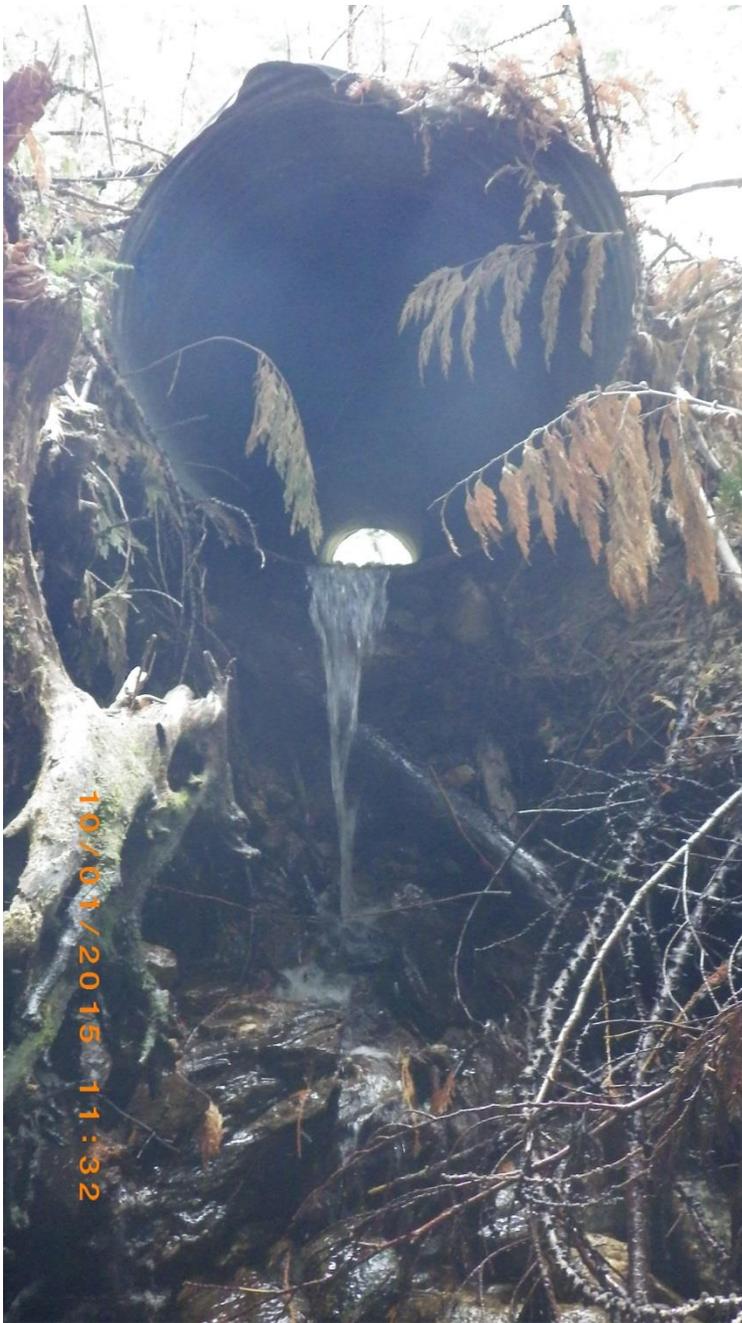
Figure 30. Fish barrier on tributary to Berry Creek.

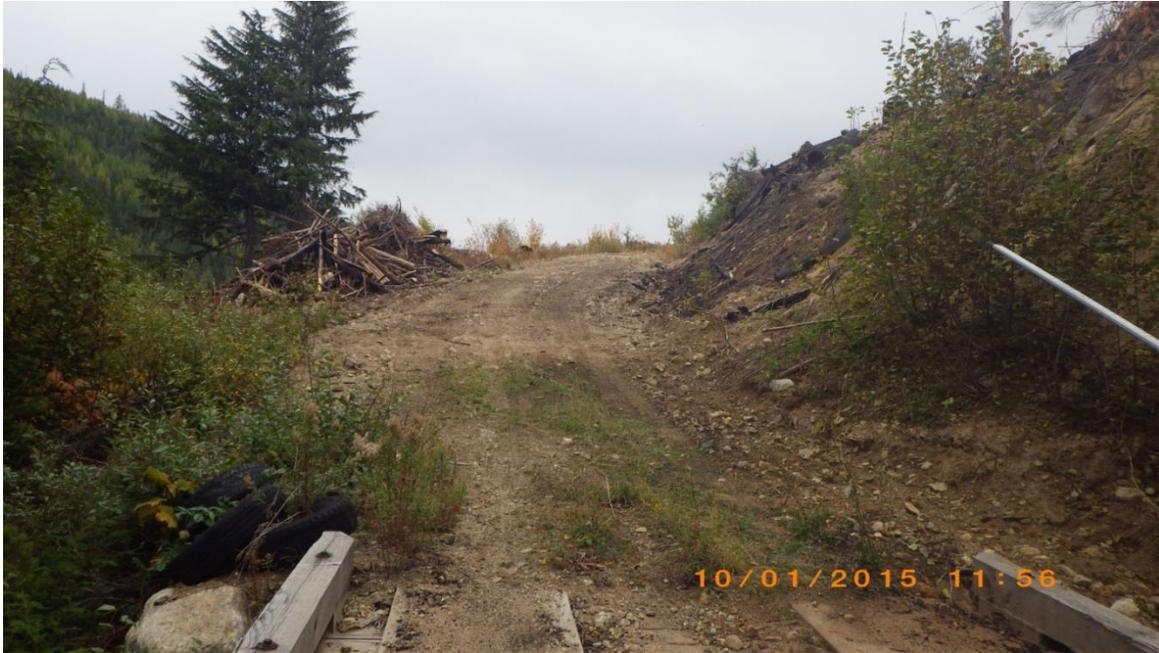
Figure 31. Clear cut with potential to drain to Berry Creek.

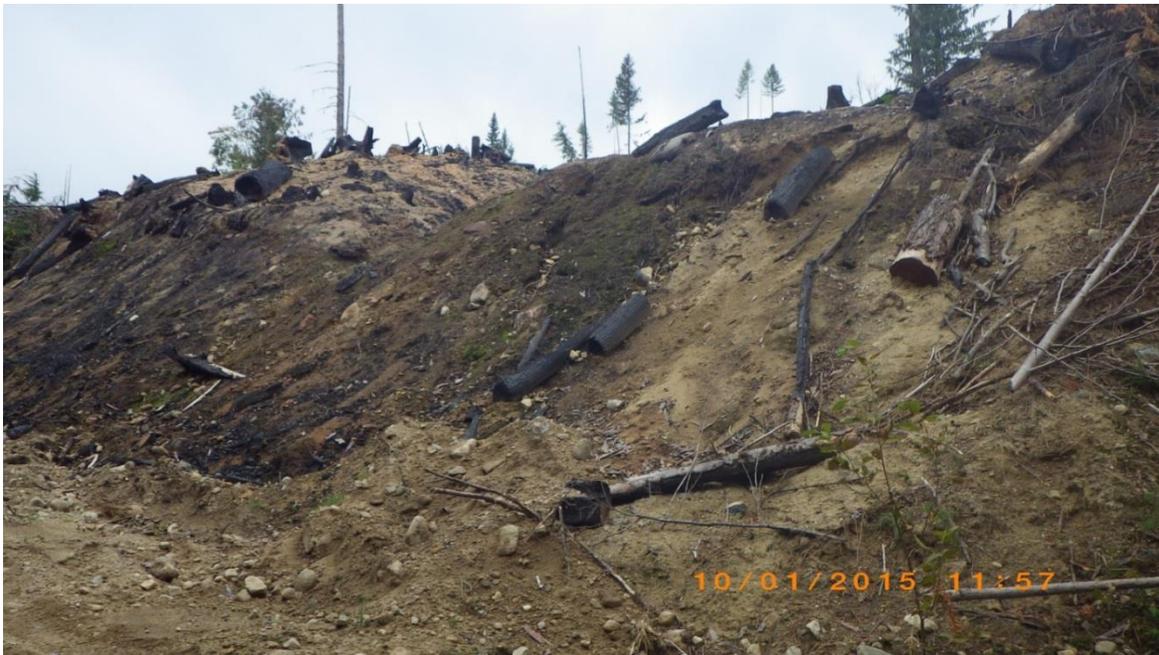
Figure 32. Clear cut upslope of Berry Creek stream crossing.

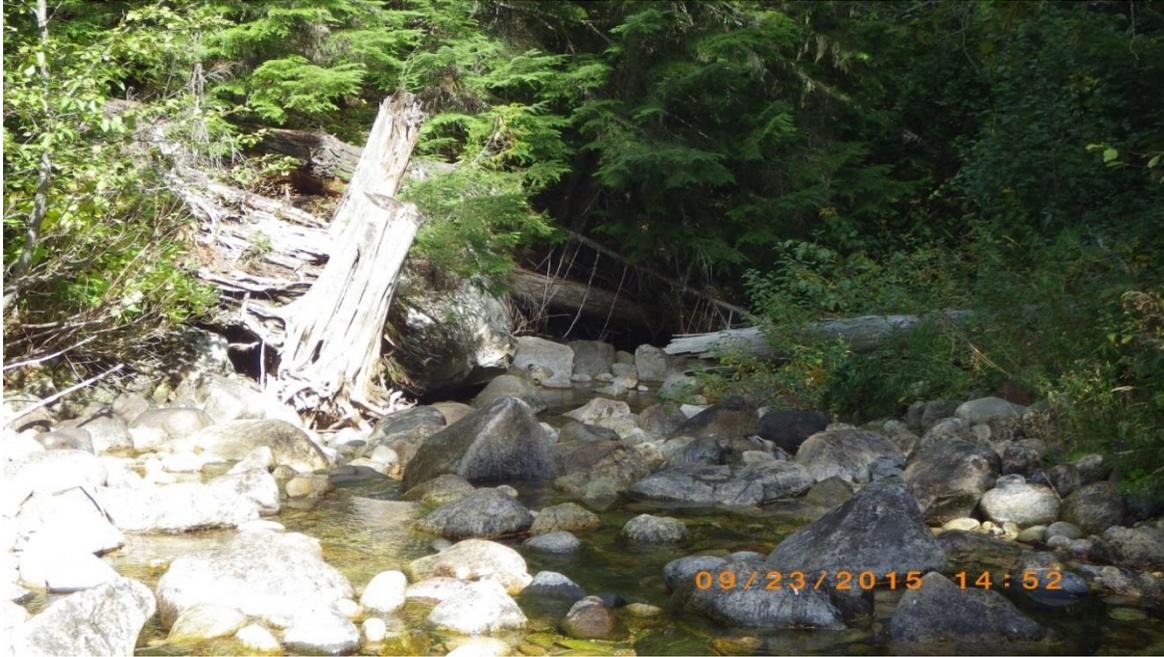
While log jams were not abundant in upper Caribou Creek, there existed an abundance of LWD 1 foot or greater in diameter. Recruitment potential of large wood was moderate due to the

presence of a healthy cedar-hemlock riparian area (Figure 38). Based on this evaluation, woody debris cover exhibited a minor departure from reference conditions.

Figure 38. Large woody debris in Caribou Creek.

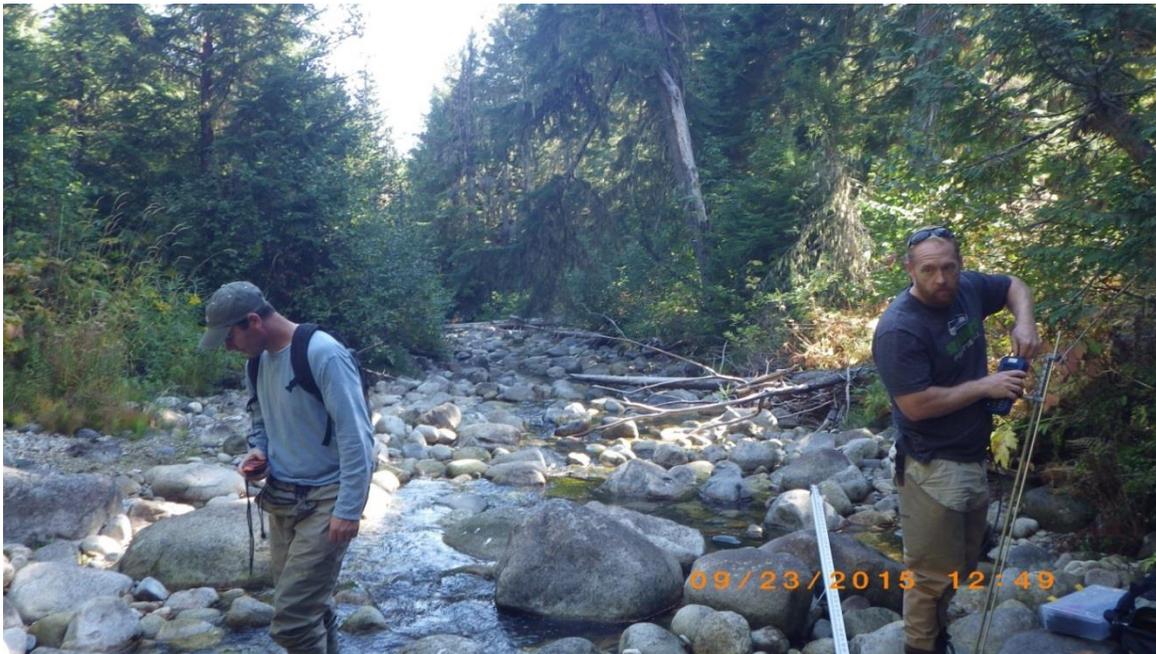
The riparian area was in good condition with near maximum channel canopy and a diversity of vegetation species (Figure 42). No invasive species were present. The riparian buffer width was between 150 and 250 feet, providing excellent shade and thermal refuge, root density, and streambank stability. The buffer appeared to promote moderate lateral connectivity and excellent longitudinal continuity in the stream corridor.

Figure 42. Riparian area in Caribou Creek.

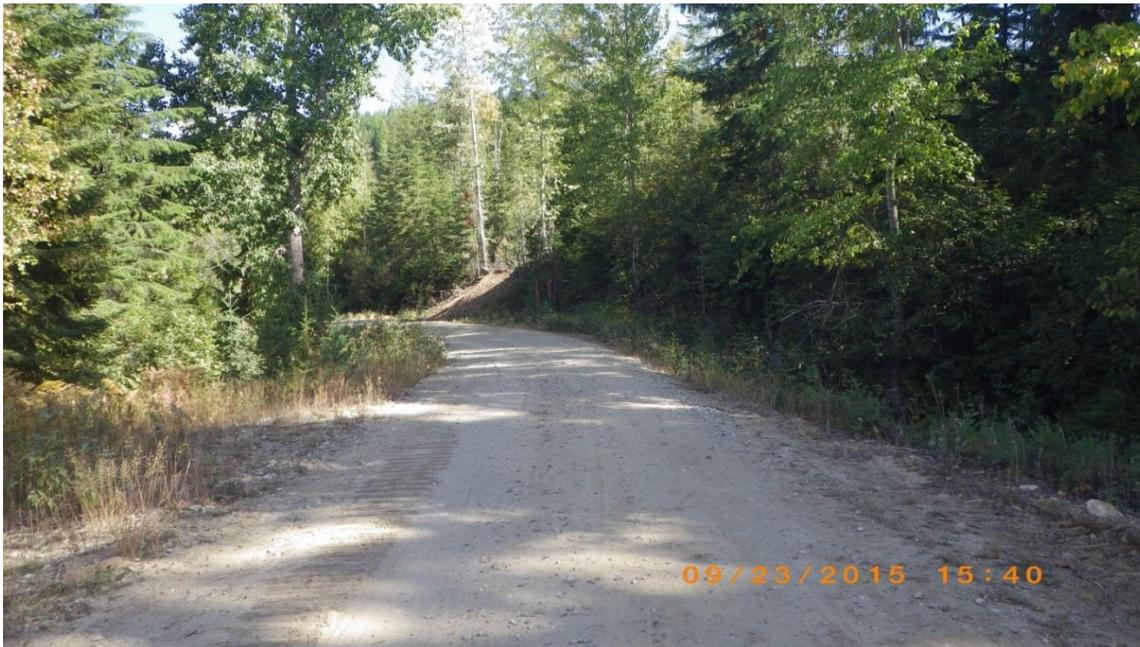
In general, the road surfaces were well maintained, with well-vegetated ditches. Many relief and stream crossing culverts had been replaced, and a major bridge was replaced (Figure 43, Figure 44). No erosion issues were noted on the survey. Crossings evaluated using the randomized road evaluation protocol are listed in Table 16.

Figure 43. Road surface, Caribou Creek Road.

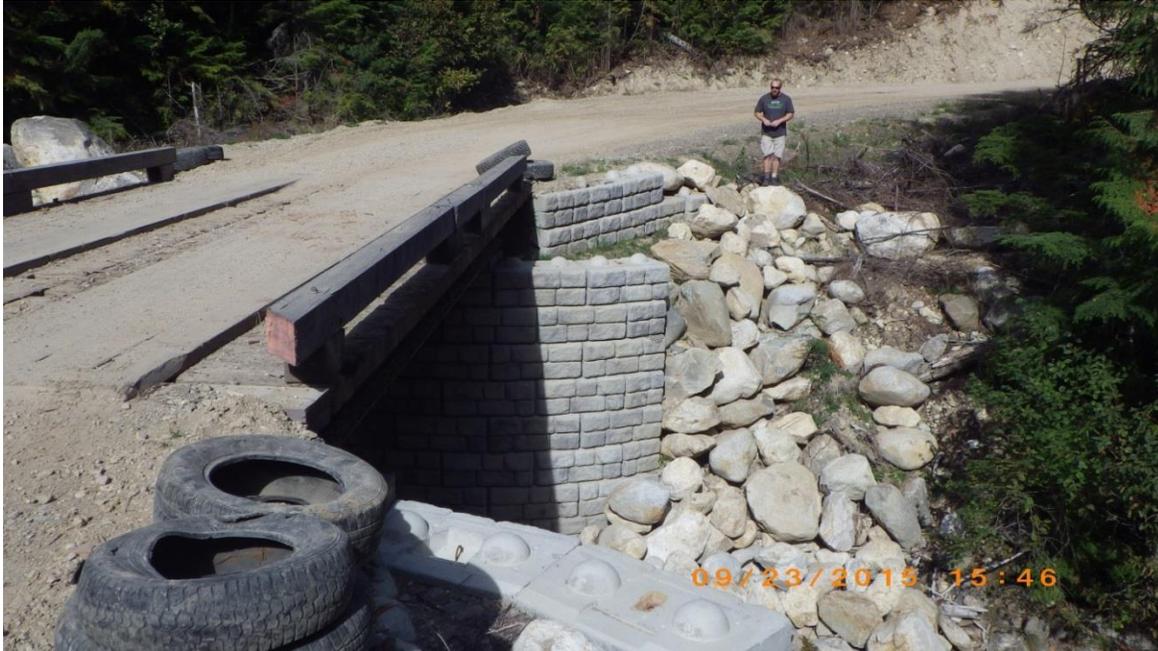
| Type of Crossing | Road | Water Body | Lat | Long | Erosion severity |
|---|---|---|---|---|---|
| Bridge—concrete with timber decking | Caribou Creek Road | Caribou Creek | N48.471505 | W116.564965 | Low |

Figure 44. Recent bridge replacement on upper Caribou Creek.

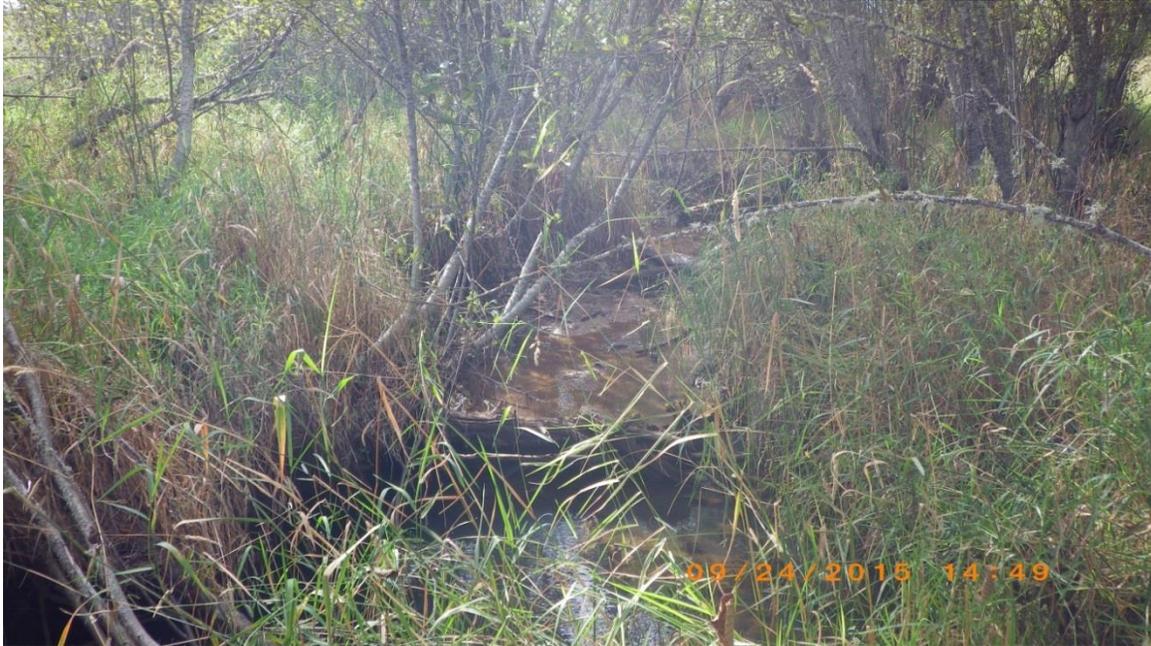
Log jams were abundant in Colburn Creek, with greater than 5 log jams per mile. An abundance of LWD 1 foot or greater in diameter was also observed. Recruitment potential of large wood was moderate due to the presence of a healthy alder/willow riparian area (Figure 50). Based on this evaluation, woody debris showed a minor departure from reference conditions.

Figure 50. Large wood in Colburn Creek.

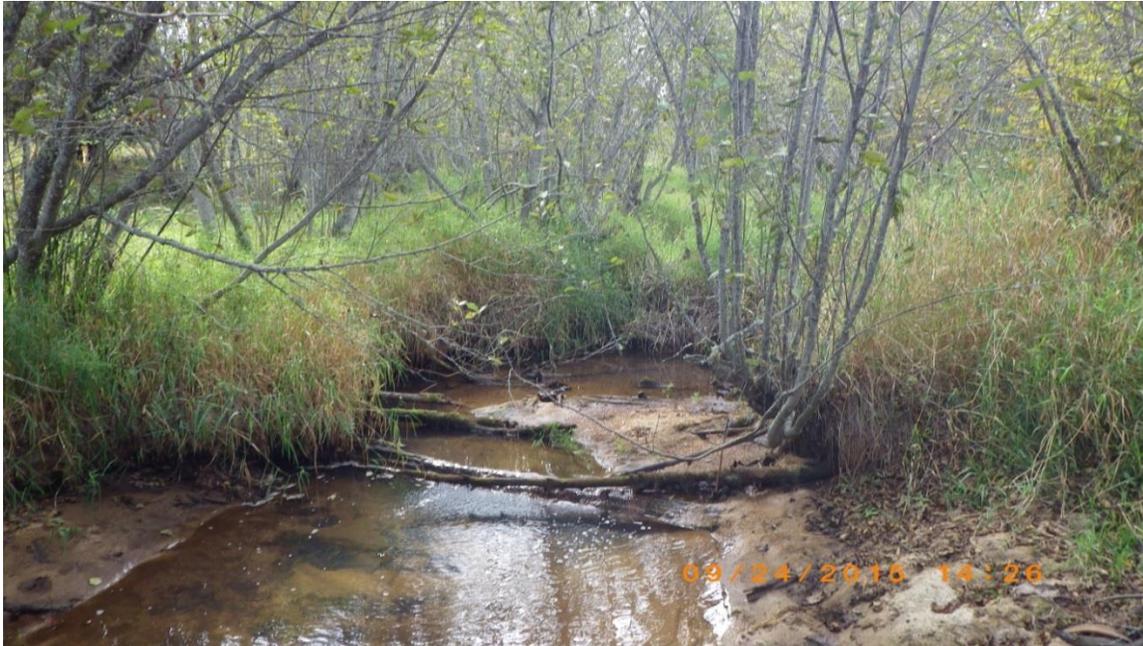
Colburn Creek had a relative abundance of pools at a depth of 2 feet or greater. Pool size and abundance provided good cover and thermal refuge for fish. Some unidentifiable fish were observed, which was exceptional for such a low water year. Riffle formation was limited, with only two depth-velocity combinations present (slow shallow, slow deep). The thalweg was moderately identifiable with some evidence of bar formation (Figure 51).

Figure 51. Point bar in Colburn Creek.

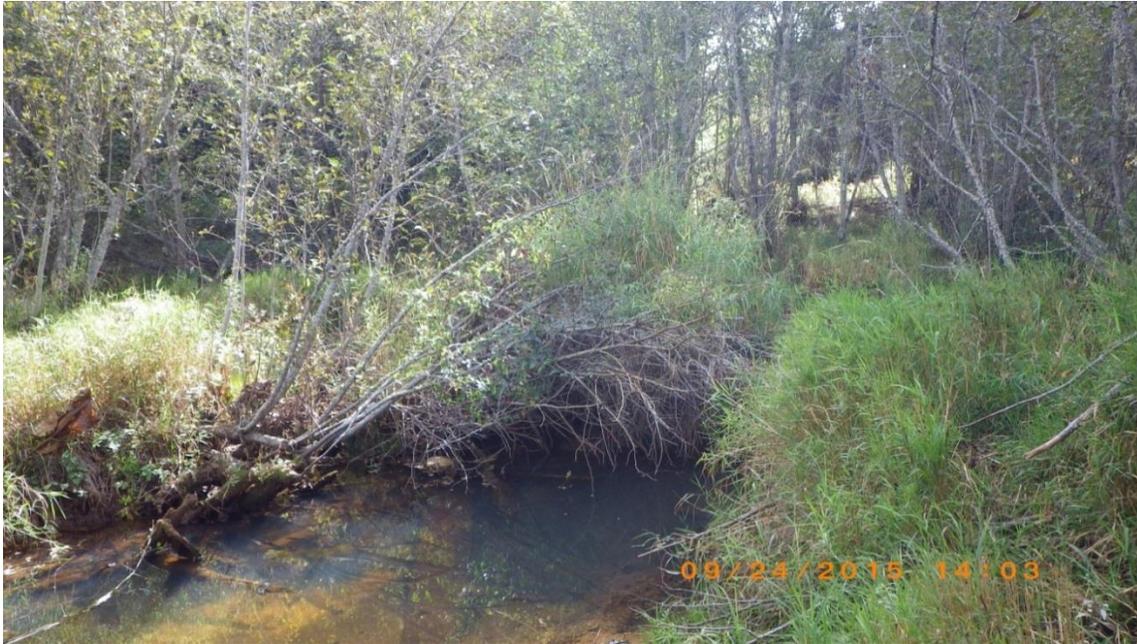
Aside from being entrenched, the streambanks showed a minor departure from reference conditions in Colburn Creek. Streambank erosion was minimal. Undercut banks were fairly abundant with mostly stable boundaries, abundant overhanging vegetation, and consistent water adjacency. Bank canopy was between 80 and 90%. The abundance of sedge, willow, and alder provided good cover with roots that stabilize the bank (Figure 52). No mass failures were observed on the streambanks within the study reach.

Figure 52. Stable overhanging banks in Colburn Creek.

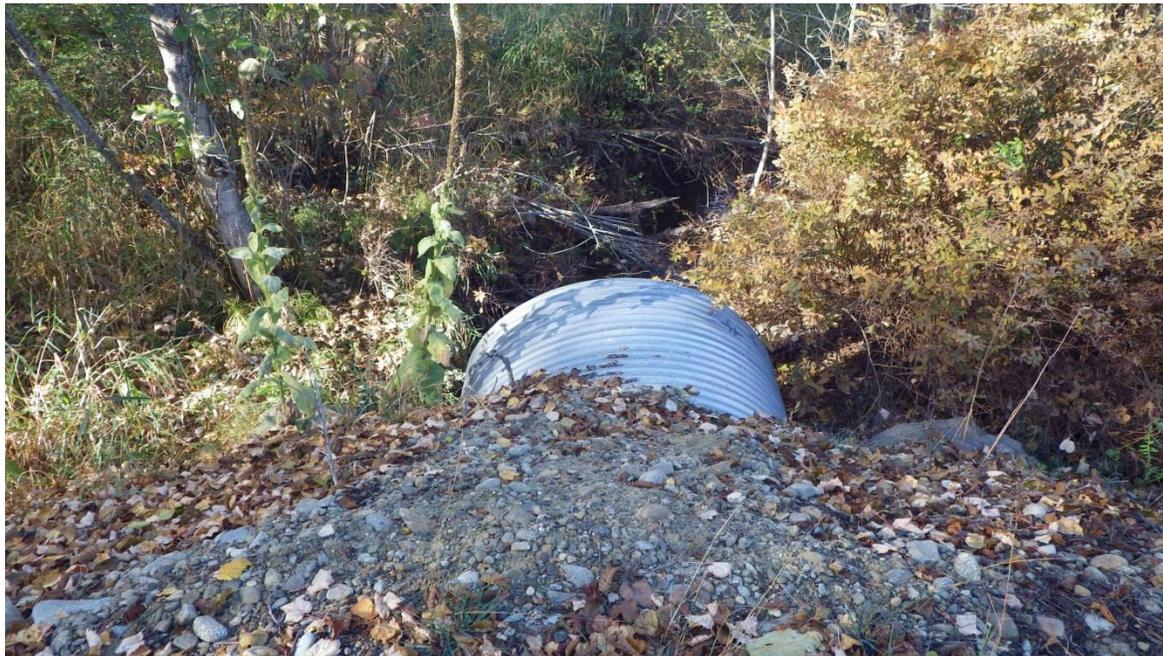
Figure 59. Culvert 1 on Gold Creek.

In October 2015, DEQ conducted a survey of road crossing conditions in the Gold Creek watershed. Two road crossings were selected for evaluation. Road crossing characteristics are represented in Table 19. Both crossings were culverts maintained by the county. Both culverts were in good-to-excellent condition with a low erosion potential (Figure 59, Figure 60). However, the fill material on the round, corrugated steel culverts had gully erosion formation near the culvert (Figure 61). Both culverts seemed to be barriers to fish passage.

| Water Body | Type | GPS Coordinates | Erosion Severity | Overall Condition | Fish Barrier? |
|---|---|---|---|---|---|
| Gold Creek | Round, corrugated metal pipe | N 48.403706 W -116.403912 | Low | Good | Yes |

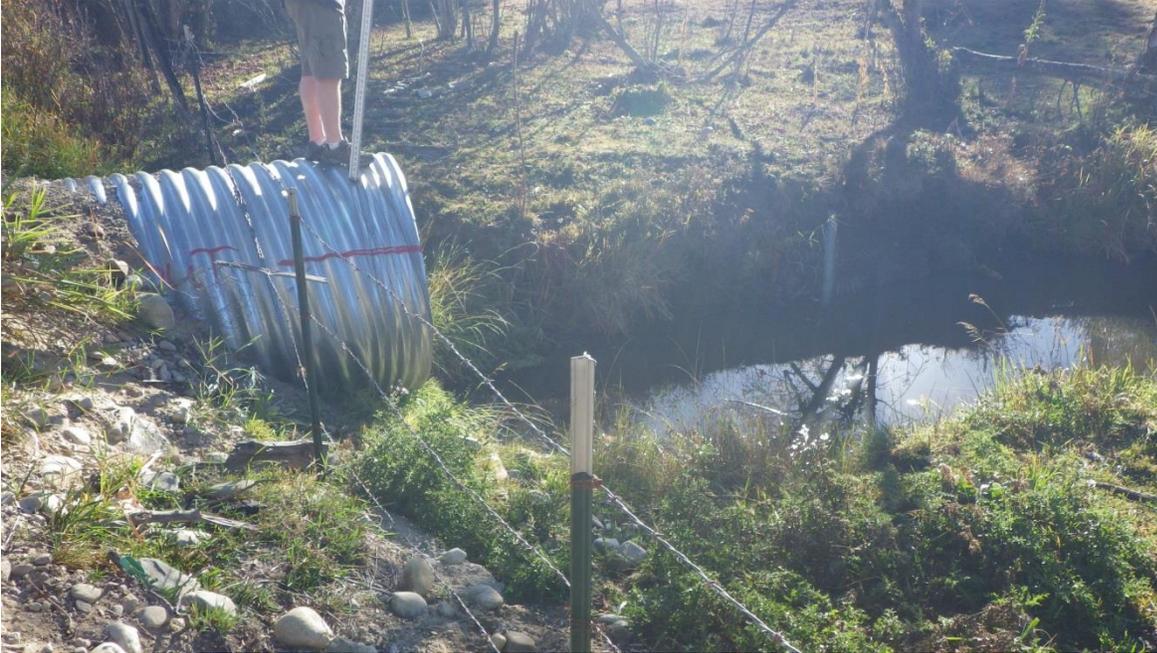
Figure 60. New culvert on Gold Creek.

| Water Body | Type | GPS Coordinates | Erosion Severity | Overall Condition | Fish Barrier? |
|---|---|---|---|---|---|
| Gold Creek | Round, corrugated steel | N 48.393040 W -116.410432 | Low | Excellent | Yes |

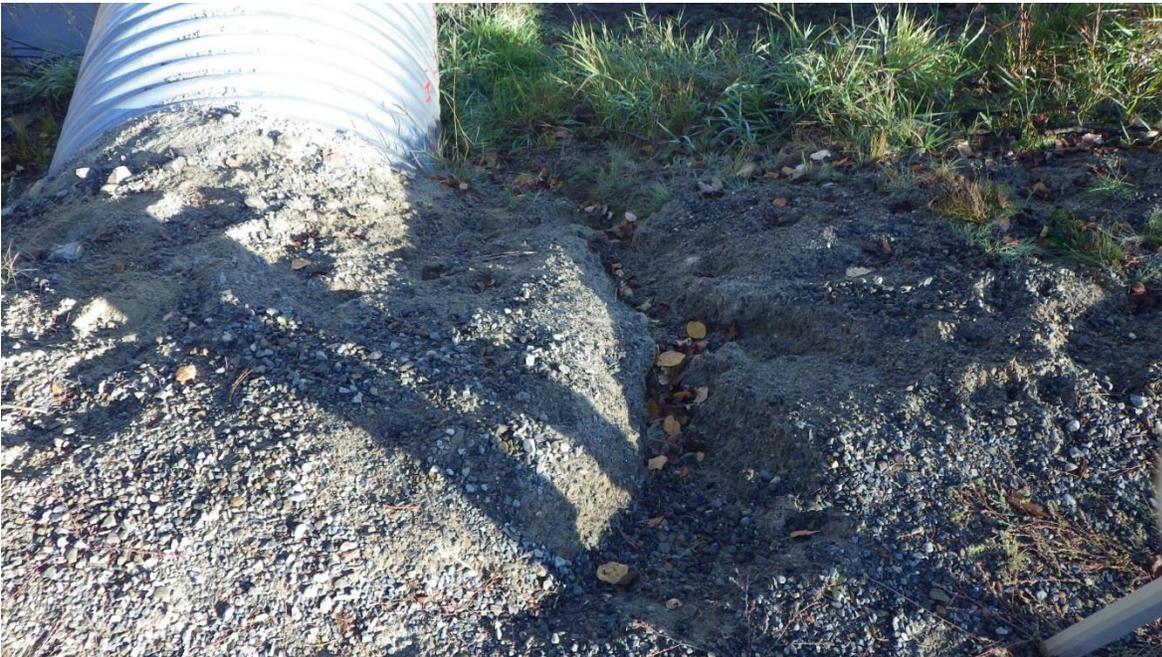
Figure 61. Gully erosion on new culvert on Gold Creek.

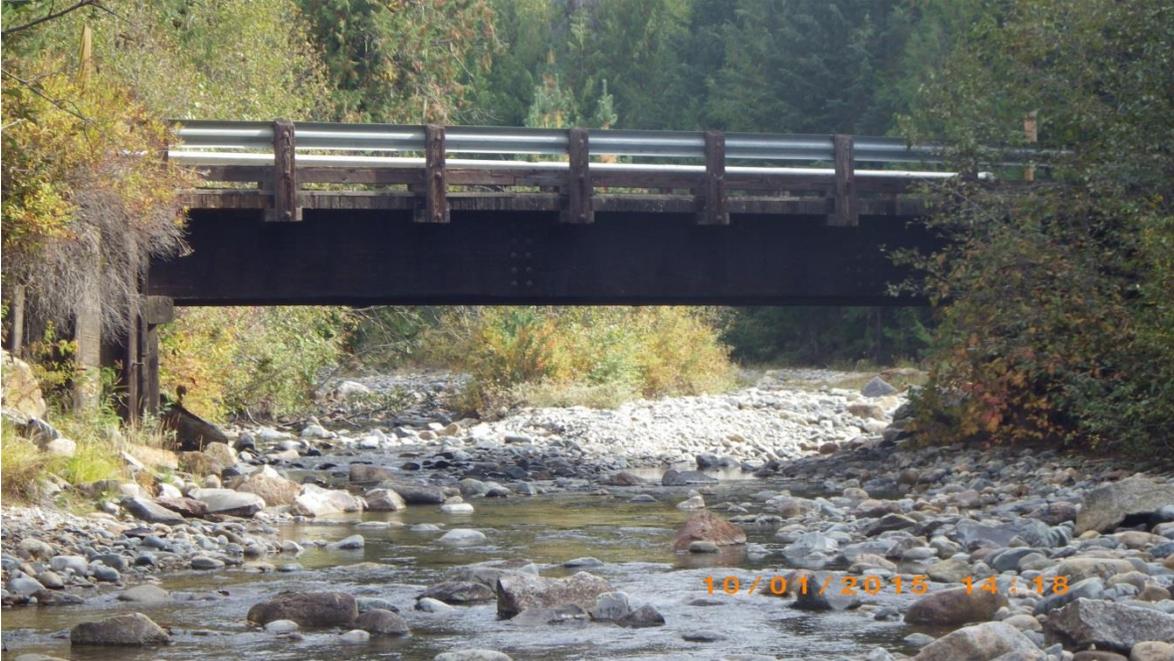
In October 2015, DEQ conducted a survey of road crossing conditions in the Grouse Creek watershed. Two road crossings were selected for evaluation. Road crossing characteristics are presented in Table 28. The bridge over Grouse Creek on Grouse Creek Road was a fairly new bridge in good condition with a low erosion potential (Figure 69). The bridge appeared to be sized correctly for bankfull flow.

| Water Body | Type | GPS Coordinates | Erosion Severity | Overall Condition | Fish Barrier? |
|---|---|---|---|---|---|
| Grouse Creek | Timber-framed, timber decked bridge | N 48.455371 W -116.289359 | Low | Good | No |

Figure 69. Newly constructed bridge on Grouse Creek.

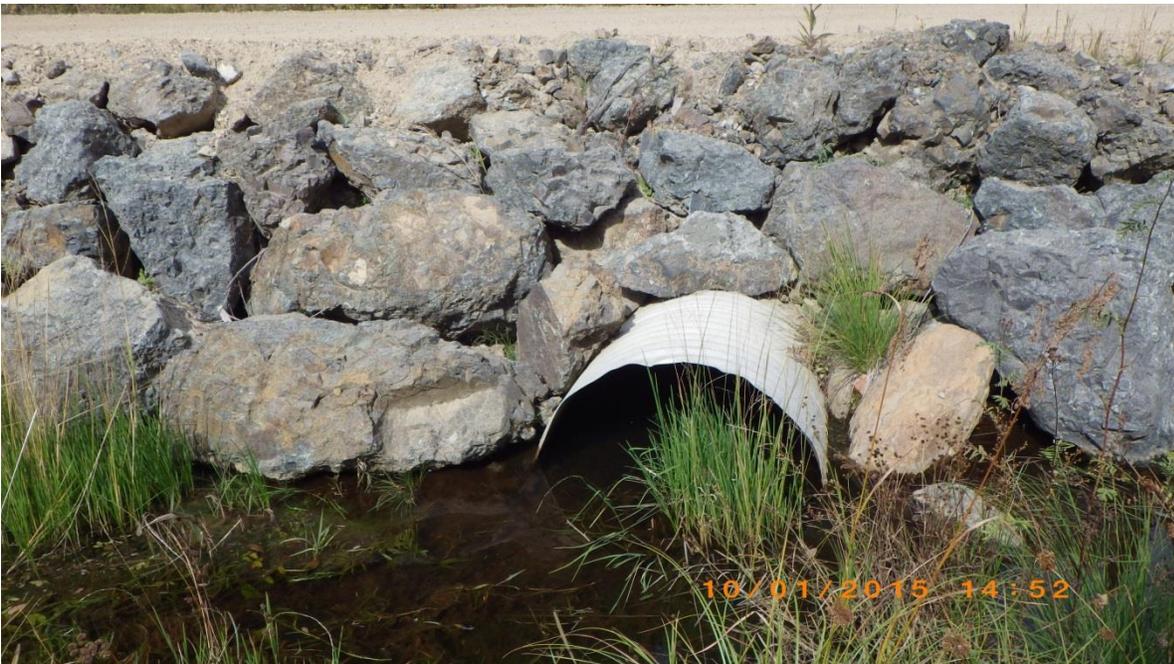
A culvert on an unnamed tributary to Grouse Creek was inspected. The stream was low-gradient and depositional in character. Approximately 75 feet from the culvert was a beaver dam. The culvert was under-sized with damage to the inlet (Figure 70). However, water still passed through. Erosion potential at this culvert was medium.

| Water Body | Type | GPS Coordinates | Erosion Severity | Overall Condition | Fish Barrier? |
|---|---|---|---|---|---|
| Unnamed tributary to Grouse Creek | Round, corrugated steel culvert | N 48.453833 W -116.362901 | Medium | Fair | No |

Figure 70. Undersized culvert on unnamed tributary to Grouse Creek.

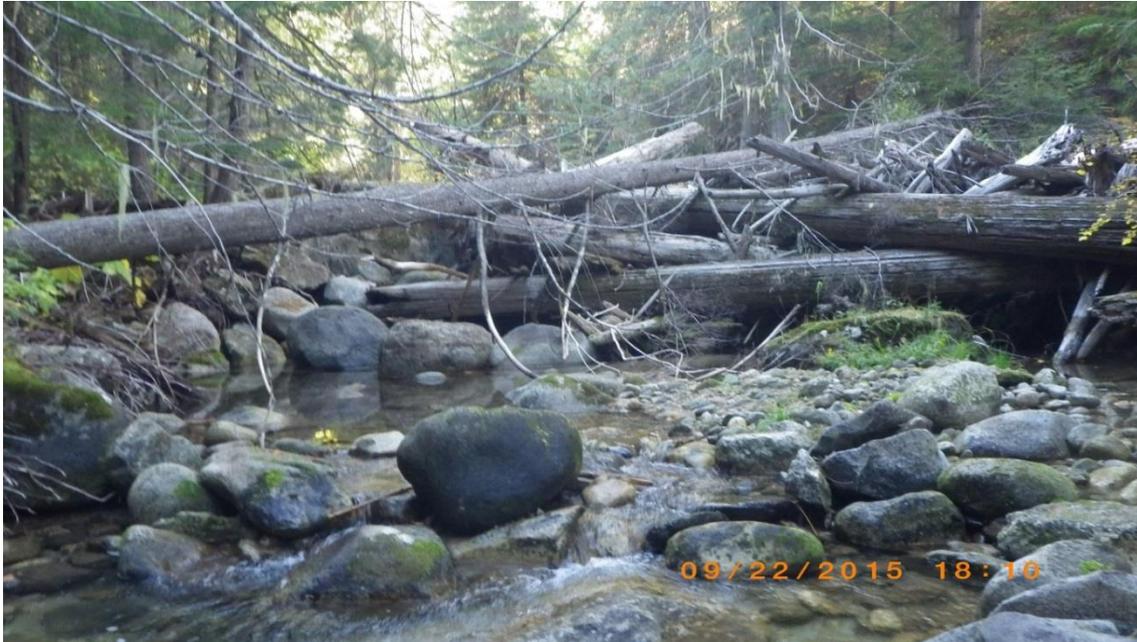
The presence of LWD and woody debris jams in Hellroaring Creek exhibited a minor deviation from reference conditions. LWD greater than 2 feet in diameter was not in relative abundance, but smaller diameter wood was. Log jams were also abundant—some of them channel spanning log jams (Figure 77). Recruitment of LWD was moderate.

Figure 77. Abundant large woody debris in lower Hellroaring Creek provides cover for aquatic life.

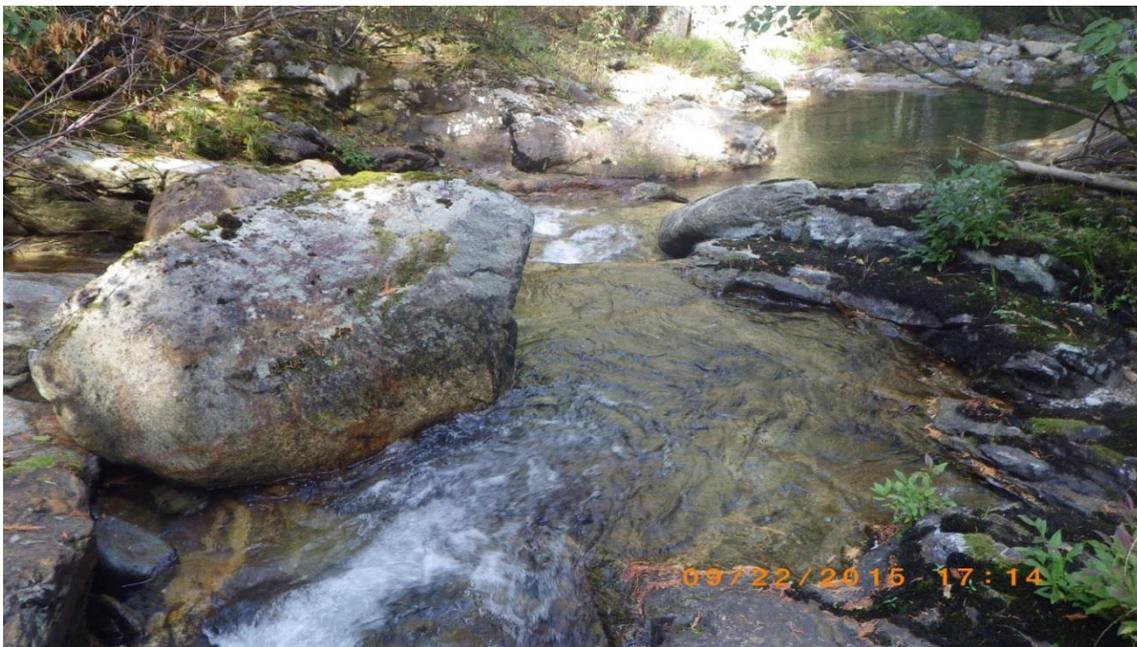
Bed substrate in lower Hellroaring Creek was bedrock in much of the study reach (Figure 78). However, large boulders dominated in the upper third of the study reach and were stable with some evidence of mobility and sorting.

Figure 78. Bedrock-dominated substrate in lower Hellroaring Creek.

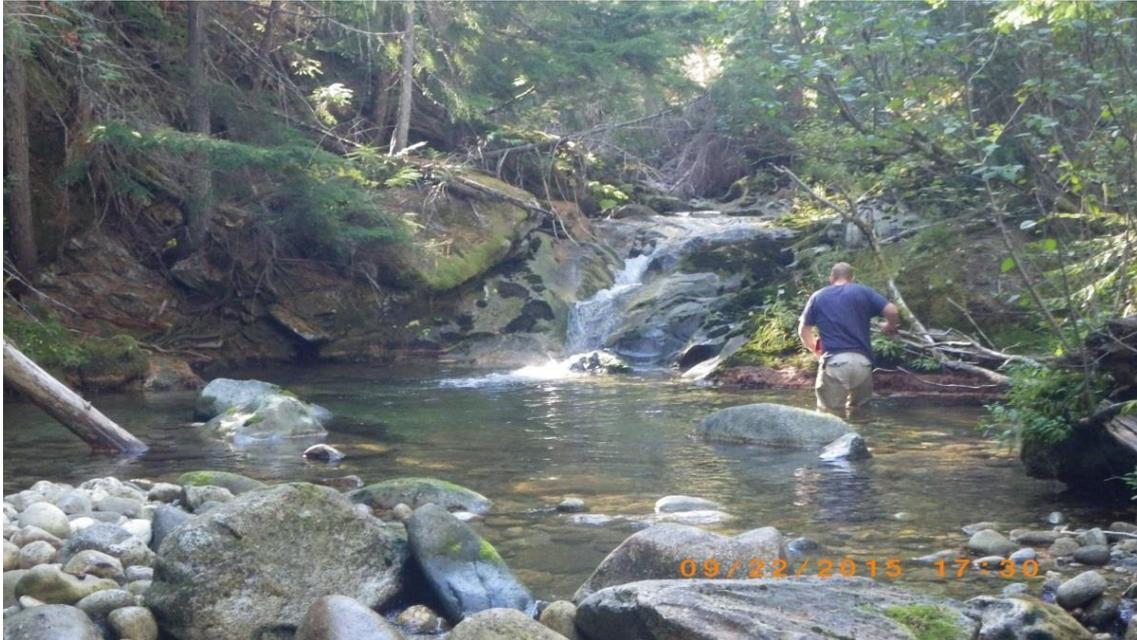
Abundant pools with excellent cover were observed in lower Hellroaring Creek, providing refuge during all flow regimes (Figure 79). These would be considered near reference conditions. The size and depth of the pools were remarkable given the extreme low-flow conditions. The pools were formed from abundant wood and the step-pool morphology, which was well-formed and stable.

Figure 79. Pools in lower Hellroaring Creek provide abundant refuge even in low flow years.

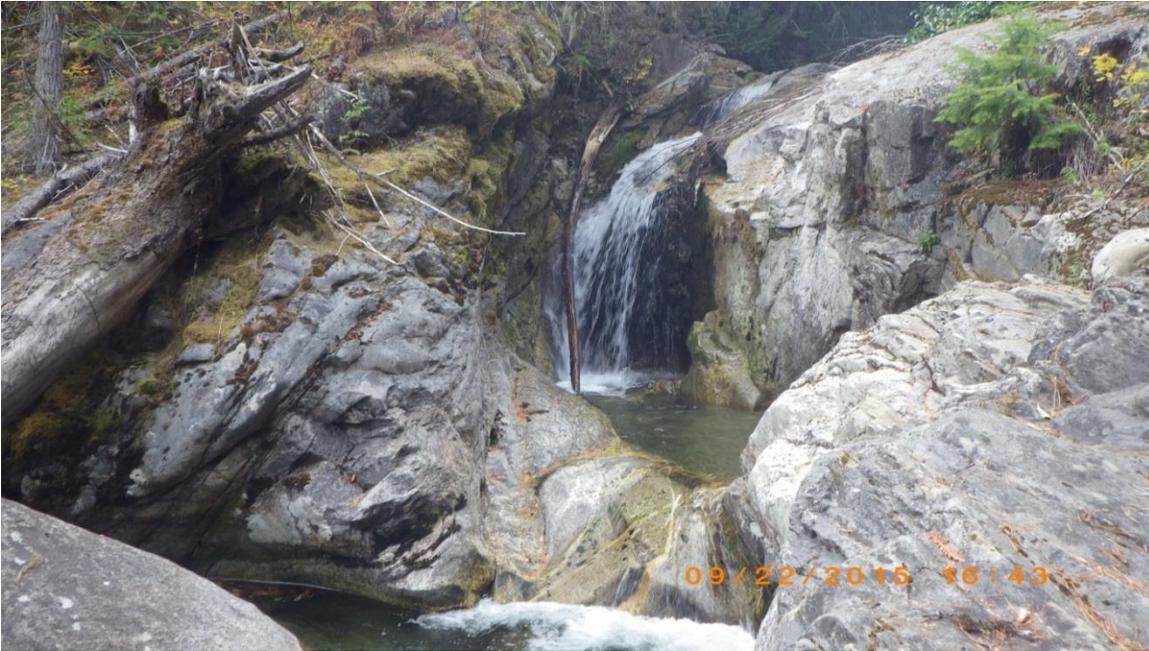
Given it was an extreme low-flow year, the wetted width of lower Hellroaring Creek was good, with an abundance of refuge during high and low flow. No flow alteration existed on lower Hellroaring Creek. However, a waterfall did obstruct longitudinal connectivity at the lower end of the study reach (Figure 80). Due to minor entrenchment, there was little obstruction to floodplain connectivity. However, the floodplain was narrow due to the steep mountain side-slopes.

Figure 80. Waterfall on lower Hellroaring Creek.
