Pend Oreille Lake and River Tributaries

TMDL Five-Year Review

**State of Idaho
Department of Environmental Quality
April 2017**

**Prepared by
Coeur d'Alene Regional Office
Department of Environmental Quality
2110 Ironwood Parkway
Coeur d'Alene, ID 83801**

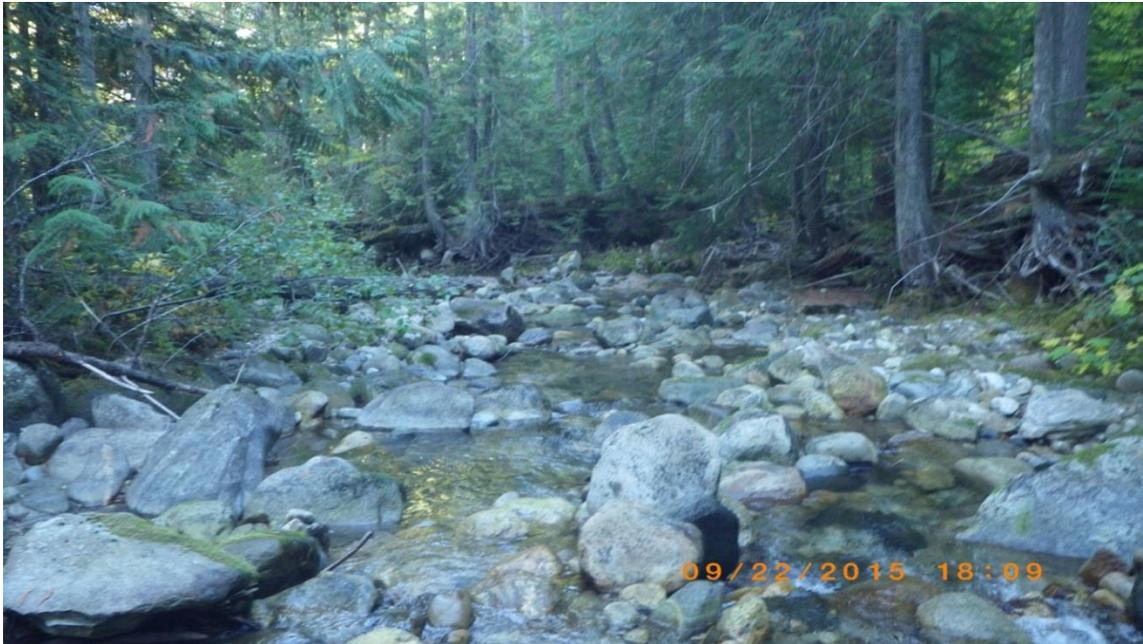
The riparian area was composed of cedar and hemlock overstory with fern and devil's club understory (Figure 81). The buffer width was greater than 200 feet with maximum channel canopy. The riparian area was at reference conditions.

Figure 81. Dense riparian buffer at lower Hellroaring Creek.

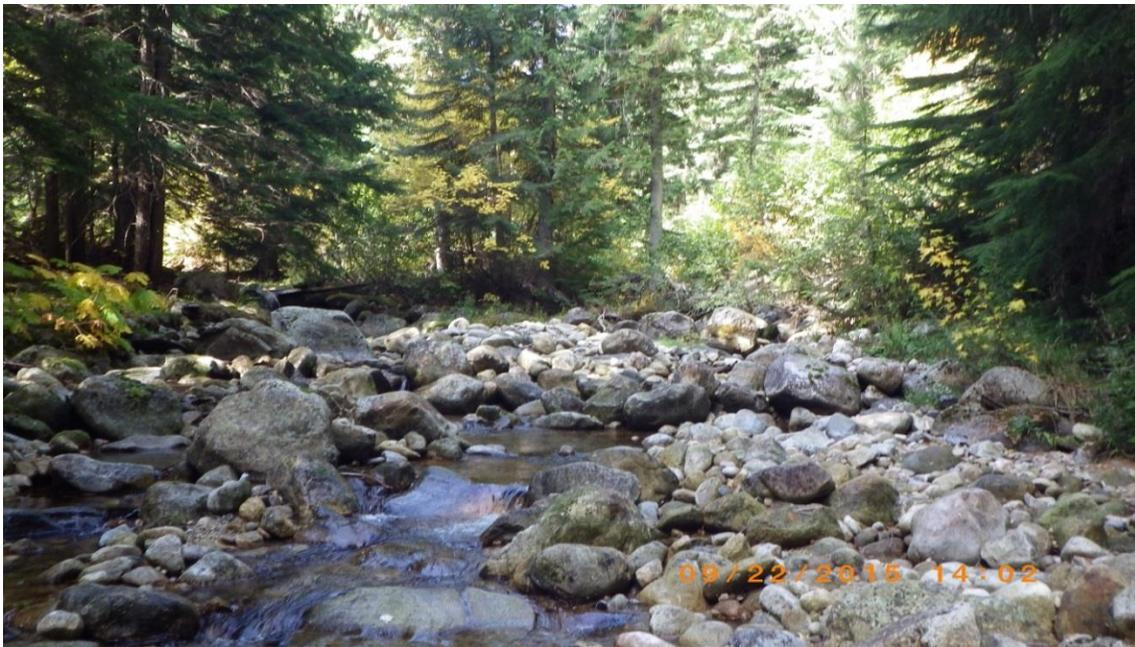
Upper Hellroaring Creek had a boulder-dominated substrate with some evidence of sediment mobility and lack of sorting (Figure 82). The excess bedload somewhat limited the stream's transport capacity. Pool and margin embeddedness was not a concern. Small substrate patches were covered in dense algae growth suggesting some nutrient enrichment (Figure 83). The source of nutrients was likely natural due to the lack of development and infrastructure in the watershed.

Figure 82. Boulder substrate, upper Hellroaring Creek.

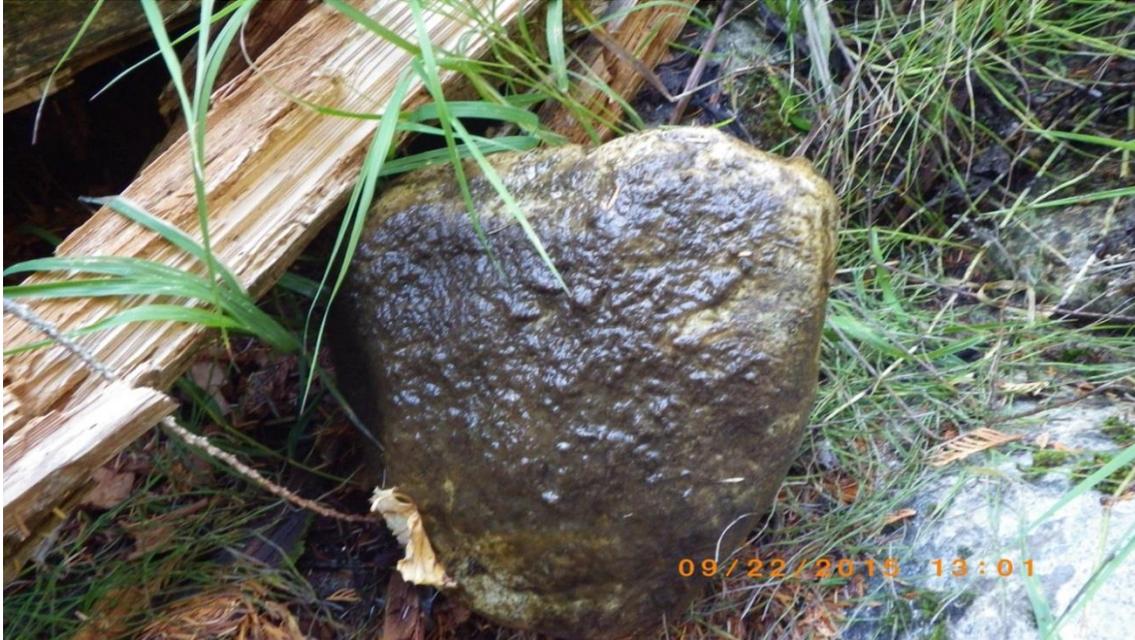
Figure 83. Algae growth on substrate, upper Hellroaring Creek.

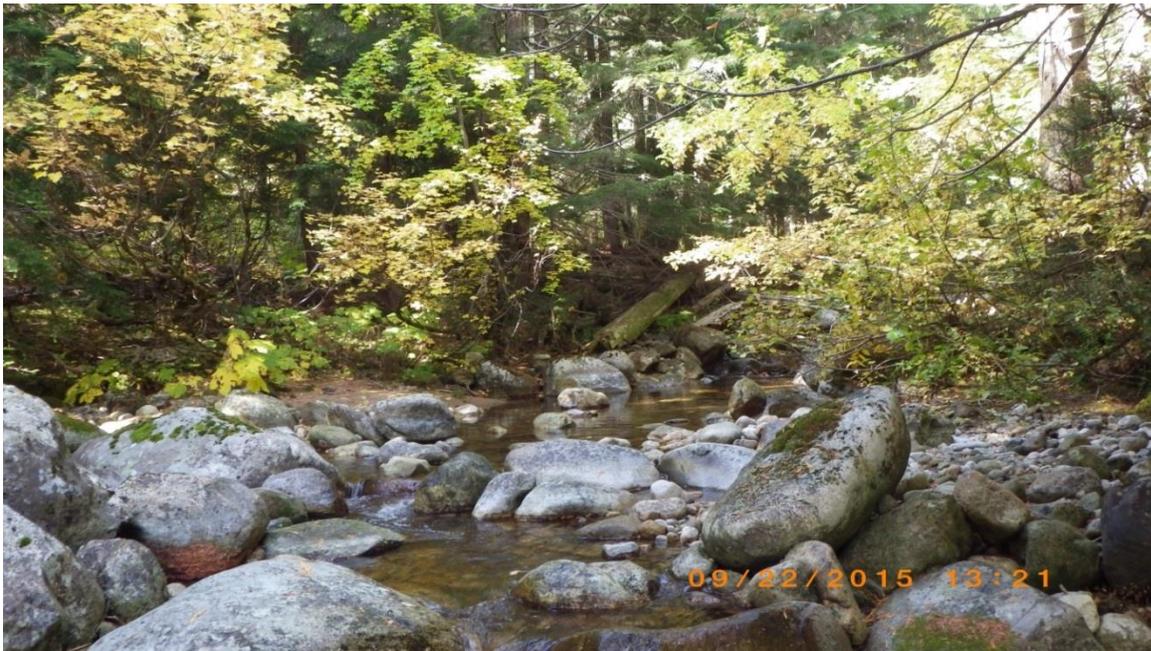
Upper Hellroaring Creek had a step-pool morphology with steps moderately well-formed, complete, and stable. Due to the excessive bedload, pool size and cover varied. Overall pool abundance was good, providing good habitat in the extreme low-flow conditions of 2015 (Figure 84).

Figure 84. Pools in upper Hellroaring Creek.

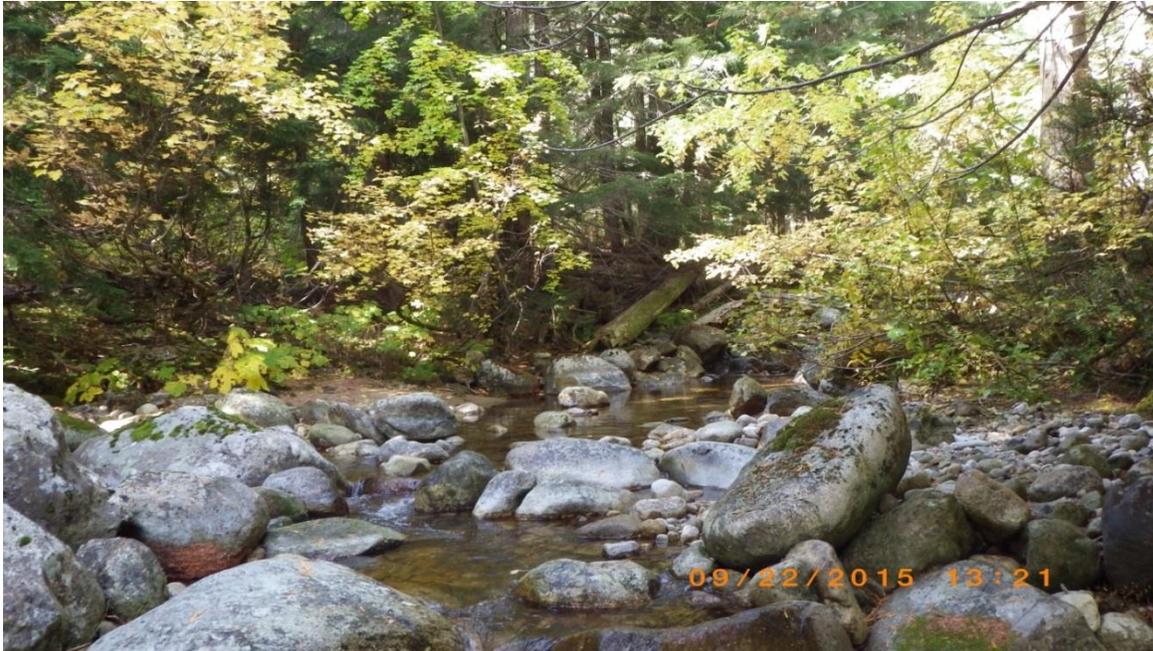
The riparian area was composed of a cedar and hemlock overstory with a fern and devil's club understory (Figure 86). The riparian buffer width varied from less than 100 feet to 200 feet, with the narrower buffer on the north side of the creek. The canopy was 75% to 90% maximum channel capacity. Land use was strictly timber production in this watershed, so river corridor development and infrastructure was absent.

Figure 86. Riparian overstory, upper Hellroaring Creek.

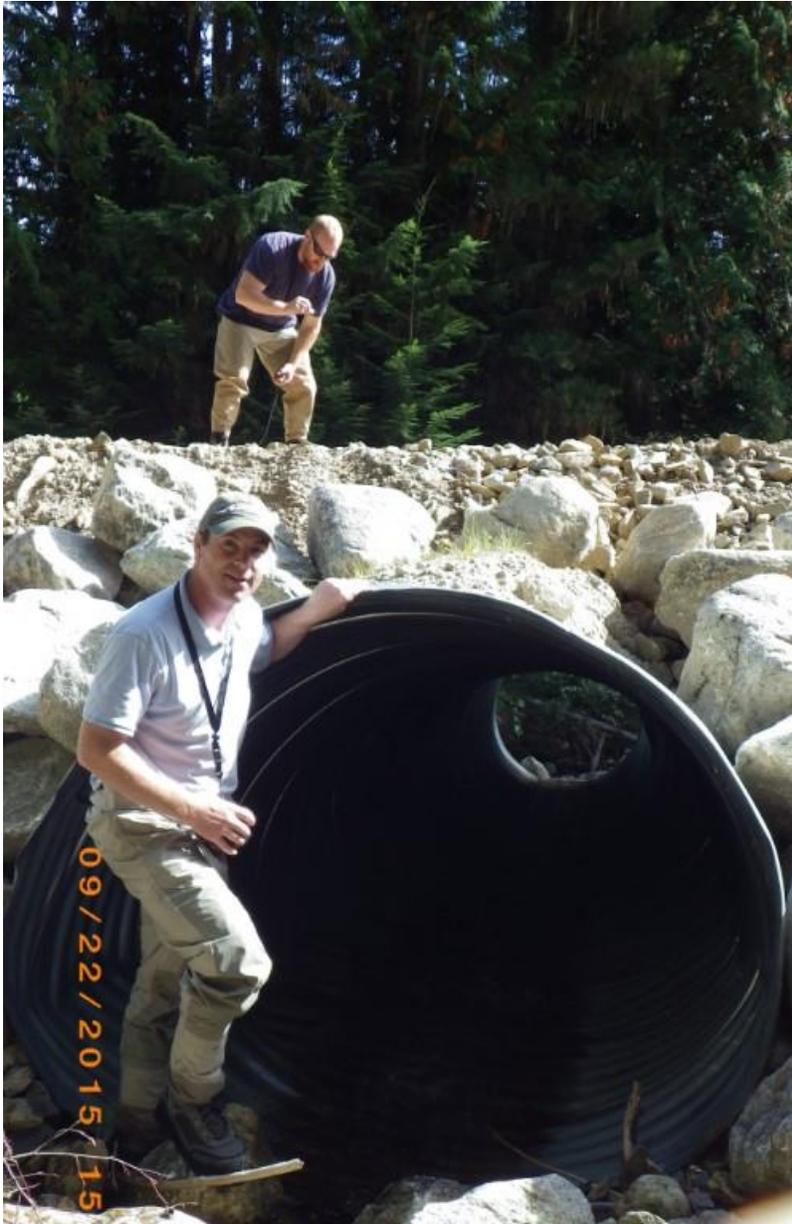
Due to the long distance between the road and Hellroaring Creek, there was a very low risk of sediment delivery to Hellroaring Creek from the road, except at the single crossing on North Fork Hellroaring Creek. However, proper maintenance of the road and water bars and limited access on this road is critical to limit the risk of rill and gully erosion on the road surface. At the North Fork Hellroaring Creek crossing, the culvert had been replaced and was well armored upstream and at the outlet (Figure 88). However, it appeared that water could flow underneath the culvert. Limited access and proper maintenance of the road surface and water bars near the road crossing is critical to protecting habitat and water quality in Hellroaring Creek.

Figure 88. New culvert on North Fork Hellroaring Creek Road.

Hellroaring Creek watershed. A 200-foot buffer is recommended at all times. More caution should be practiced near the stream crossing on North Fork Hellroaring Creek. Sediment delivery at this crossing could be costly to water quality.

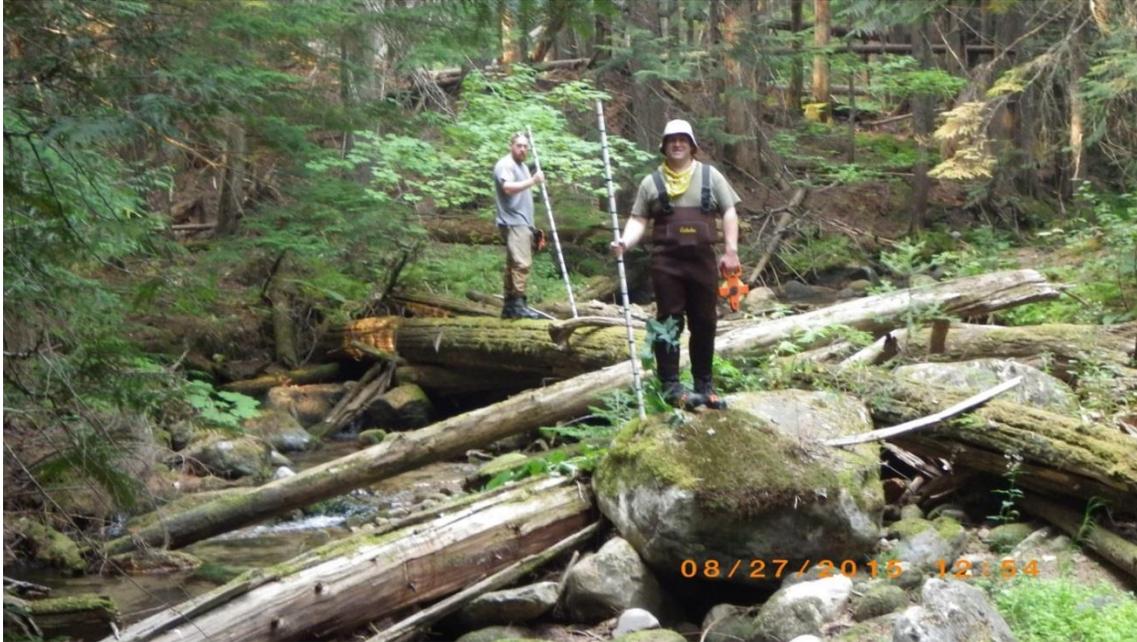
Upper Little Sand Creek had abundant woody debris cover, with large wood greater than 1 foot in diameter. Log jams were abundant (Figure 92). The stream also had high woody debris recruitment potential.

Figure 92. Log jam in upper Little Sand Creek.

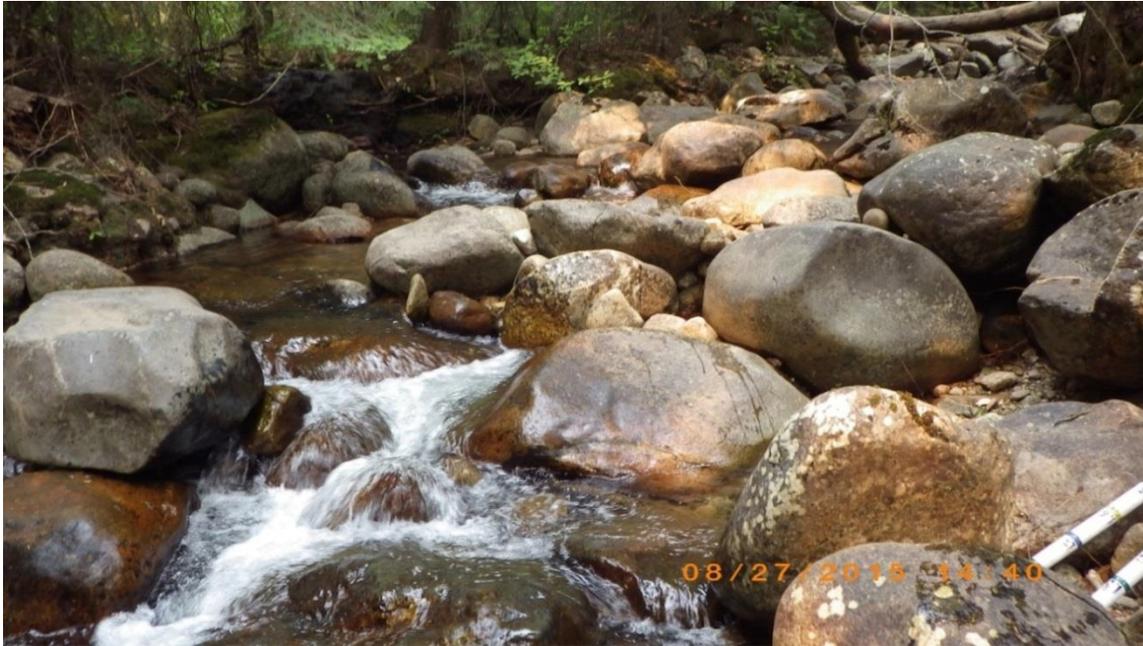
Upper Little Sand Creek was at reference conditions for scour and depositional features with an abundance of pools and excellent pool cover. Pools greater than 3 feet deep made up about 50% of the total pools, which was important given the extreme low-flow conditions. Steps were well-formed, complete, and stable with more than two depth-velocity combinations present (Figure 93).

Figure 93. Pools provide abundant refuge for aquatic life in upper Little Sand Creek.

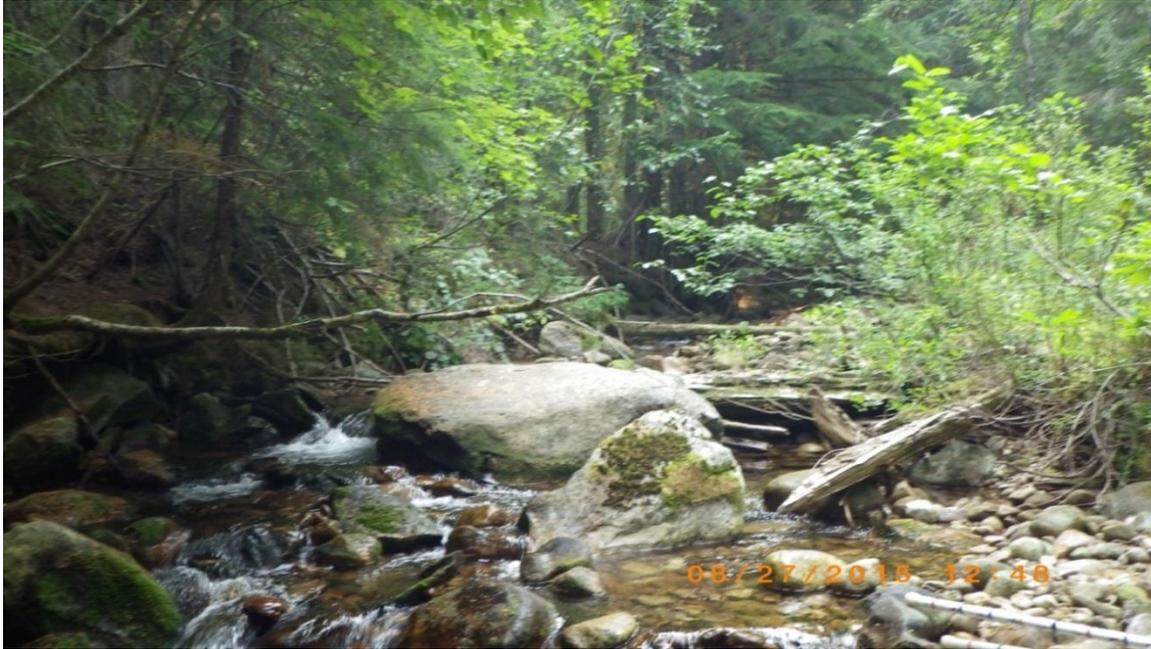
The riparian area was composed of cedar and hemlock, with fern overstory and devil's club understory. The area was at or near its maximum canopy over the creek (Figure 94). The riparian buffer width was between 150 and 200 feet.

Figure 94. Dense riparian area in upper Little Sand Creek.

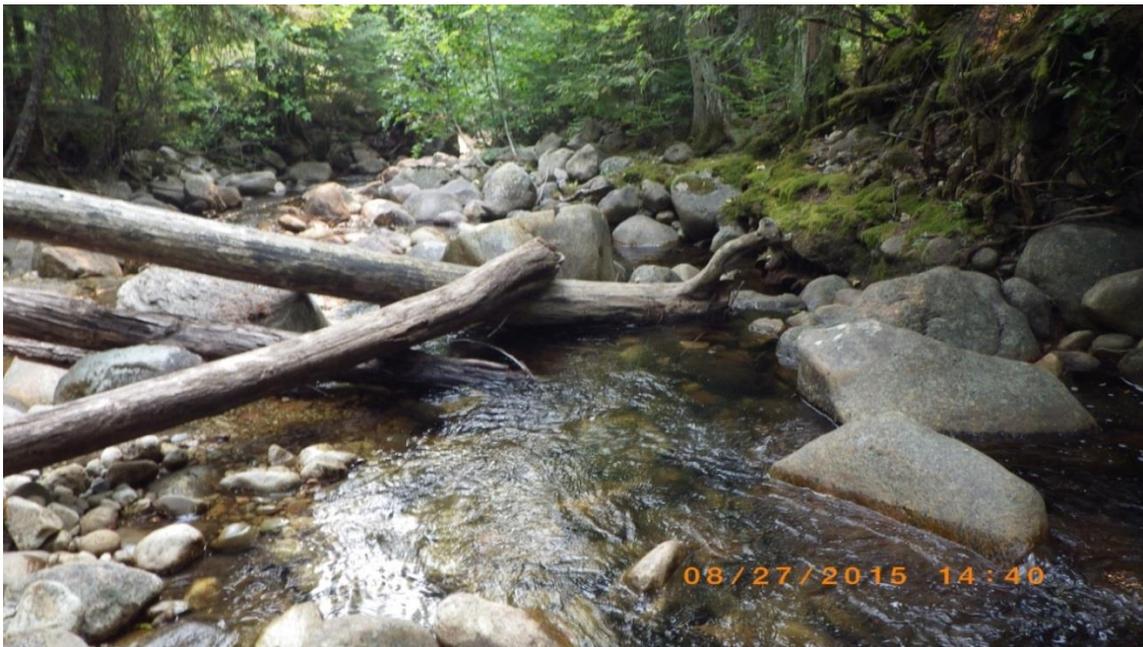
Lower Little Sand Creek had some woody debris cover, with less abundant large wood greater than 1 foot in diameter (Figure 95). No log jams were observed in the study reach. Woody debris recruitment potential was moderate.

Figure 95. Large woody debris provided abundant cover for aquatic life.

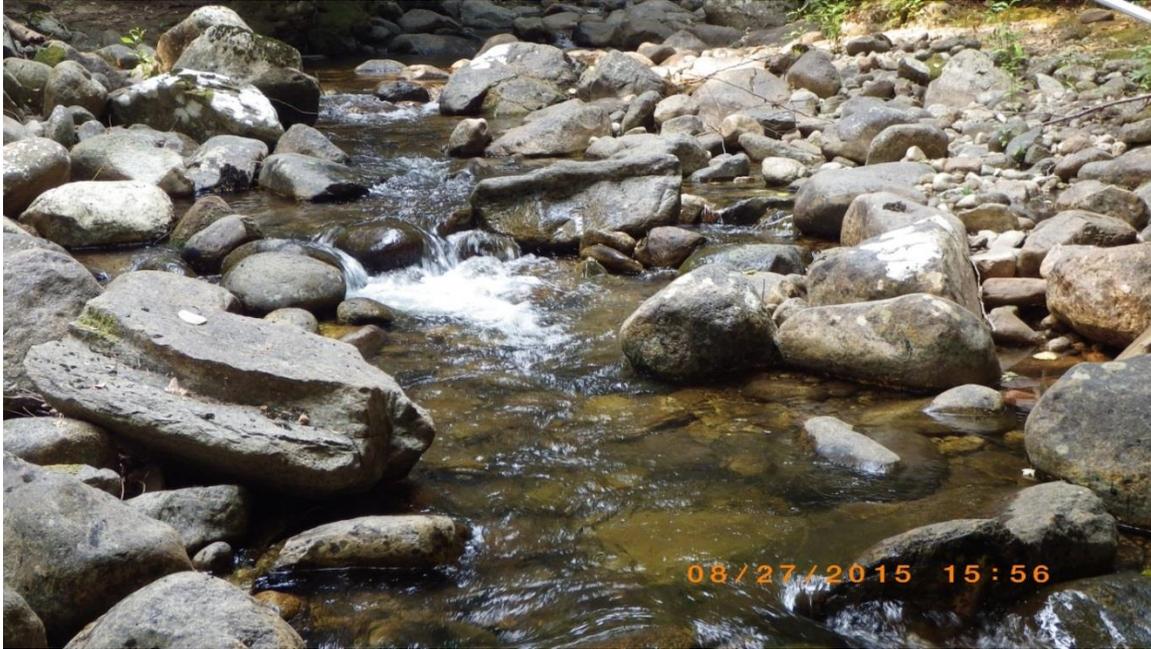
Lower Little Sand Creek had an abundance of pools and good pool cover (Figure 96). Many of the pools were greater than 3 feet deep. Steps were moderately well formed, complete, and stable.

Figure 96. Pools in lower Little Sand Creek.

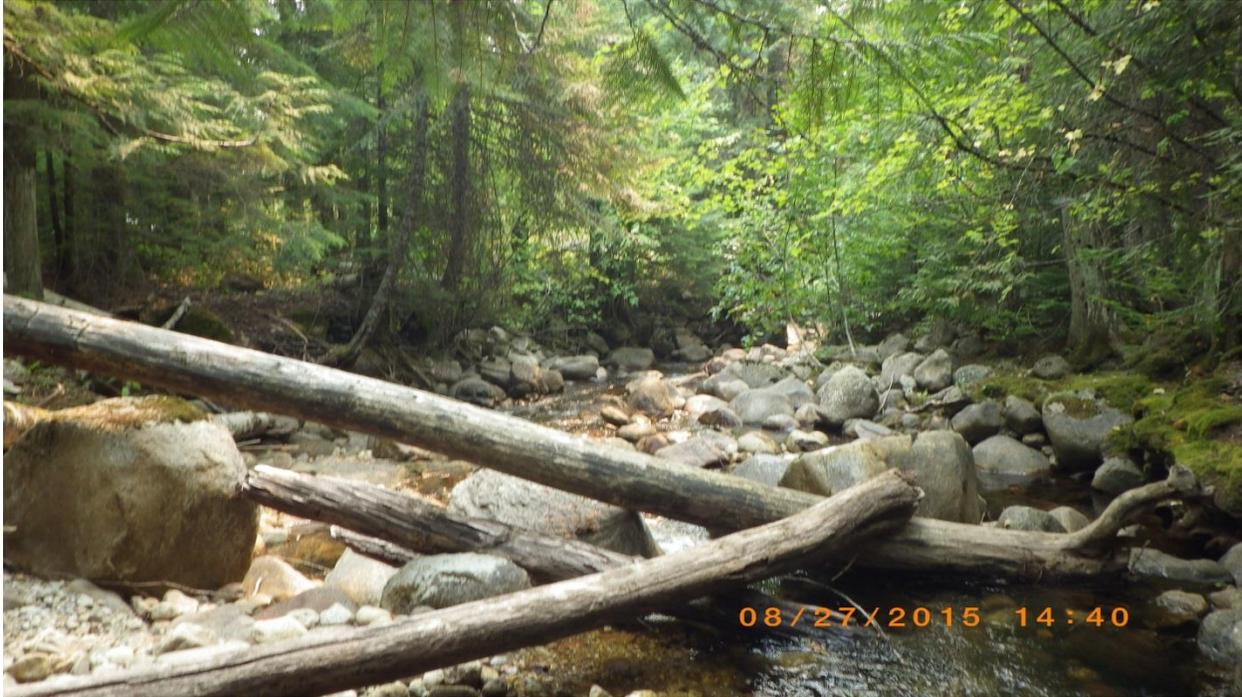
The riparian area was composed of cedar and hemlock, with fern overstory and devil’s club understory. The buffer width was 150–200 feet wide with 75%–90% maximum channel canopy (Figure 97). Minimal invasive plants were present.

Figure 97. Riparian area on lower Little Sand Creek.

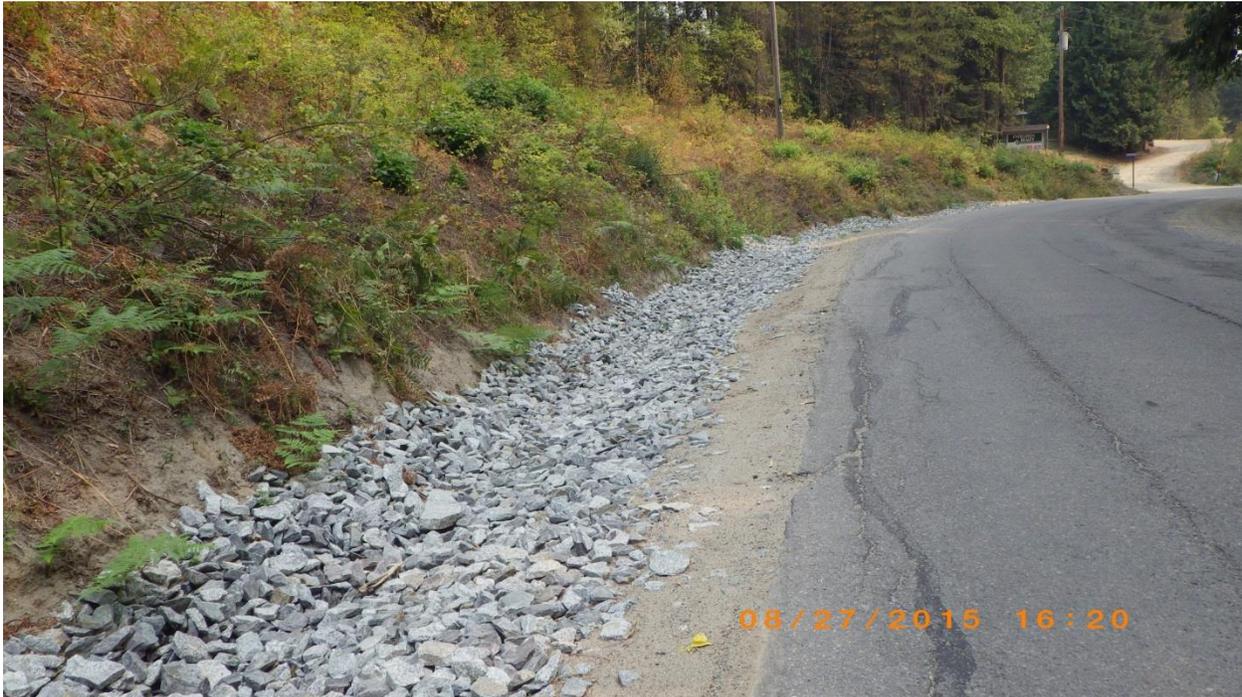
To minimize the amount of erosion from the ditch line on the road, Independent Highway District cleaned and rock lined approximately 1.7 miles of ditch line from Woodland (mile post 0.3) to Switch Back 3 (mile post 3.4) (Figure 98). Switch Back 3 is where the road turns and heads away from Little Sand Creek. The highway district will continue rock the ditch line in the future to limit erosion.

Figure 98. Rock-lined ditch best management practice on Schweitzer Mountain Road.

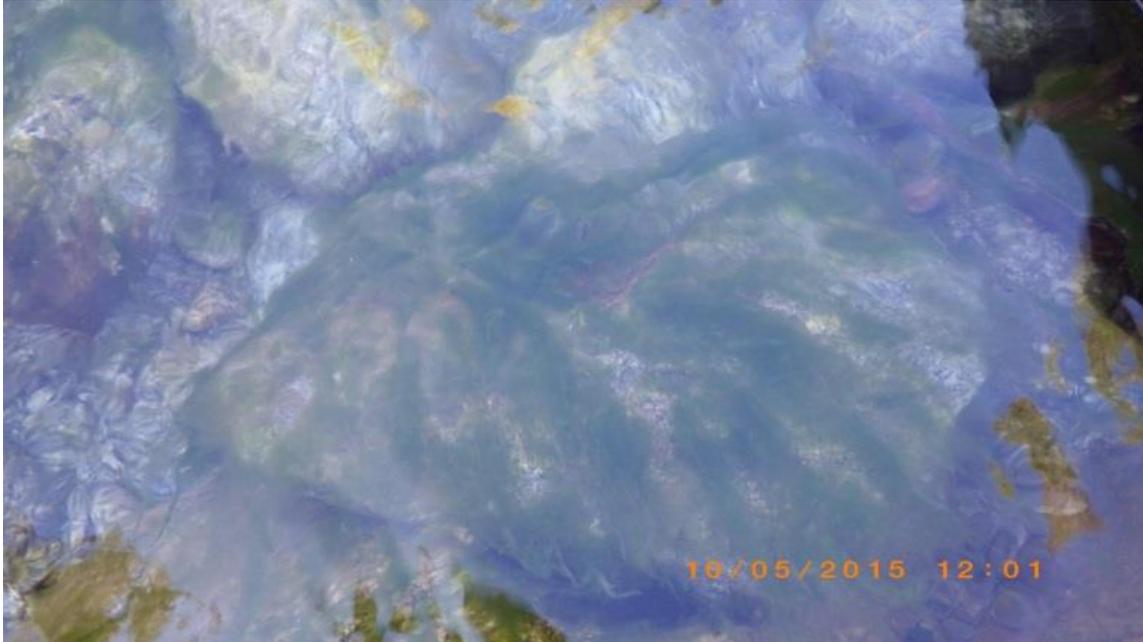
McCormick Creek was a cobble-dominated stream with large boulders throughout. Cobbles were slightly embedded in pools and pool margins. The cobble substrate showed evidence of sediment mobility and lack of sorting. This excessive mobility resulted in a reduced diversity of aquatic habitat. Small patches of substrate were covered by dense algae growth (Figure 102).

Figure 102. Dense algae patch in McCormick Creek.

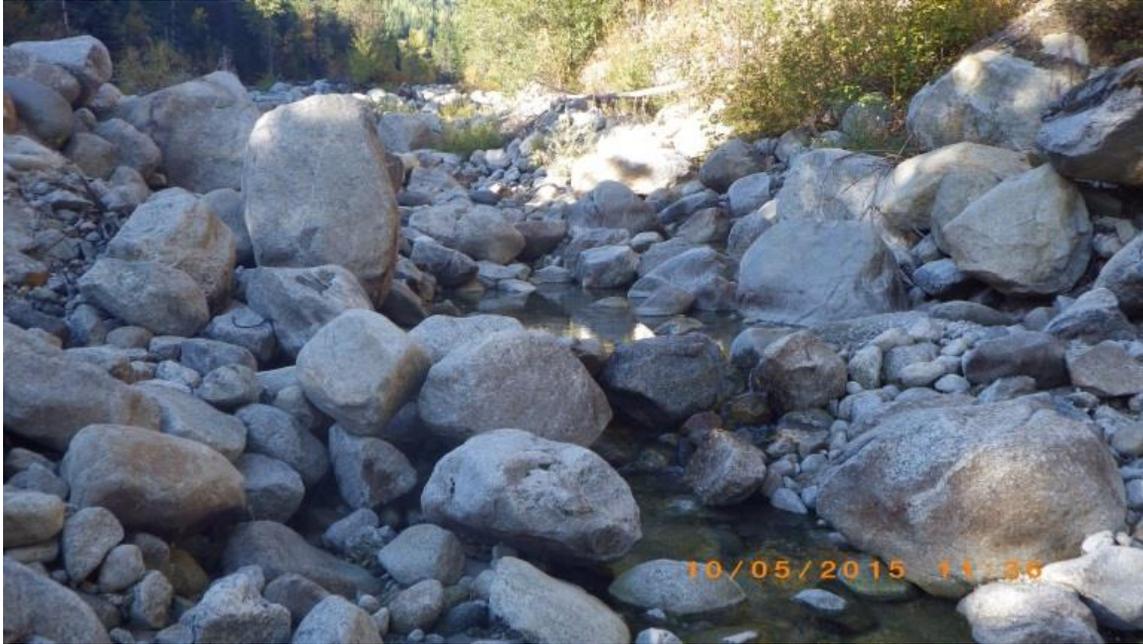
McCormick Creek had a relative abundance of pools at a depth of 2 feet or greater. Pool size and abundance provided good cover and thermal refuge for fish. These conditions were excellent given the very low flow in fall 2015. Some fish were observed; however, the species could not be identified. Steps were moderately well-formed, complete, and stable with step spacing between 3 and 5 bankfull widths. Despite substrate mobility, large boulders provided stability for the pools (Figure 103). Only two depth-velocity combinations were present (fast shallow and slow deep).

Figure 103. Pools in McCormick Creek.

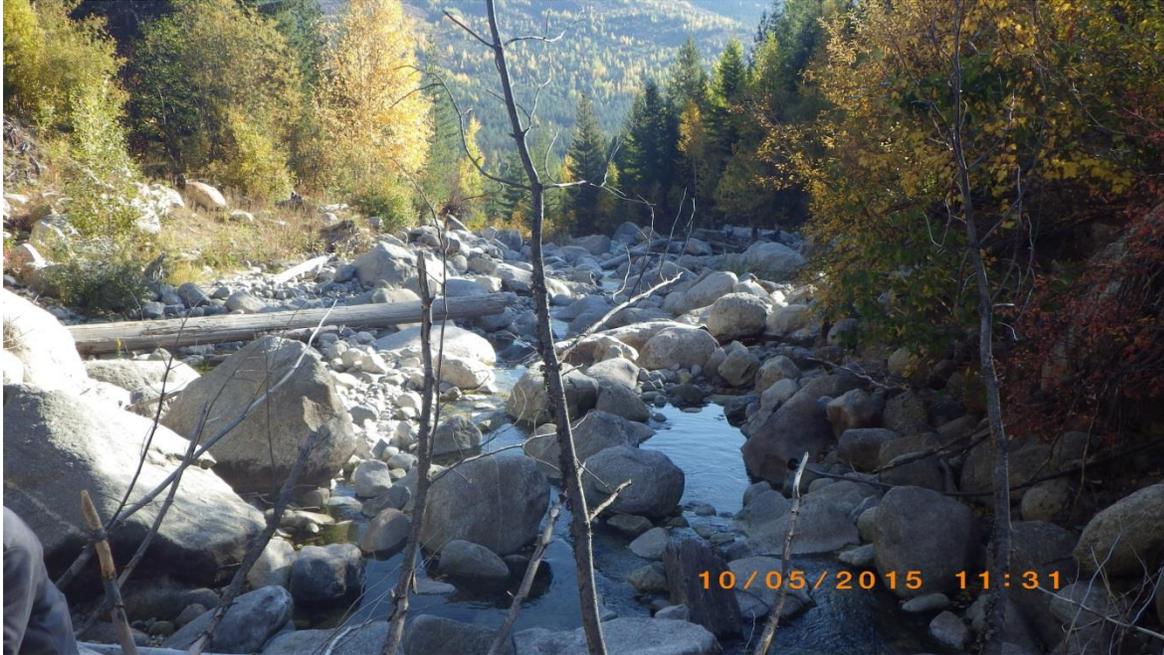
The channel gradient and large cobble substrate precludes a well-developed riparian community. However, the riparian area within the study reach was in fairly good condition with a diversity of vegetation species and minimal invasive species (Figure 106). The riparian buffer width was greater than 200 feet, providing some shade and thermal refuge.

Figure 106. Riparian buffer adjacent to McCormick Creek.

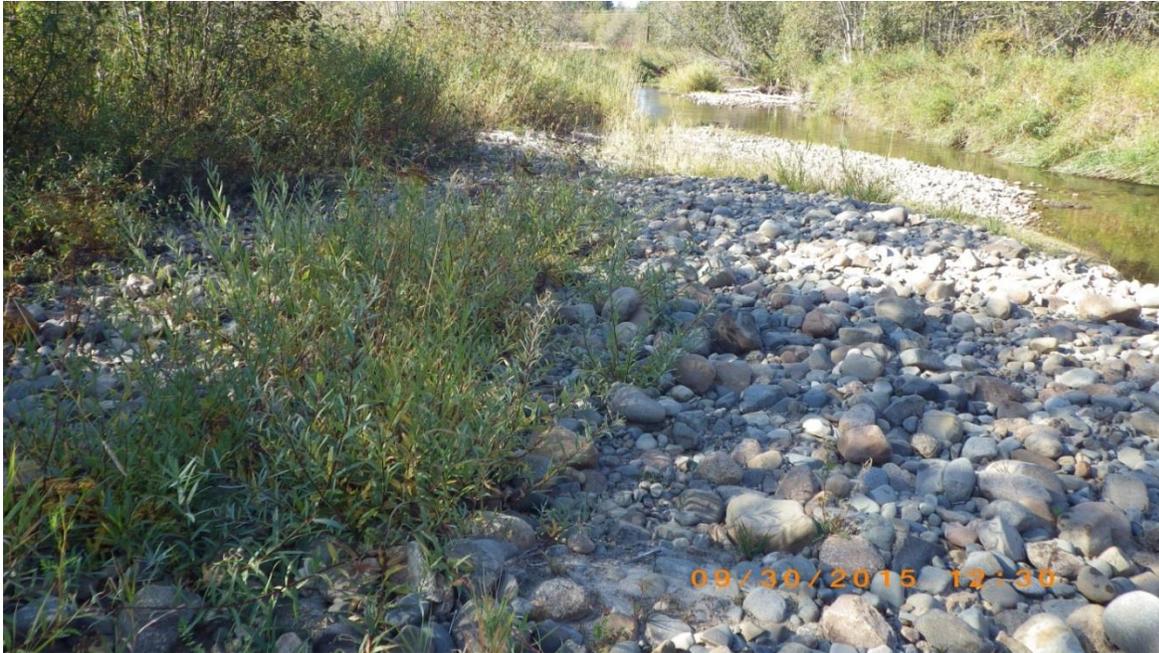
There was some evidence of sediment mobility and lack of sorting; however, some willow recruitment on point bars was observed (Figure 113).

Figure 113. Recruitment of willows on point bars.

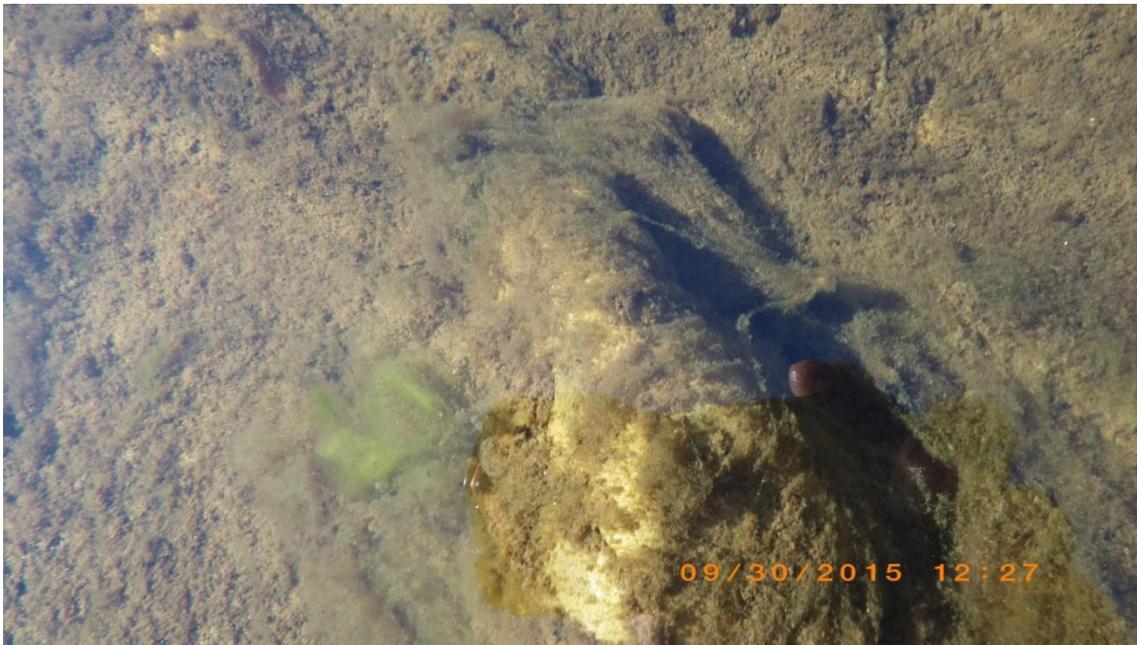
Substrate embeddedness was measured within a riffle and the margin of the riffle. In both cases, the substrate was considerably embedded. Except in riffles, periphyton covered the substrate in a fine layer, and algae was excessive on much of the rock, indicating there may be a nutrient impairment in Rapid Lightning Creek (Figure 114, Figure 115).

Figure 114. Excessive periphyton growth on rocks.

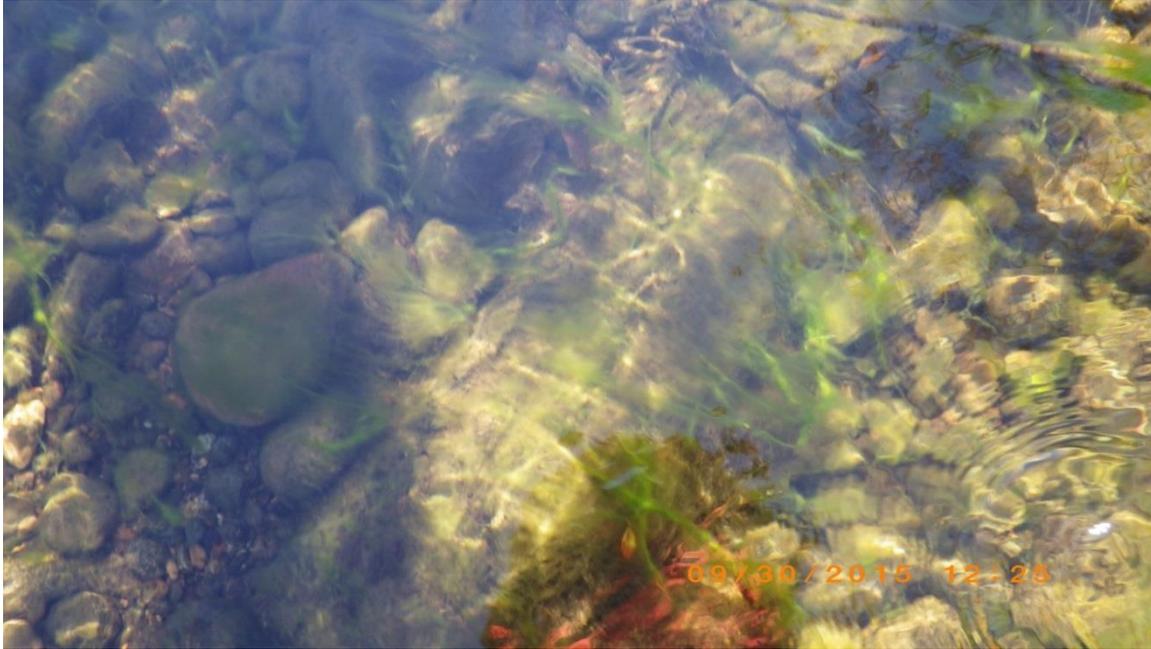
Figure 115. Algae on rocks, Rapid Lightning Creek.

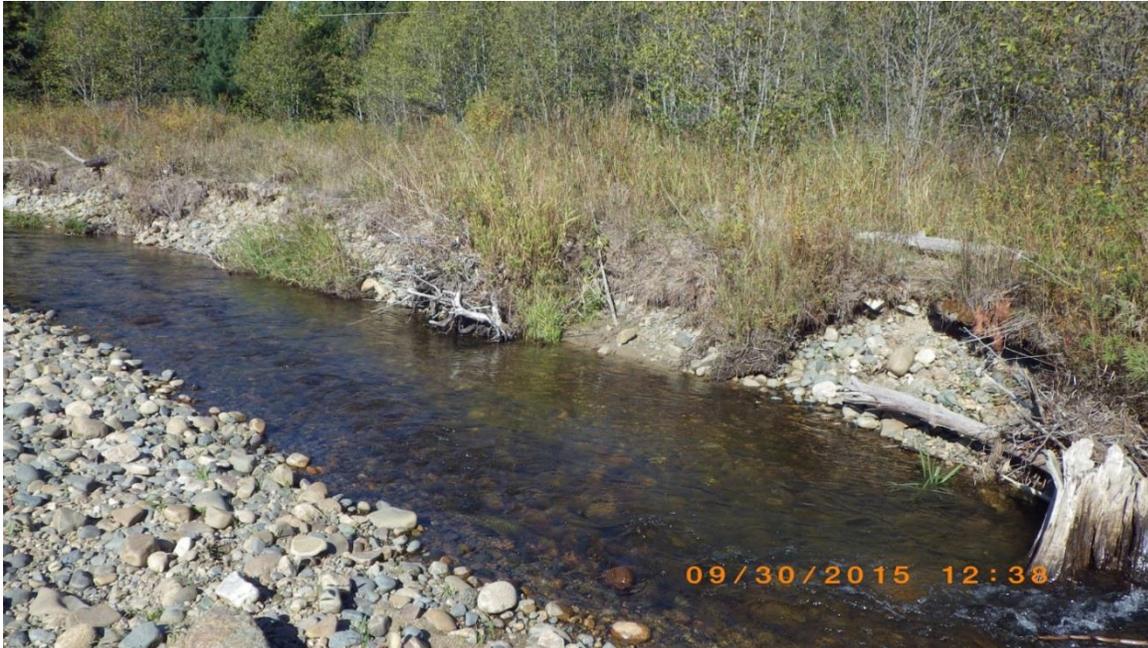
Streambank erosion was variable in the study reach, ranging from 10–30% to greater than 60% (Figure 116). Streambank stability was directly related to the presence of bank-stabilizing vegetation. Undercut banks were abundant and were the primary cover for fish; however, a number of the undercut banks were unstable and at risk of slumping into the stream.

Figure 116. Bank erosion on Rapid Lightning Creek.

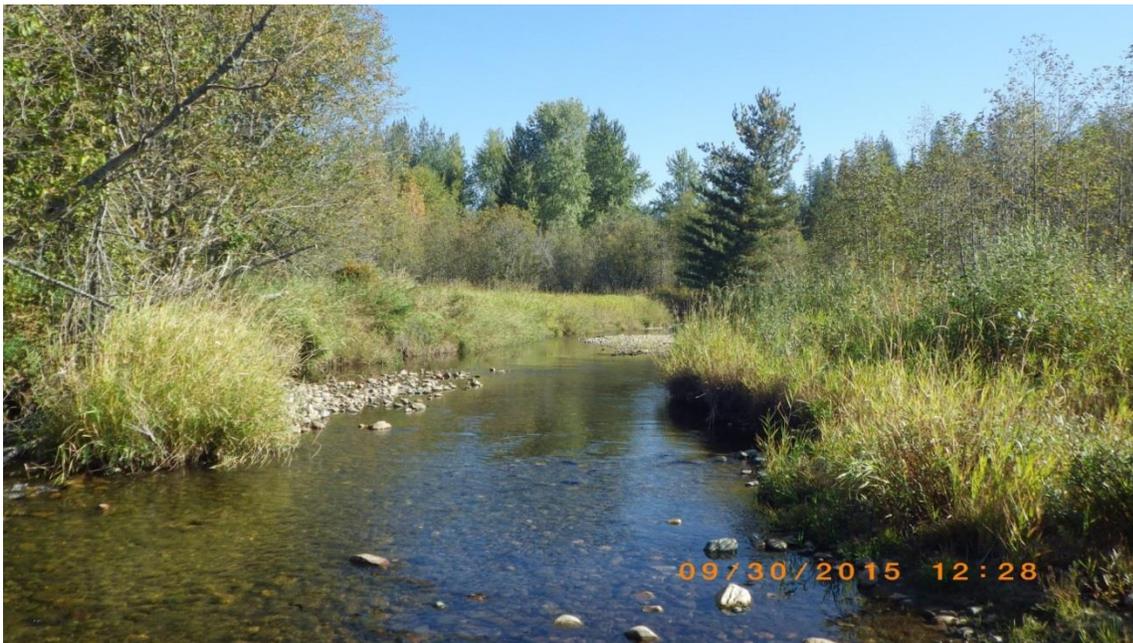
The riparian area on Rapid Lightning Creek provided a 50–100 foot buffer width in the study area (Figure 117). However, it provided a reduced canopy and was estimated to be less than 50% of its potential natural condition. Invasive species such as reed canary grass and tansy were present throughout the study reach.

Figure 117. Riparian area on Rapid Lightning Creek.

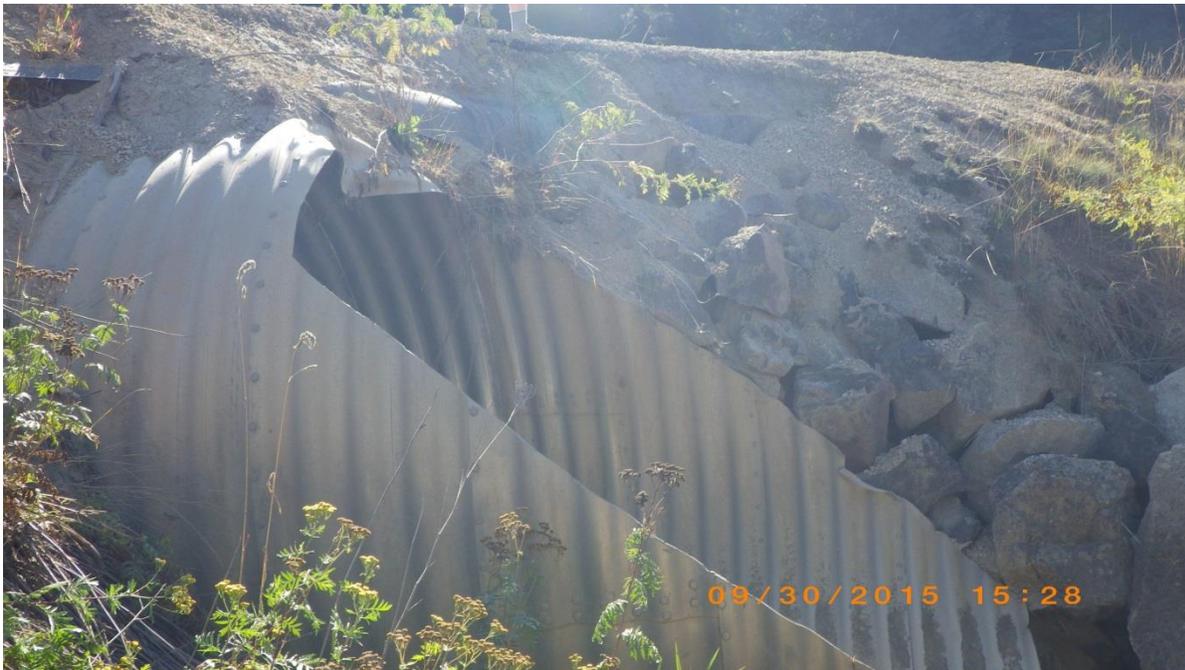
In September 2015, DEQ conducted a survey of road crossing conditions in the Rapid Lightning Creek watershed. Four road crossings were selected for evaluation. Road crossing characteristics are presented in Table 49. Three of the crossings were bridges maintained by the county. Three bridges were in good-excellent condition with a low erosion potential (Figure 118–Figure 120). However, one bridge was poorly aligned with the stream and may be an erosion hazard at higher flows. The culvert was new and in excellent condition. However, fill material near the culvert had fine material that will erode into the creek with precipitation and snowmelt. The culvert was not a barrier to fish passage (Figure 121).

Figure 121. Culvert on tributary to Rapid Lightning Creek.

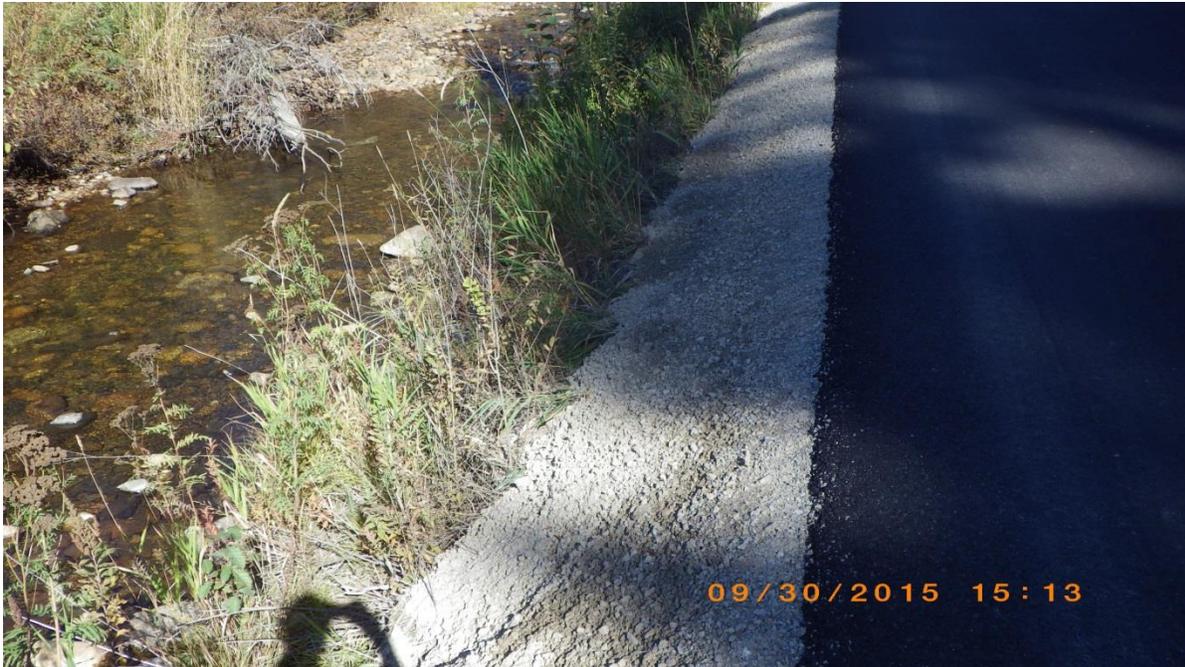
The Rapid Lightning Creek Road was newly upgraded to pavement. It was in excellent condition. However, a section of road near Rapid Lightning Creek had fill material containing fines (Figure 122). This material will erode into the creek with runoff from precipitation and snowmelt.

Figure 122. Newly constructed Rapid Lightning Creek Road.

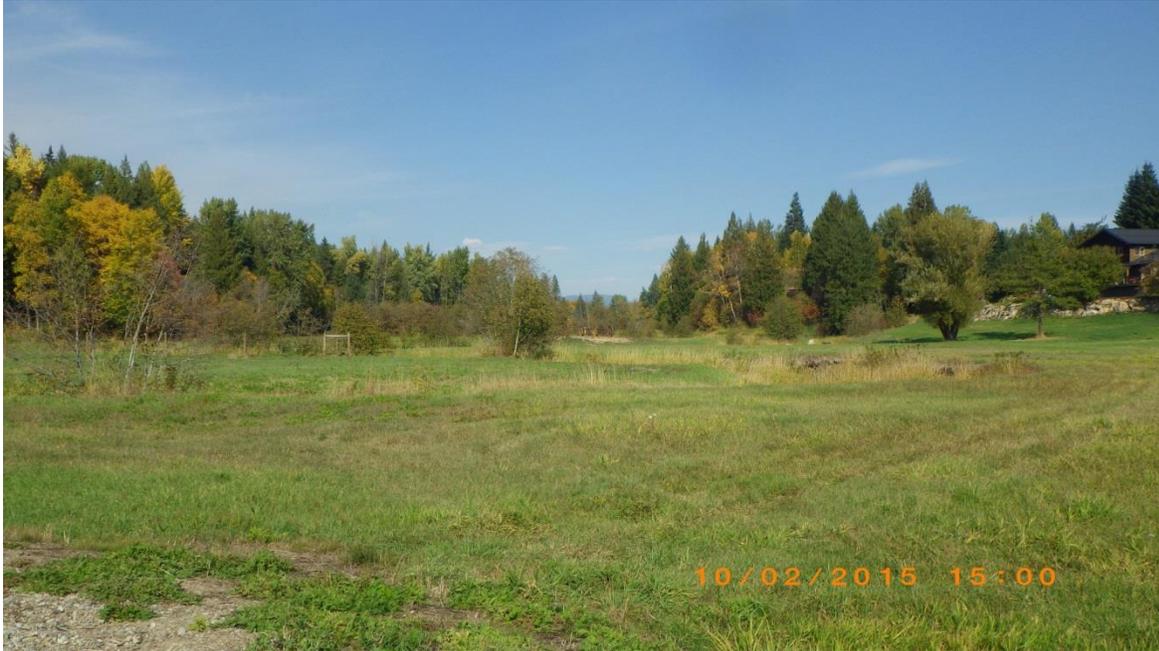
Within the study reach, lower Sand Creek was an agriculture pasture with no riparian exclusion fencing and decreasing riparian vegetation moving downstream in the study reach (Figure 126). The lack of large woody shrubs resulted in low woody debris recruitment potential and a low number of LWD. There were no log jams in the study reach.

Figure 126. Lower Sand Creek, downstream end of the study reach.

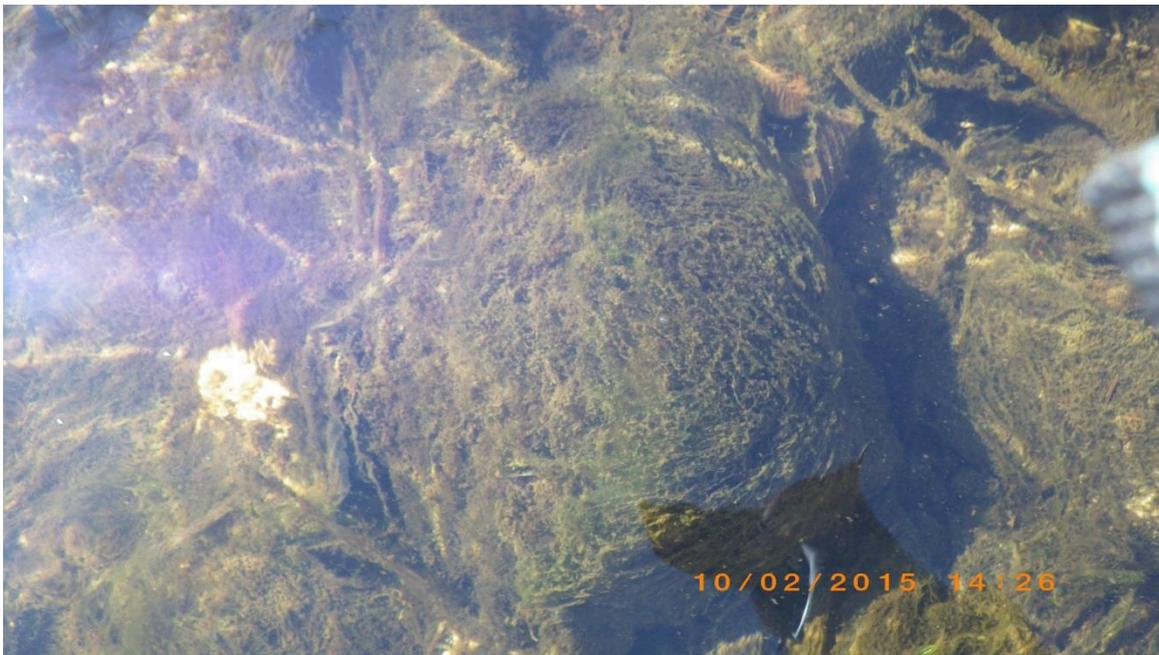
The channel substrate was primarily sand and very fine pebbles, typical of a valley meadow stream. The substrate was covered in about 1/8-inch of periphyton, perhaps indicating nutrient impairment (Figure 127).

Figure 127. Excessive periphyton on substrate in Sand Creek.

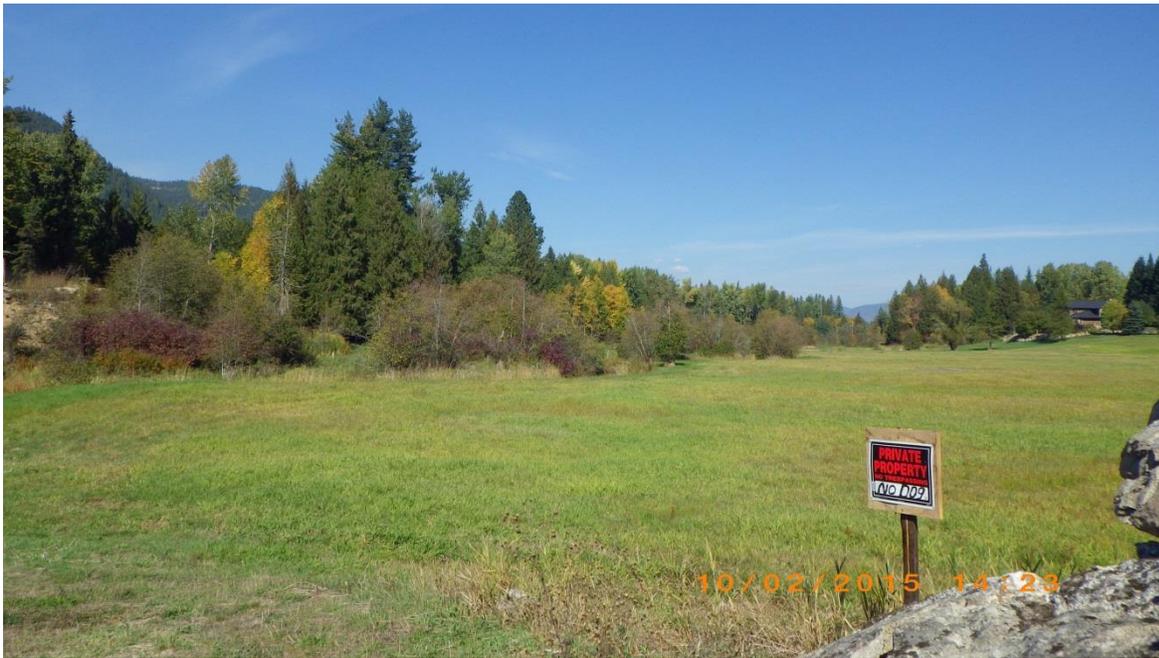
Lower Sand Creek had a stable meander pattern with a wide floodplain (Figure 128). However, it was evident that the channel had been historically channelized. The channel was somewhat widened and entrenched, but the stream still had access to its floodplain. The large parcel size on the creek provided low density of structures on the stream, allowing it lateral movement within the floodplain.

Figure 128. Sand Creek at the upstream end of the study reach.
