Pend Oreille Lake and River Tributaries

TMDL Five-Year Review

**State of Idaho
Department of Environmental Quality
April 2017**

**Prepared by
Coeur d'Alene Regional Office
Department of Environmental Quality
2110 Ironwood Parkway
Coeur d'Alene, ID 83801**

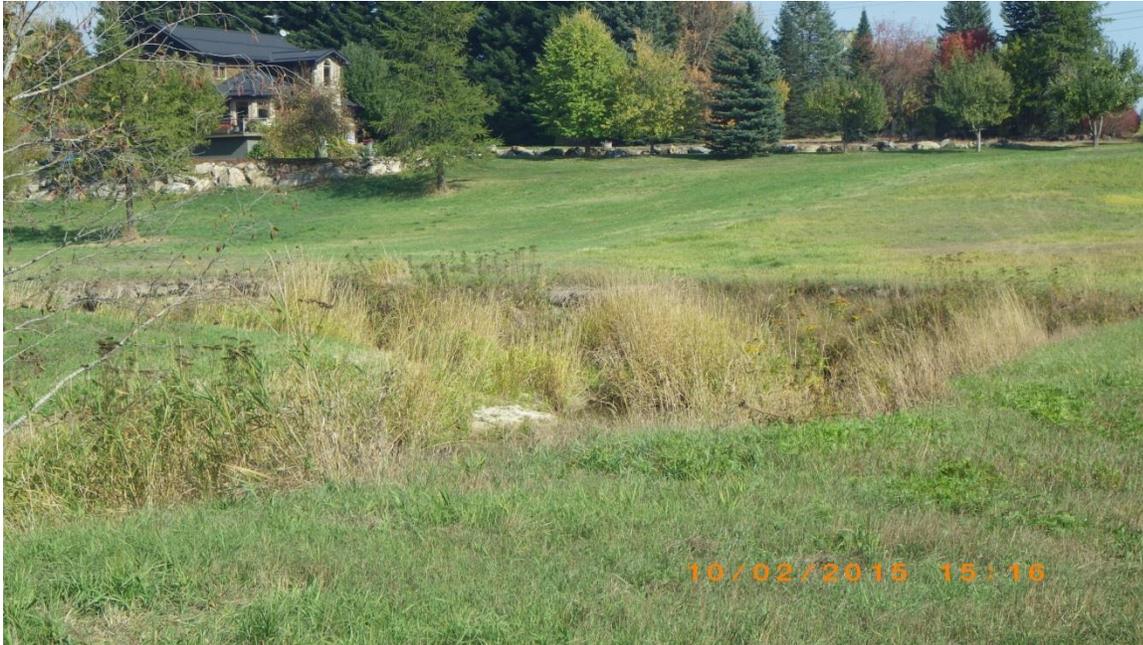
Streambank erosion was evident in the study reach, ranging from 30–60%. Most of the streambank erosion was in the downstream end of the study reach where riparian vegetation was less. Bank canopy decreased moving downstream in the study reach where it was less than 50%. Undercut banks were abundant and were the primary cover for fish; however, a number of the undercut banks were unstable and at risk of slumping into the stream. The streambanks, however, appeared to be recovering, perhaps due to a lack of livestock pressure on the banks (Figure 129).

Figure 129. Vertical banks on the mend in Sand Creek.

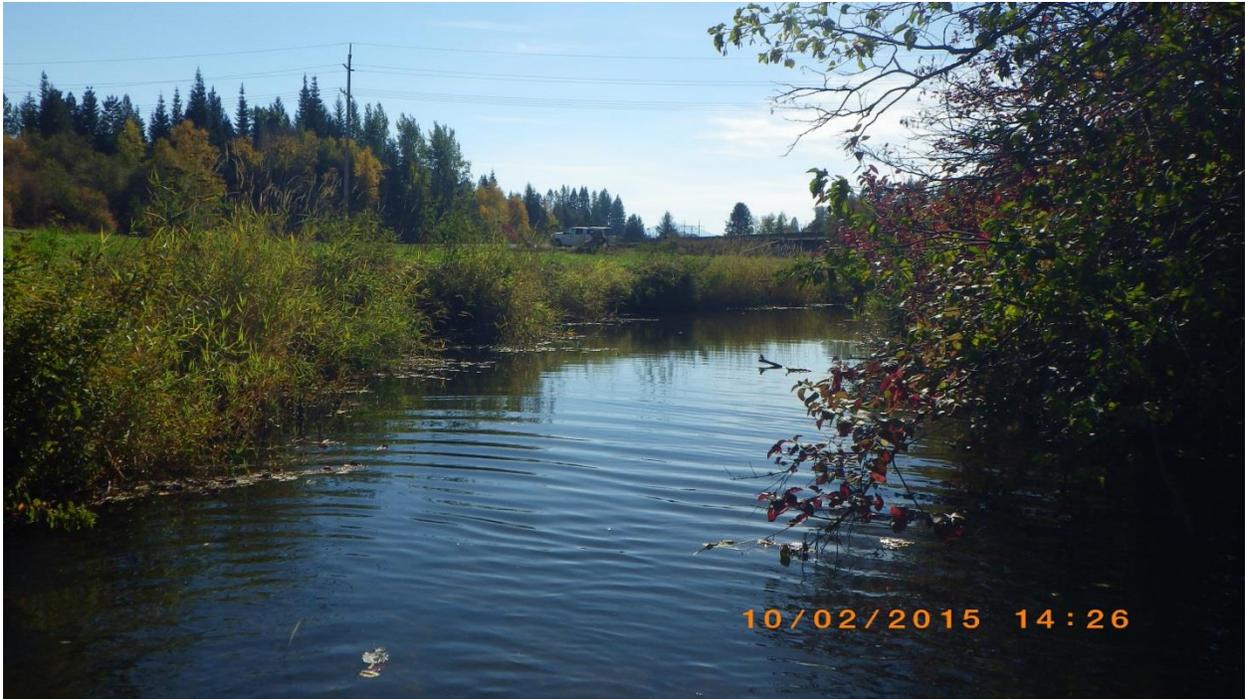
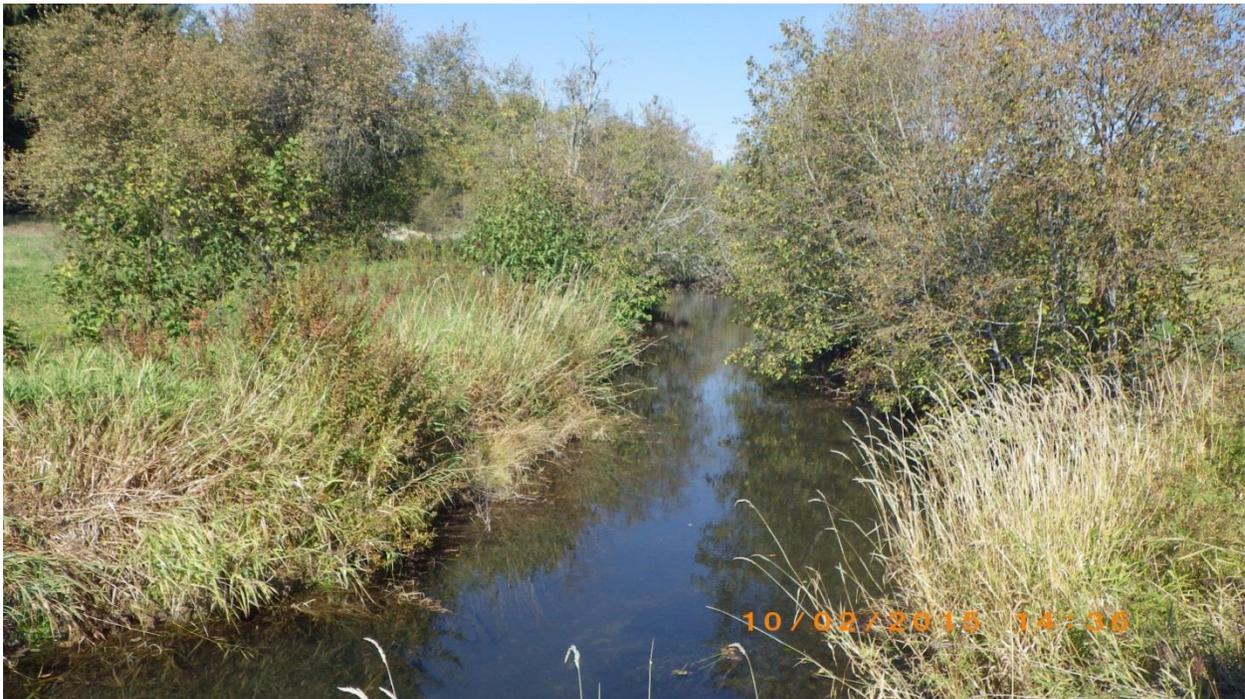
The riparian area of lower Sand Creek consisted primarily of willow, alder, grasses, and sedges (Figure 130, Figure 131). The riparian buffer width was less than 50 feet in the entire study reach due to the pasture. The canopy was in better condition in the upstream end of the study reach, but it was severely reduced in the downstream end. Near one of the streambanks, a neighbor had brought in fill material for a parking space. The material was less than 50 feet from the stream channel (Figure 132), presenting a risk of erosion with runoff from this material and sedimentation into the stream channel.

Figure 130. Riparian area in lower Sand Creek.

Figure 131. Riparian area in lower Sand Creek at the upper end of the study reach.

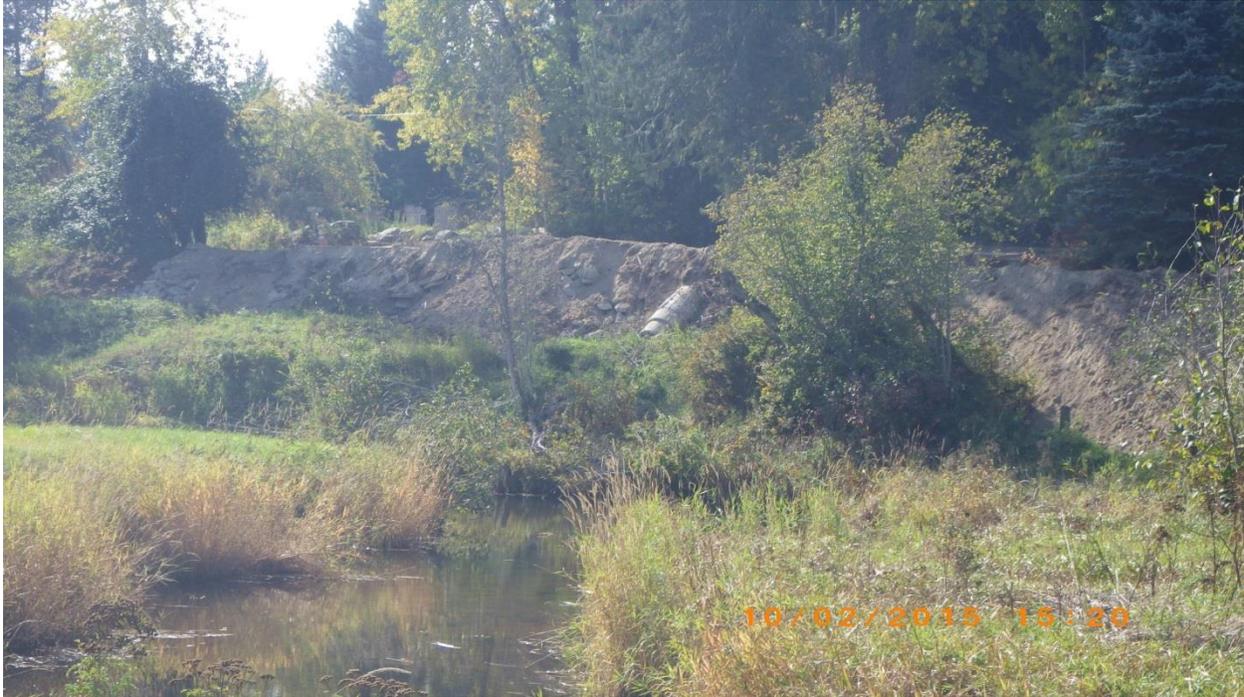
Figure 132. Earth-moving activity on lower Sand Creek.

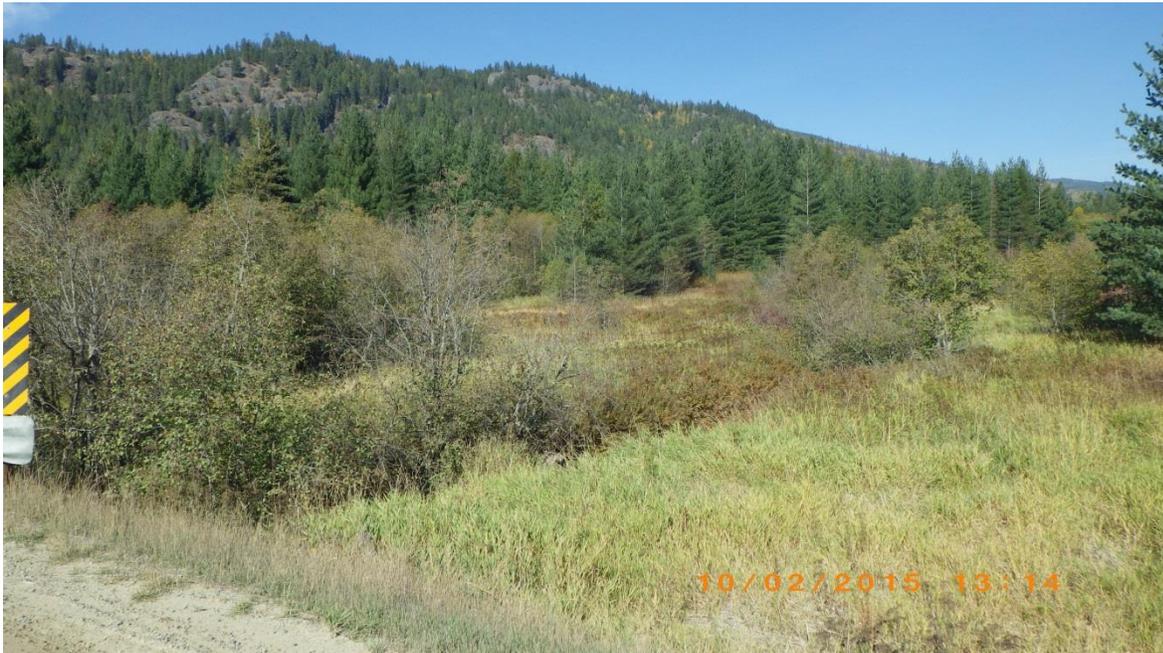
Within the study reach, upper Sand Creek was an agriculture pasture with no riparian exclusion fencing (Figure 133). LWD was present in the study reach with a low number of log jams (less than 3 per mile). The lack of large woody shrubs resulted in low woody debris recruitment potential.

Figure 133. Upper Sand Creek, upstream end of the study reach.

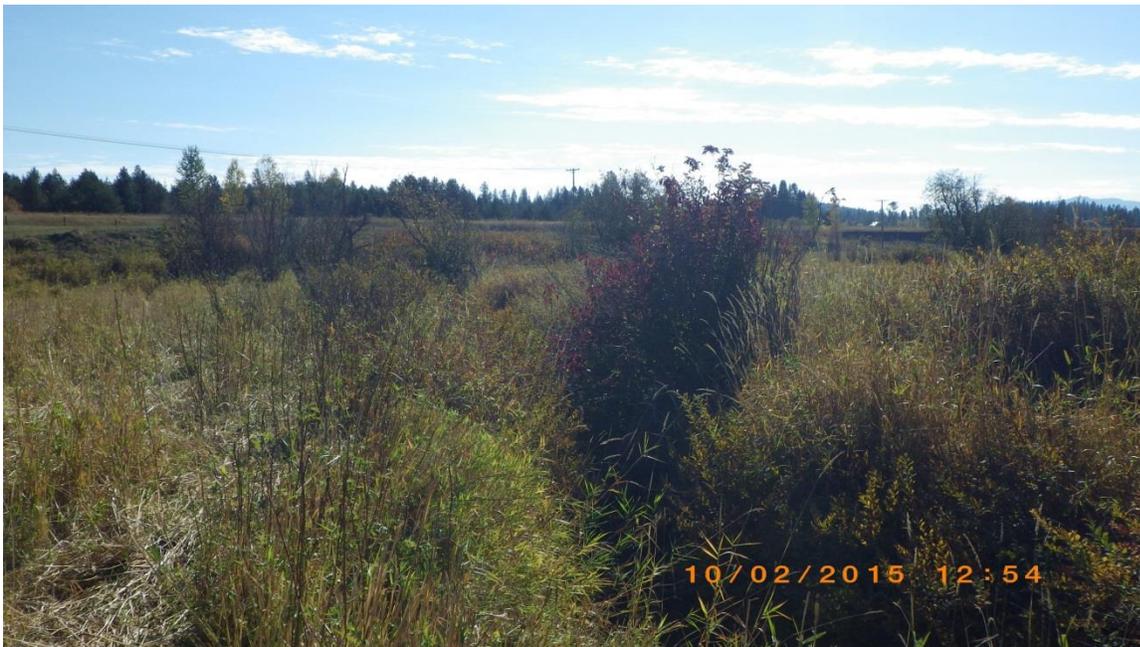
In the study reach, upper Sand Creek had a stable meander pattern with a wide floodplain (Figure 134). However, it was evident that the channel had been historically channelized. The channel had a good width-to-depth ratio, but it was entrenched (Figure 135). The stream had marginal access to its floodplain. The large parcel size on the creek provided low density of structures on the stream, allowing potential lateral movement within the floodplain.

Figure 134. Meandering channel morphology in upper Sand Creek.

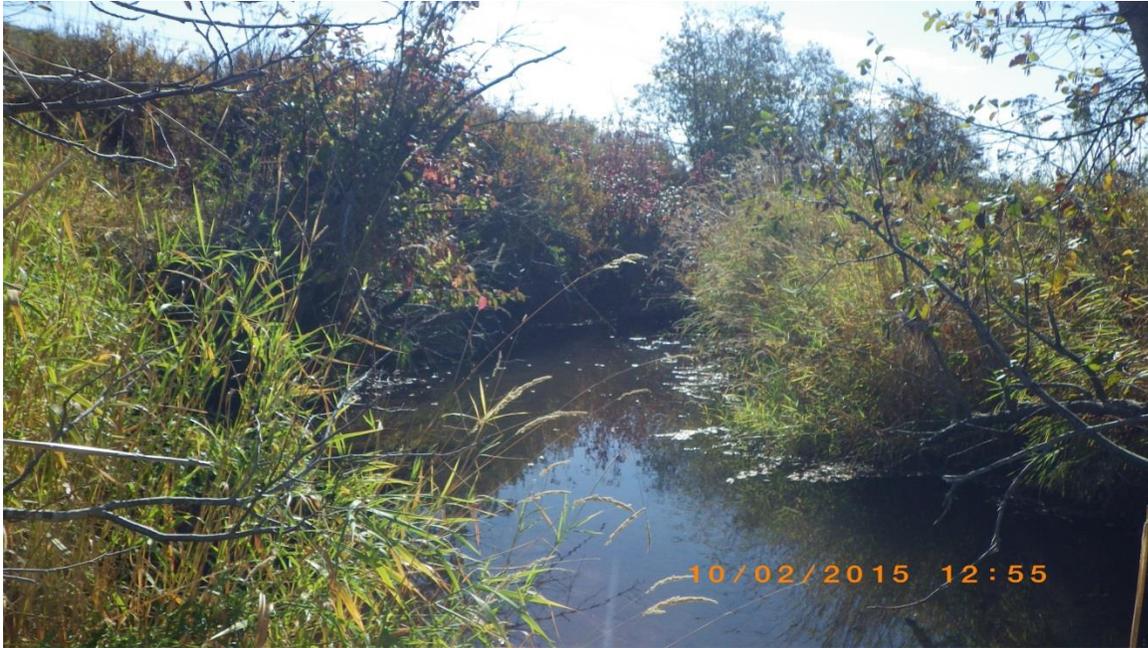
Figure 135. Entrenched nature of upper Sand Creek.

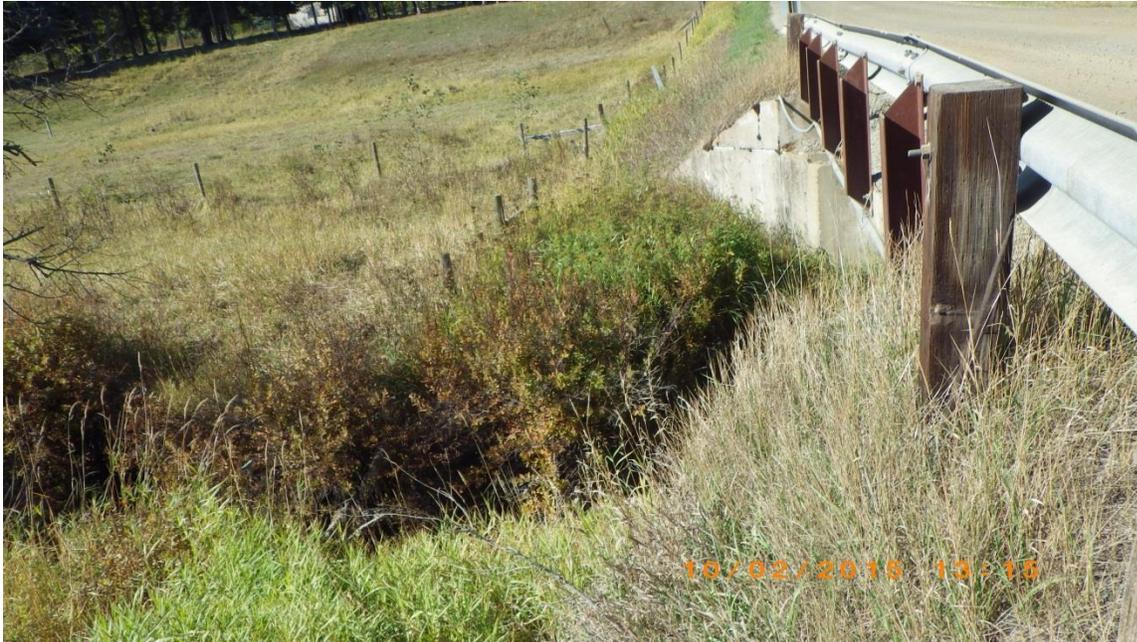
In 2015, DEQ evaluated two stream crossings on Sand Creek. Both crossings were bridges, the first on Selle Road (Figure 137). The bridge was a county bridge made of pre-stressed concrete with a gravel surface. The crossing was in good condition with a low erosion severity. The other bridge was a county bridge on lower Sand Creek (Figure 138). The bridge was a concrete bridge with asphalt decking. It was in excellent condition with a low severity of erosion.

Figure 137. Road crossing on upper Sand Creek.

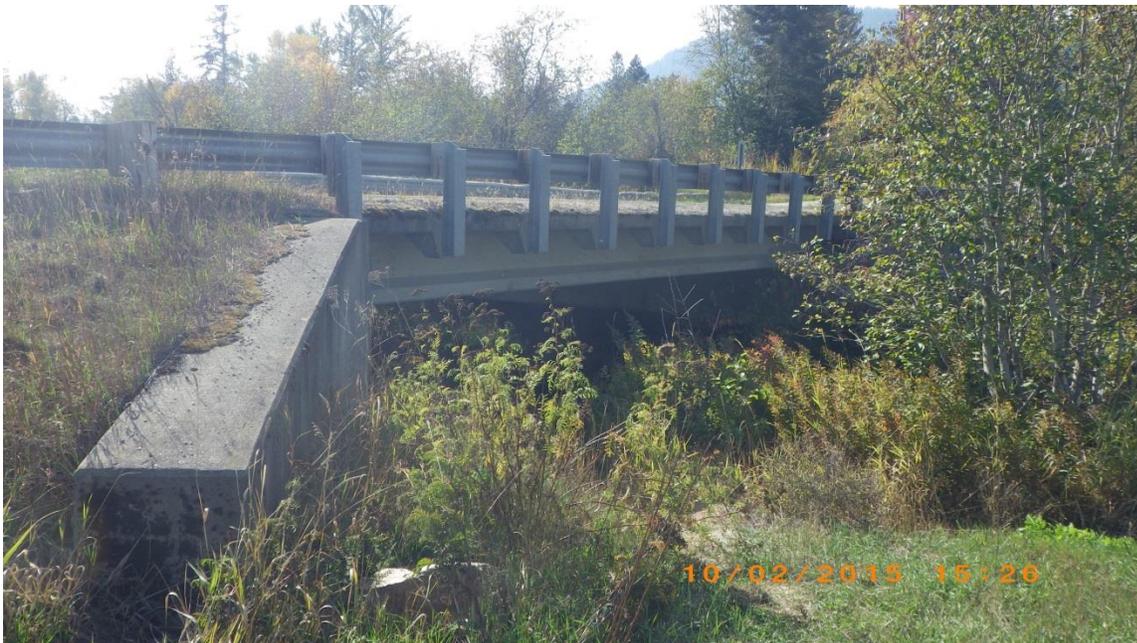
Figure 138. Road crossing on lower Sand Creek.

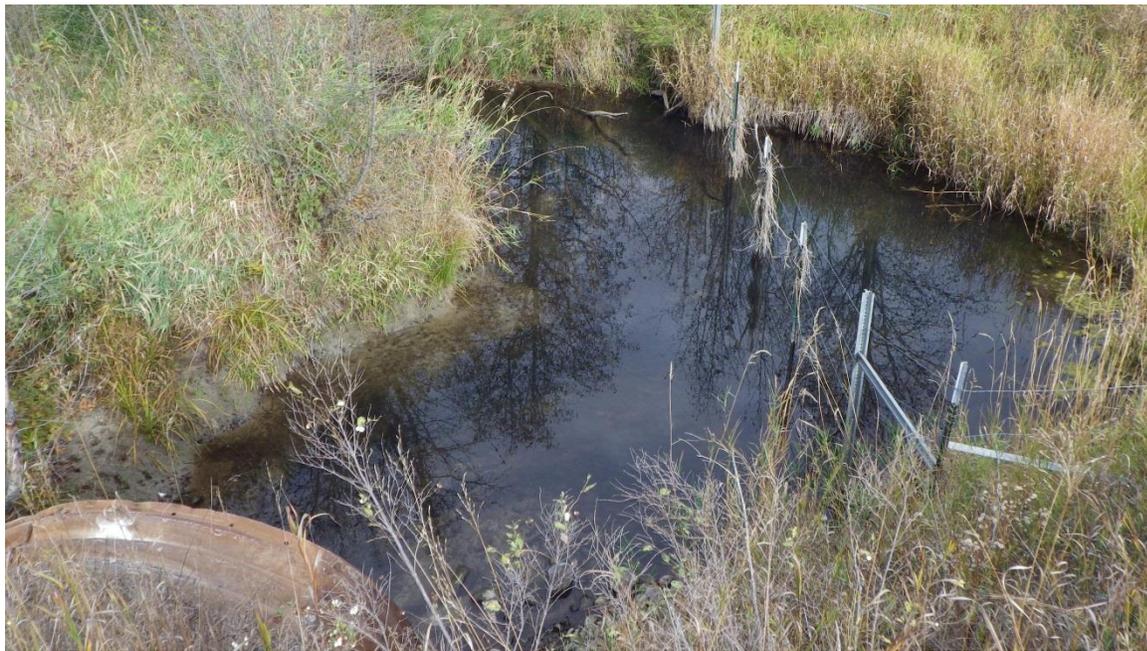
In 2015, DEQ conducted a survey of four road crossings in the Sand Creek watershed (Table 53). All of the crossings were on Sand Creek. Three of the four road crossings were in fair condition, primarily because of excessive erosion at the inlet and/or outlet of the crossing (Figure 143–Figure 145). One culvert (culvert 2) had road gravel eroding into the creek at the crossing (Figure 146).

Figure 143. Eroding outlet of culvert 1 on Sand Creek, tributary to Pack River.

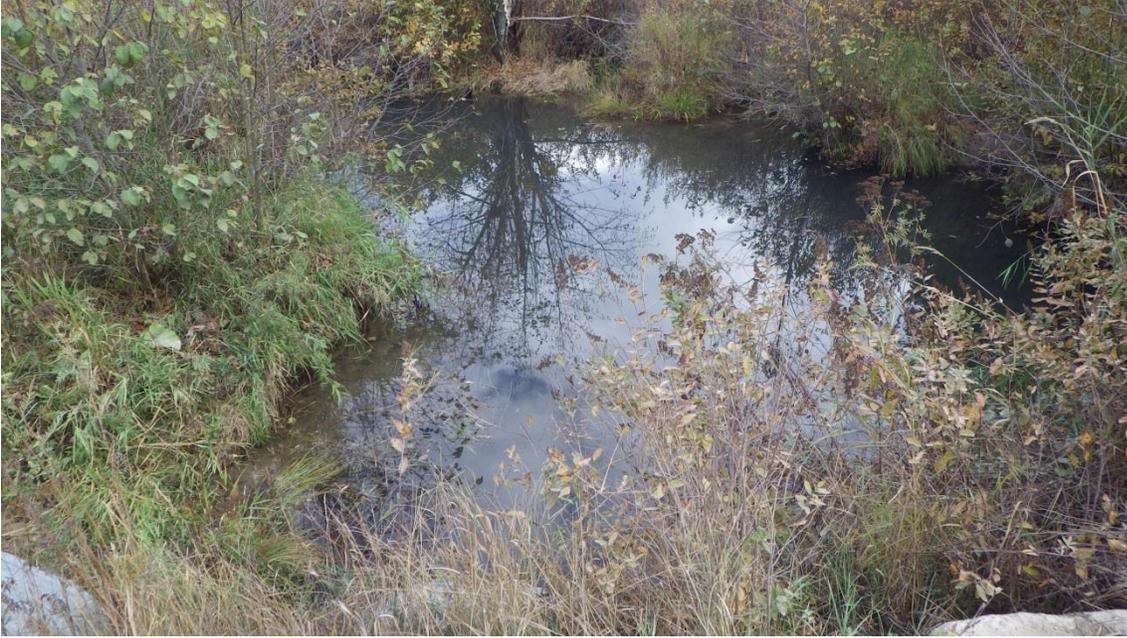
Figure 144. Eroding outlet of culvert 3 on Sand Creek, tributary to Pack River.

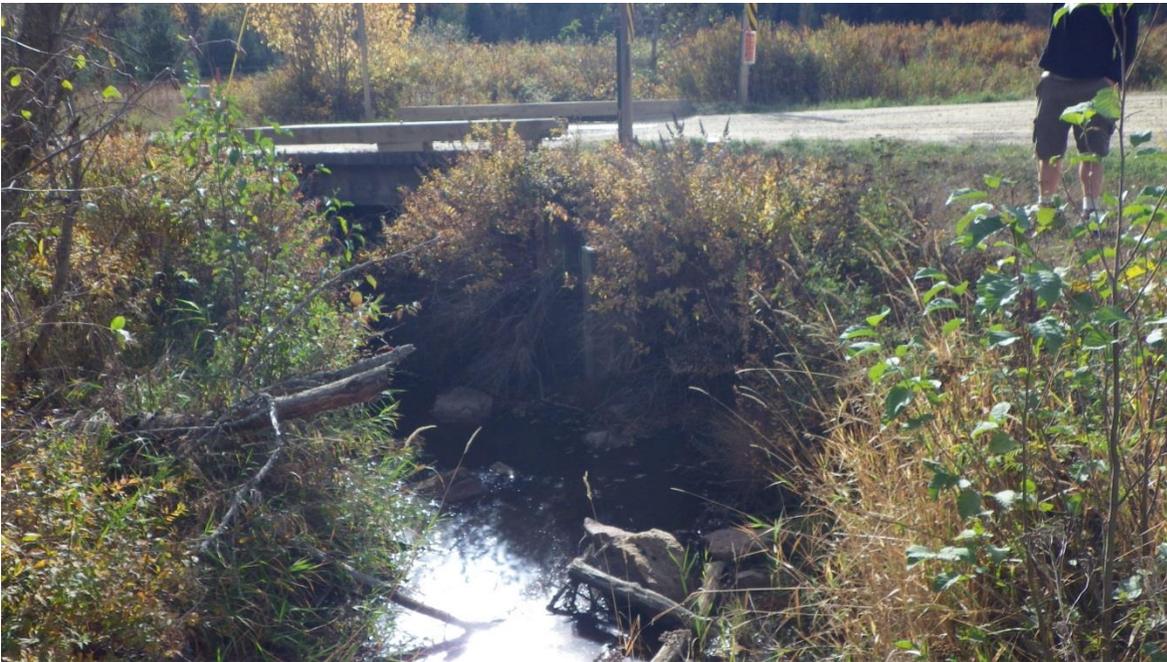
Figure 145. Eroding inlet of bridge on Sand Creek, tributary to Pack River.

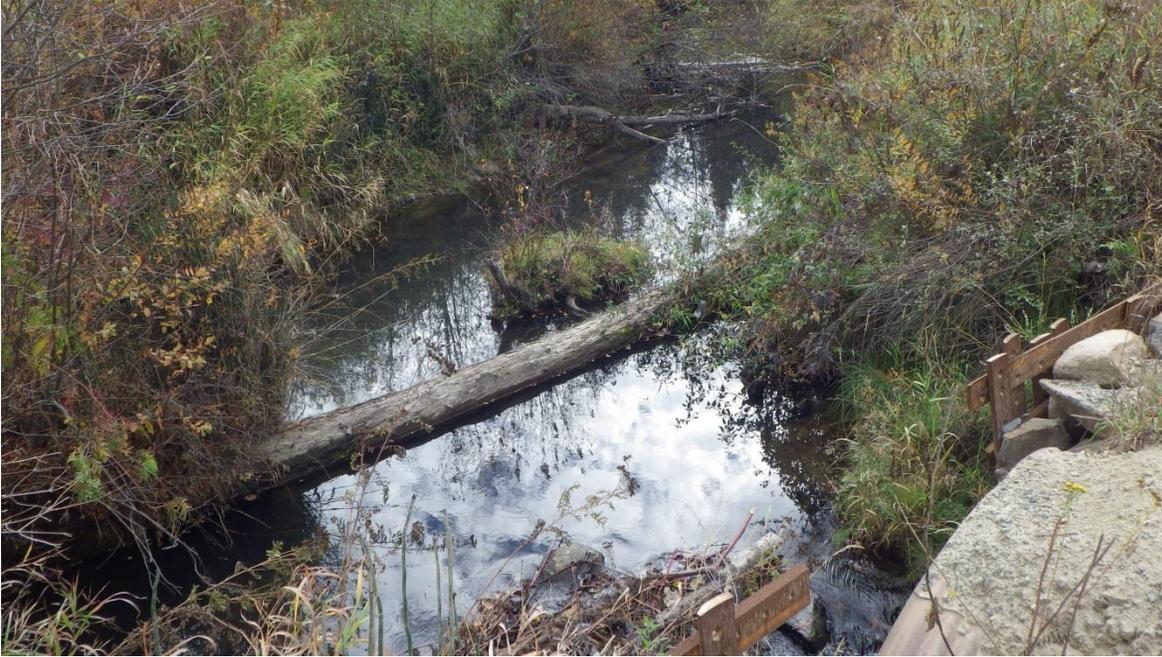
Figure 146. Culvert inlet on Sand Creek.

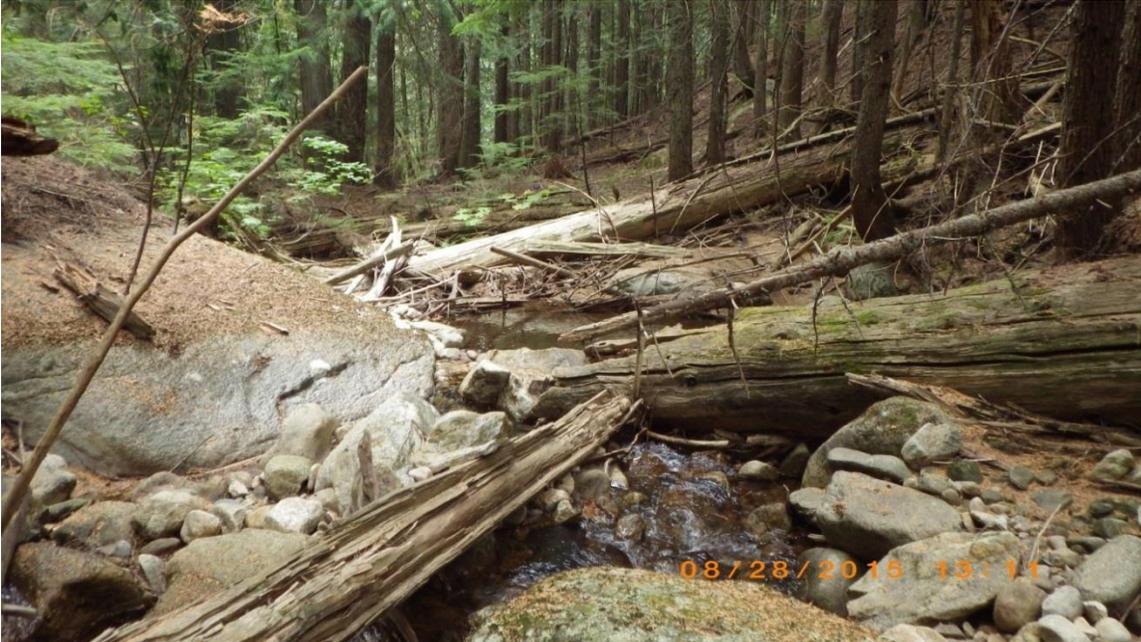
The presence of LWD and woody debris jams in Schweitzer Creek were at reference conditions. LWD greater than 2 feet in diameter was abundant. Log jams were also abundant—some of them channel-spanning log jams (Figure 150). Recruitment potential of LWD was excellent.

Figure 150. Abundant large woody debris in Schweitzer Creek provides cover for aquatic life.

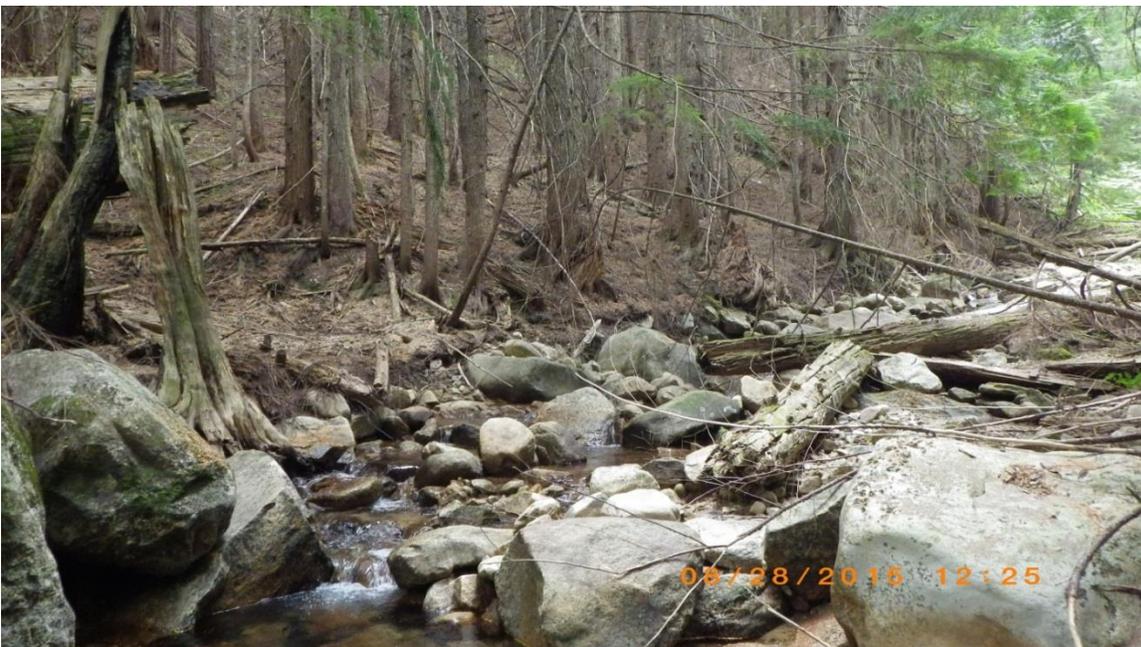
Bed substrate in Schweitzer Creek was cobble-boulders in much of the study reach (Figure 151). The sediment was stable with some evidence of mobility and sorting. Substrate embeddedness was slight. The substrate was free of dense algae growth.

Figure 151. Cobble-dominated substrate in Schweitzer Creek.

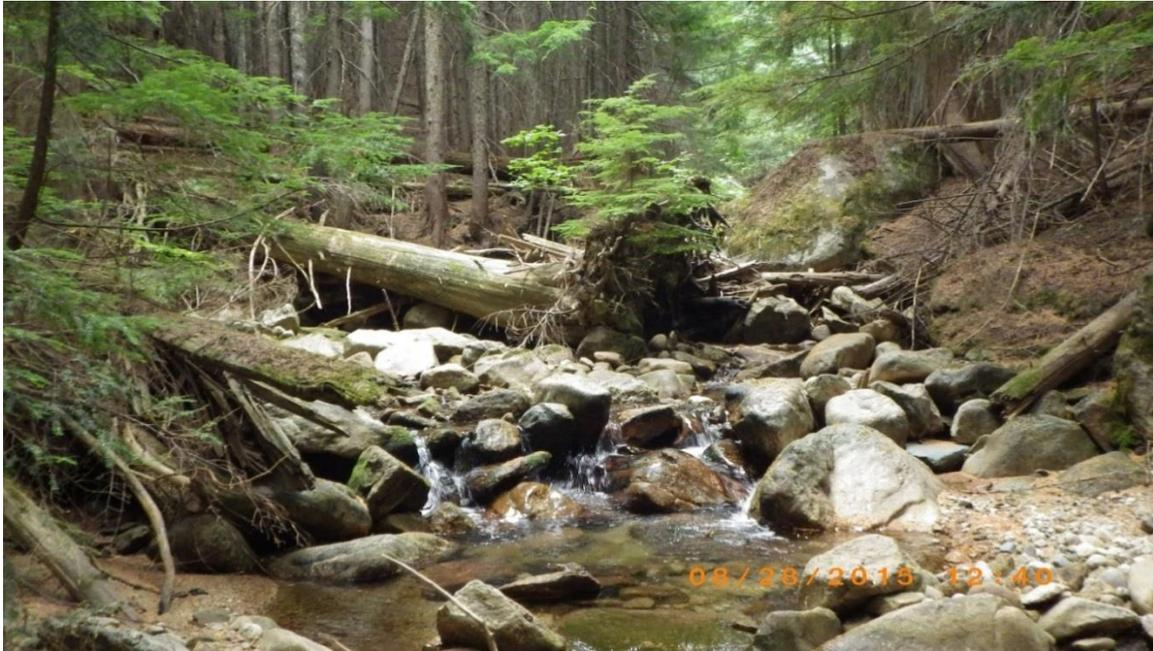
Pools are relatively abundant with good cover, providing refuge during all flow regimes (Figure 152). The pools were formed from abundant wood and the step-pool morphology, which was moderately well-formed and stable.

Figure 152. Pools in Schweitzer Creek provide relatively good refuge even in low flow years.

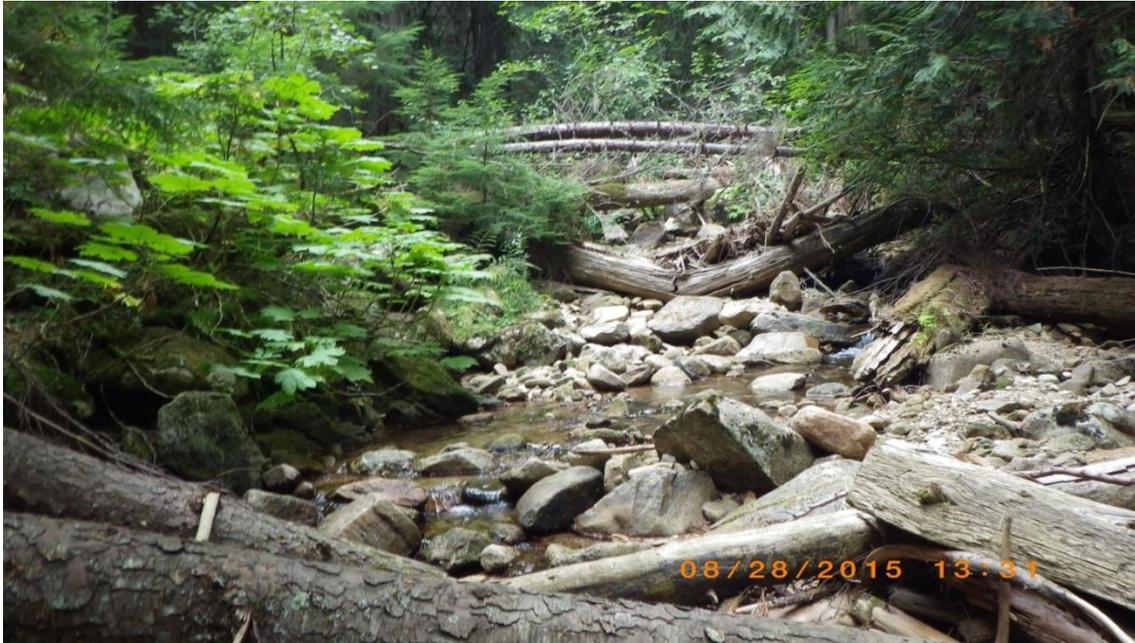
The riparian area was composed of cedar and hemlock overstory with ferns and devil's club understory (Figure 153). The buffer width was between 150 and 200 feet with maximum channel canopy.

Figure 153. Dense riparian buffer at Schweitzer Creek.

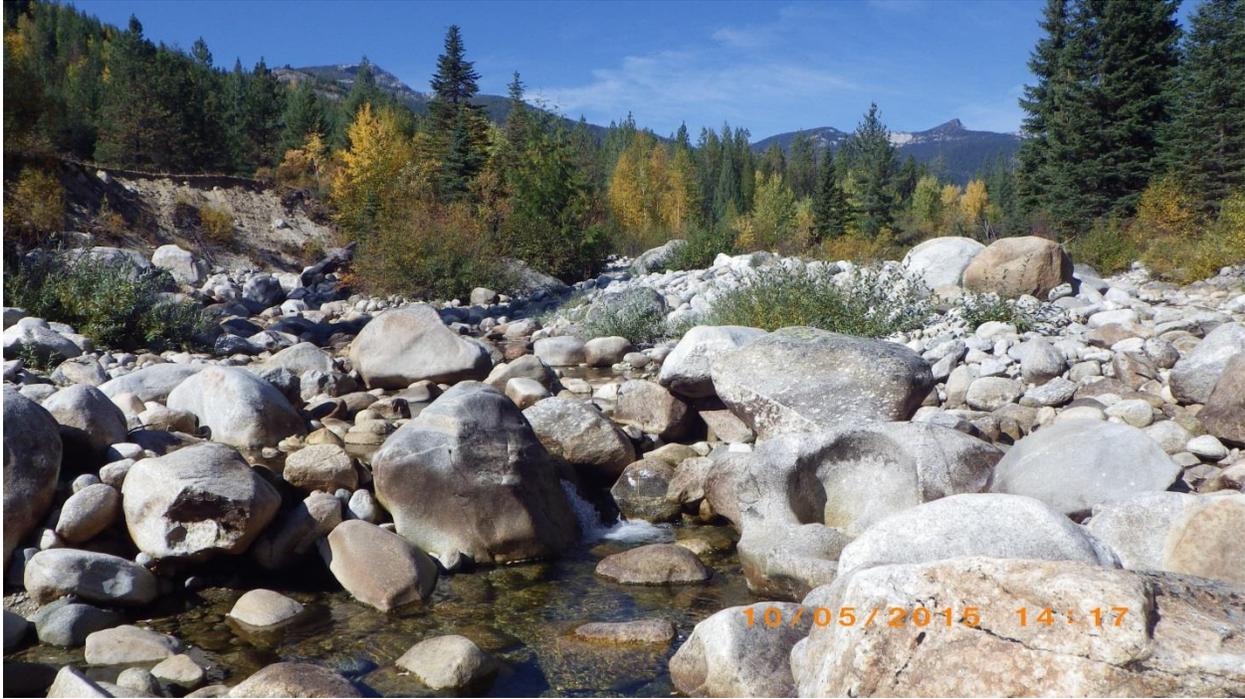
Bed substrate in upper Pack River 1 was small cobble to large cobble (Figure 157). The substrate had some evidence of sediment mobility and lack of sorting. In this reach, the substrate was 40–75% embedded in the riffles and 60–80% embedded in the pools. The substrate had patches of dense algae growth (Figure 158).

Figure 157. Large cobble-boulder substrate on upper Pack River 1.

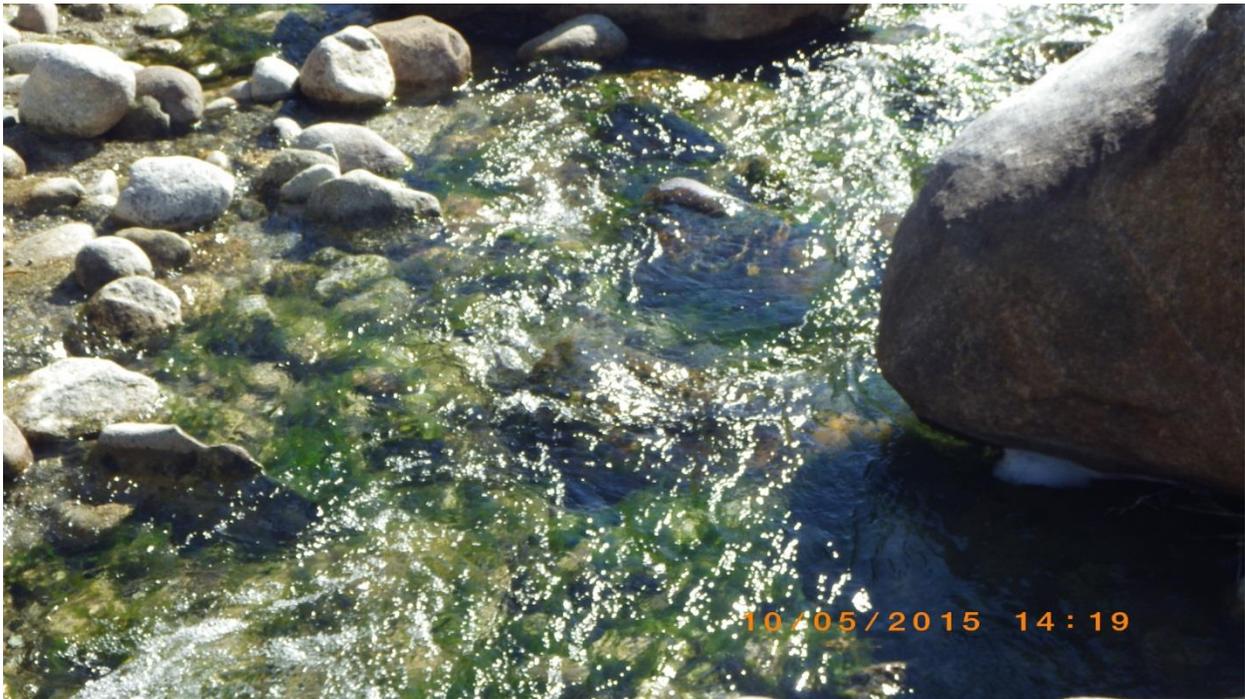
Figure 158. Algae growth on substrate in upper Pack River 1.

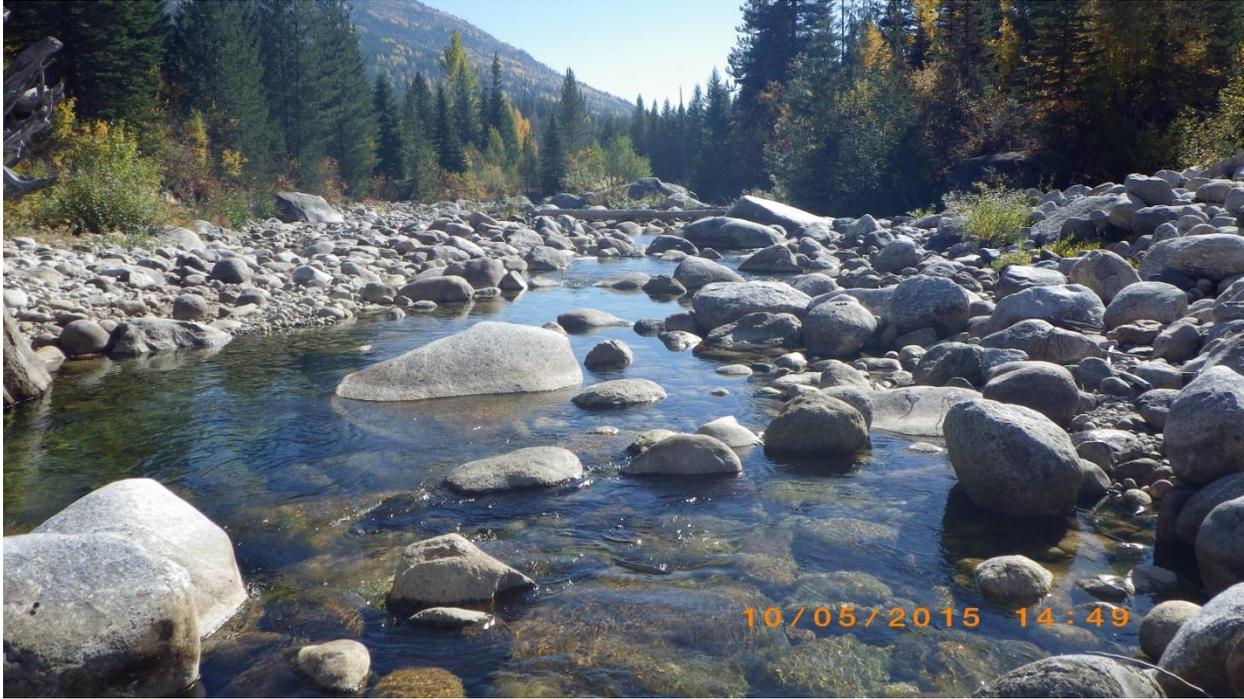
Upper Pack River 1 had an abundance of pools with good cover providing refuge during all flow regimes (Figure 159), showing a minor departure from reference conditions. The pools were formed from boulders. Pool morphology diversity was low due to a lack of LWD. The study

Figure 159. Abundant pools in the upper Pack River.

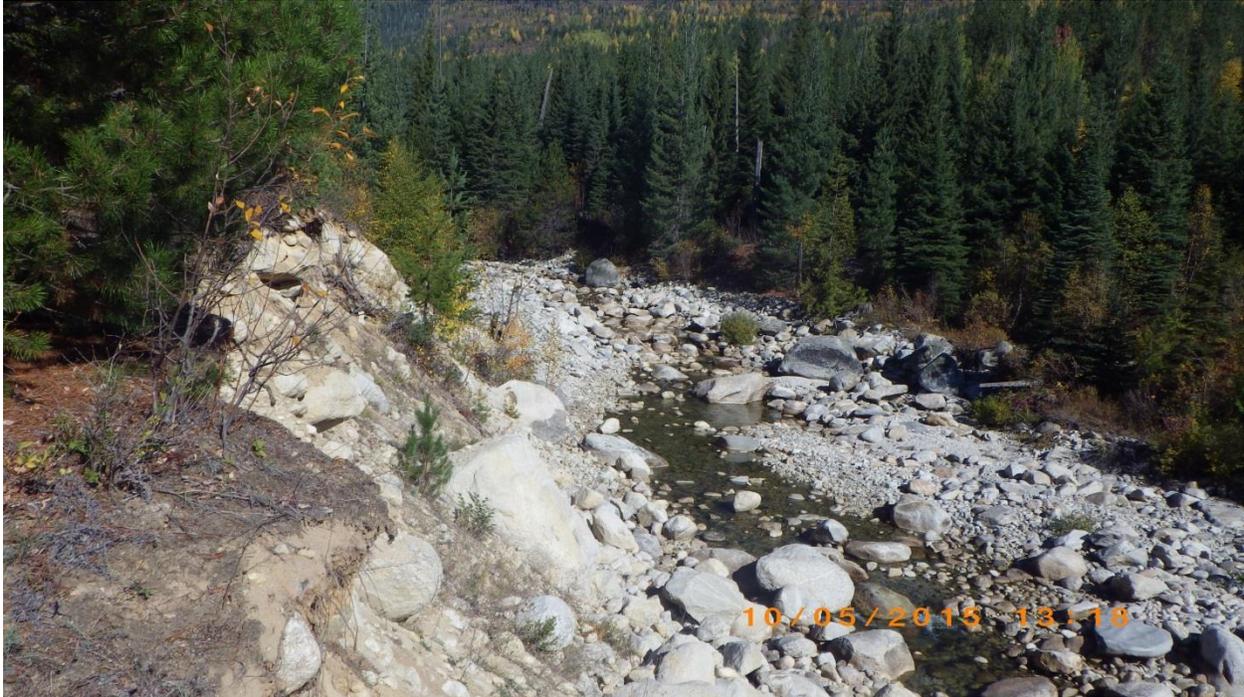
Upper Pack River 1 was considerably over-widened and entrenched, with steep, erosive banks. Major evidence of channel alteration from fire, most likely the Sundance Fire, was seen throughout the reach (Figure 160).

Figure 160. Steep, eroding bank on upper Pack River 1.

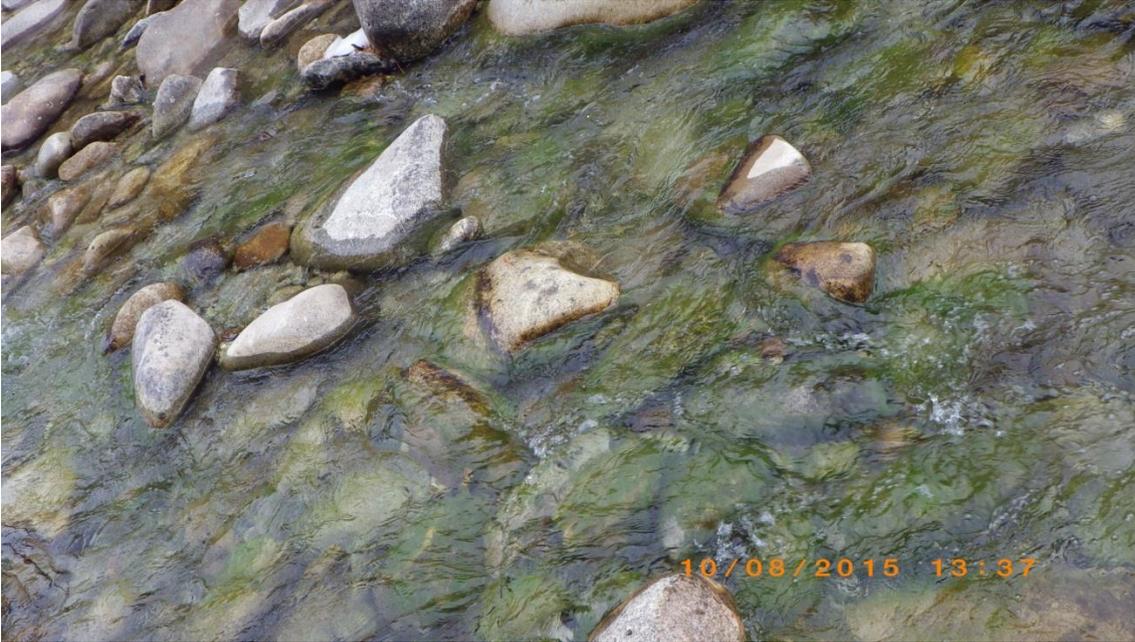
Bed substrate in upper Pack River 2 was large cobble. The substrate had some evidence of sediment mobility and lack of sorting. In this reach, the substrate was somewhat (20–40%) embedded in the riffles and somewhat (40–60%) embedded in the pools. The substrate had patches of dense algae growth (Figure 161).

Figure 161. Algae growth on substrate—Pack River.

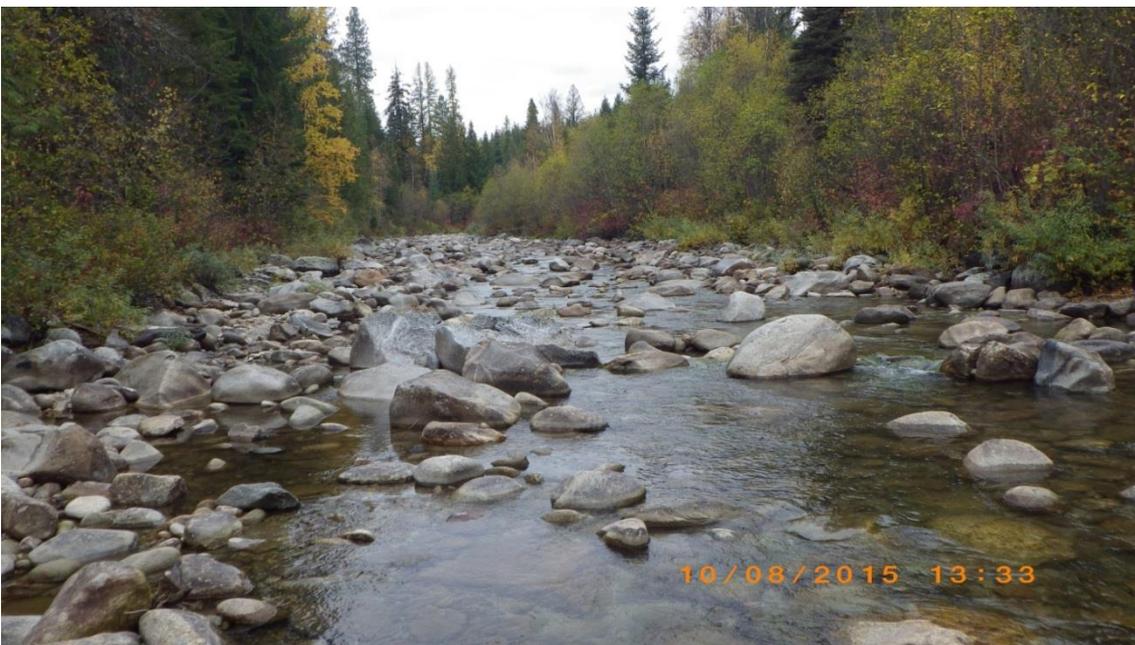
Given the extreme low-flow year, the wetted width of upper Pack River 2 was good, with an abundance of refuge during high and low flow (Figure 163). No flow alteration existed on upper Pack River 2.

Figure 163. Low flow in upper Pack River 2.

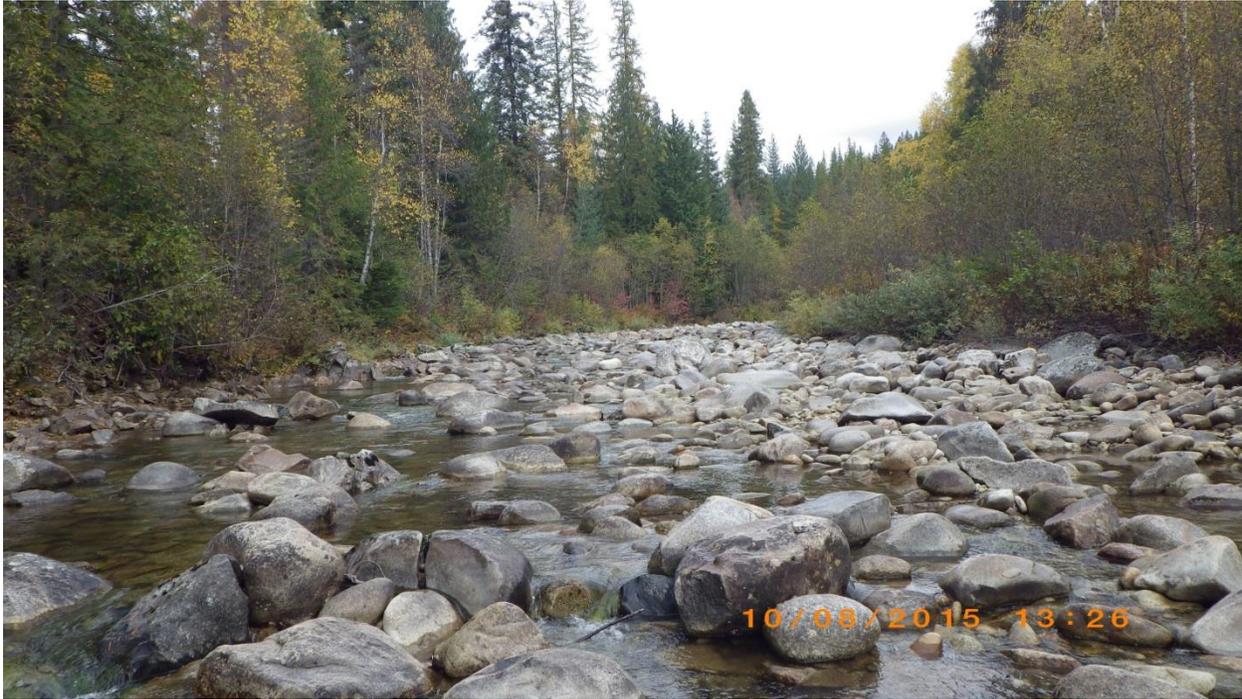
Streambank erosion was evident on entrenched, unvegetated banks. Non-entrenched banks were well vegetated with a diverse assemblage of plants creating good cover and bank stabilization (Figure 164). The bank canopy was good, providing cover near the banks. Undercut banks in the study reach were in abundance, with some unstable boundaries or reduced overhanging vegetation. Mass failures were also observed in the study reach.

Figure 164. Riparian area in upper Pack River 2.

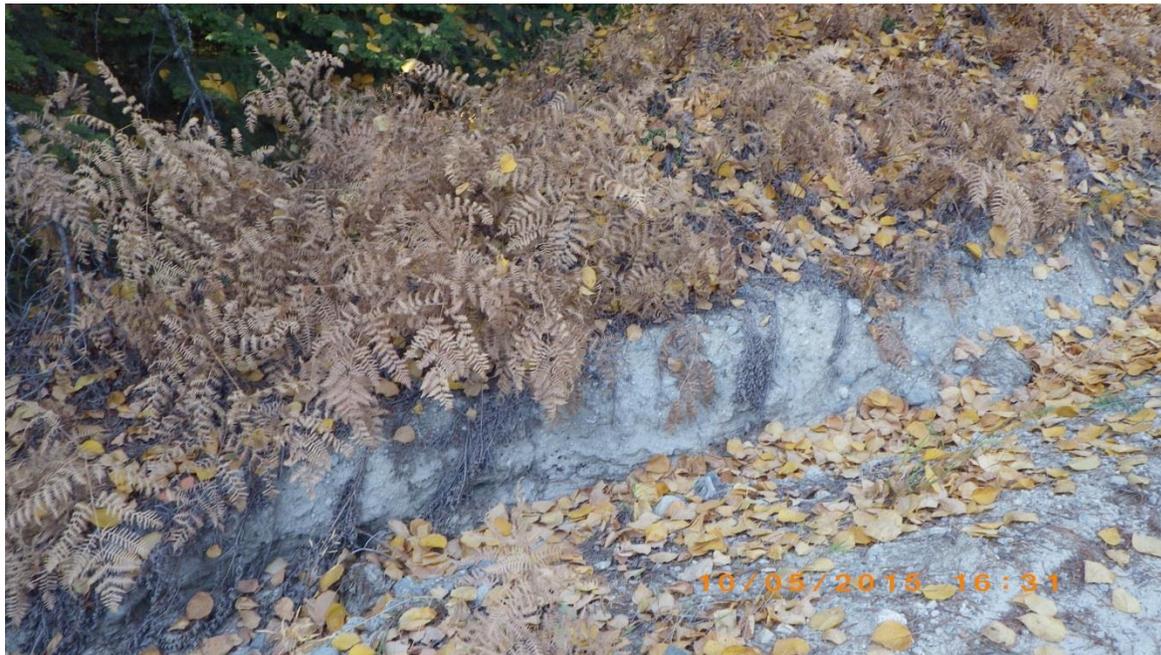
In 2015, DEQ conducted a survey of six road crossings along the Pack River Road (Table 62). Four of the six road crossings were in good condition, three with no/low erosion severity. Culvert 3 was in good condition; however, erosion severity was classified as medium due to the gully erosion from the road ditch to culvert 3 into the stream channel (Figure 165) and gully erosion near the outlet of the culvert 3 (Figure 166). Bridge 2 was in new condition; however, a mass failure of the hillslope occurred just upstream of the bridge (Figure 167). One bridge was in excellent condition. There was abundant sediment in the Pack River (Figure 168). In general, the Pack River Road was well-maintained with adequate relief of drainage off the road prism.

Figure 165. Gully erosion in road ditch draining into culvert 3, Pack River Road.

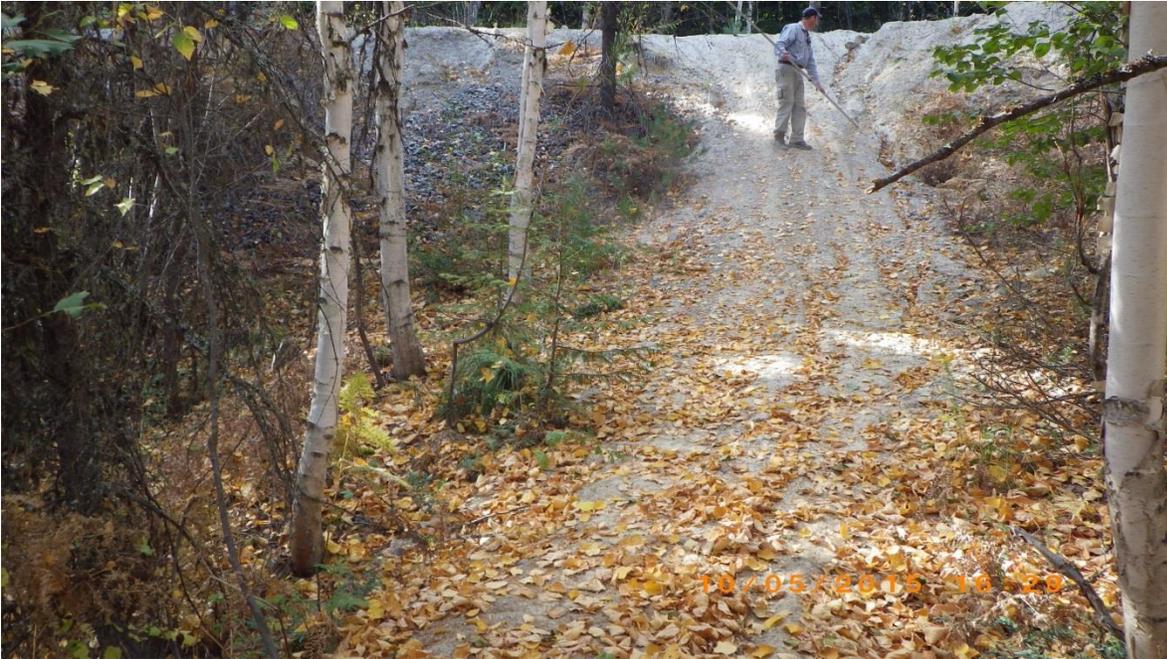
Figure 166. Gully erosion near outlet of culvert 3, Pack River Road.
