Pend Oreille Lake and River Tributaries

TMDL Five-Year Review

**State of Idaho
Department of Environmental Quality
April 2017**

**Prepared by
Coeur d'Alene Regional Office
Department of Environmental Quality
2110 Ironwood Parkway
Coeur d'Alene, ID 83801**

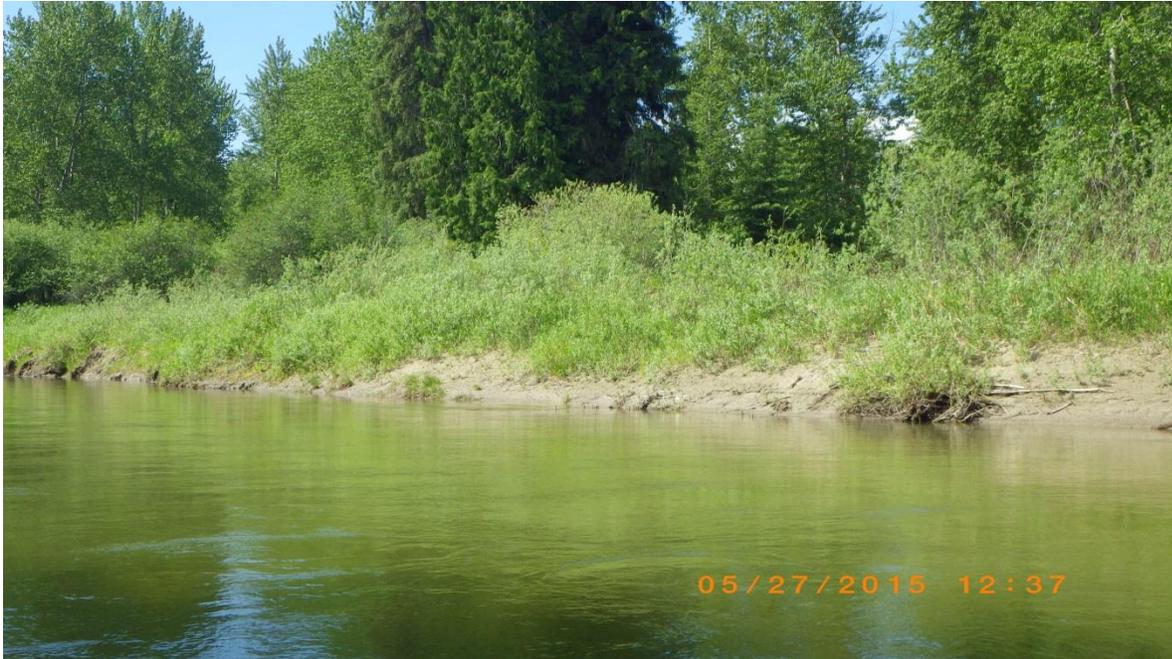
In May 2015, personnel from DEQ and the NRCS evaluated the lower Pack River by floating approximately 4.9 miles from the Colburn Bridge to the north of the intersection of Colburn Culver Rd. and Selle Rd. Overall, the channel was entrenched with excessively eroding banks and banks that were poorly vegetated with a lack of bank stability (Figure 169, Figure 170). The erosive process was through lateral migration of the channel and mass bank failure (Figure 171, Figure 172). The channel itself lacked the complexity in pool habitat and cover provided by large wood. Given this reach serves as a migratory passage habitat for salmonids, large wood projects to enhance pool habitat and refuge are needed.

Figure 170. Poorly stabilized riverbank on the lower Pack River.

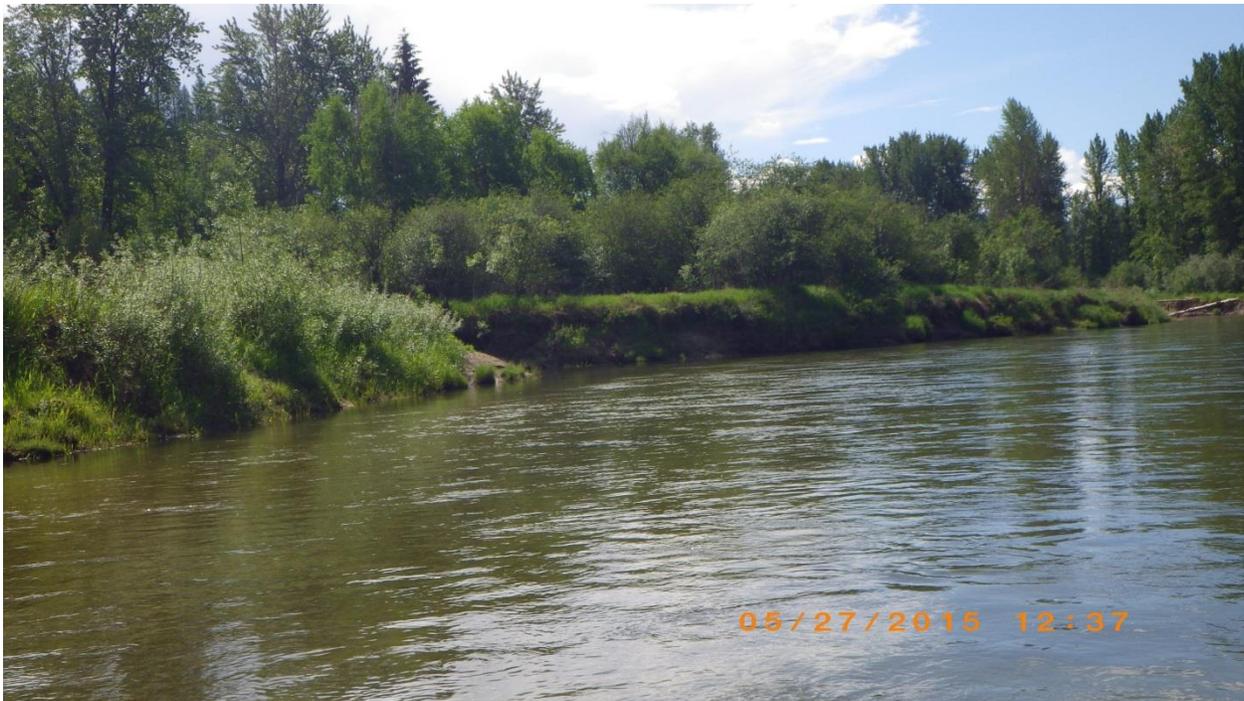
Figure 171. Slumping riverbank on lower Pack River.

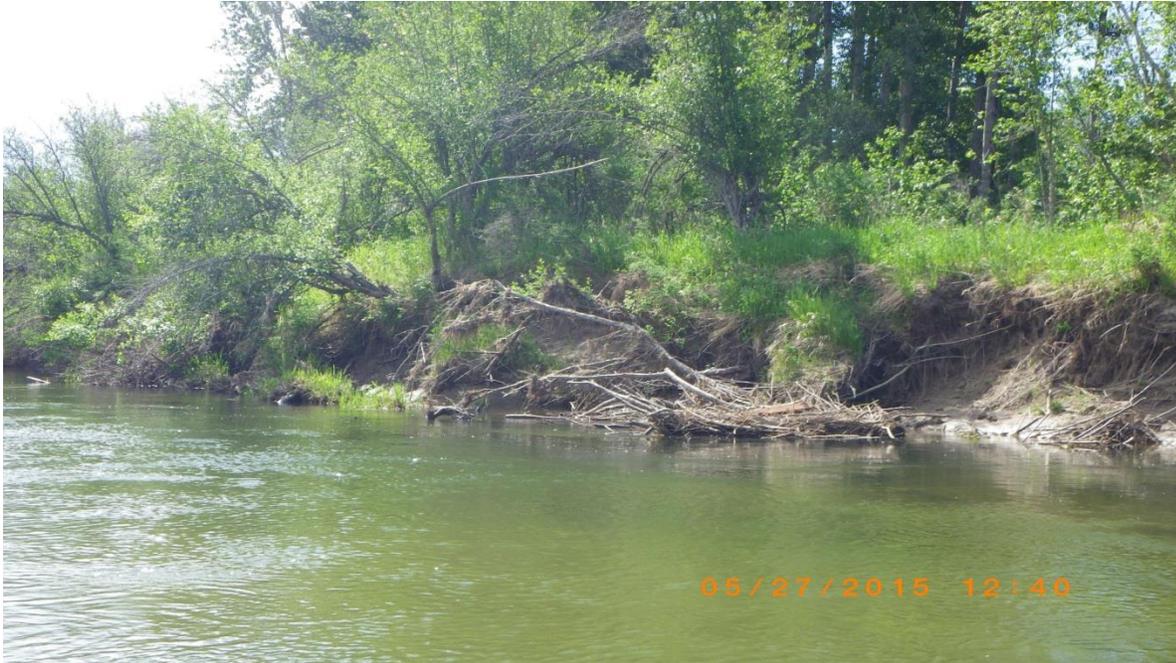
Figure 172. Eroding riverbanks on the Pack River.

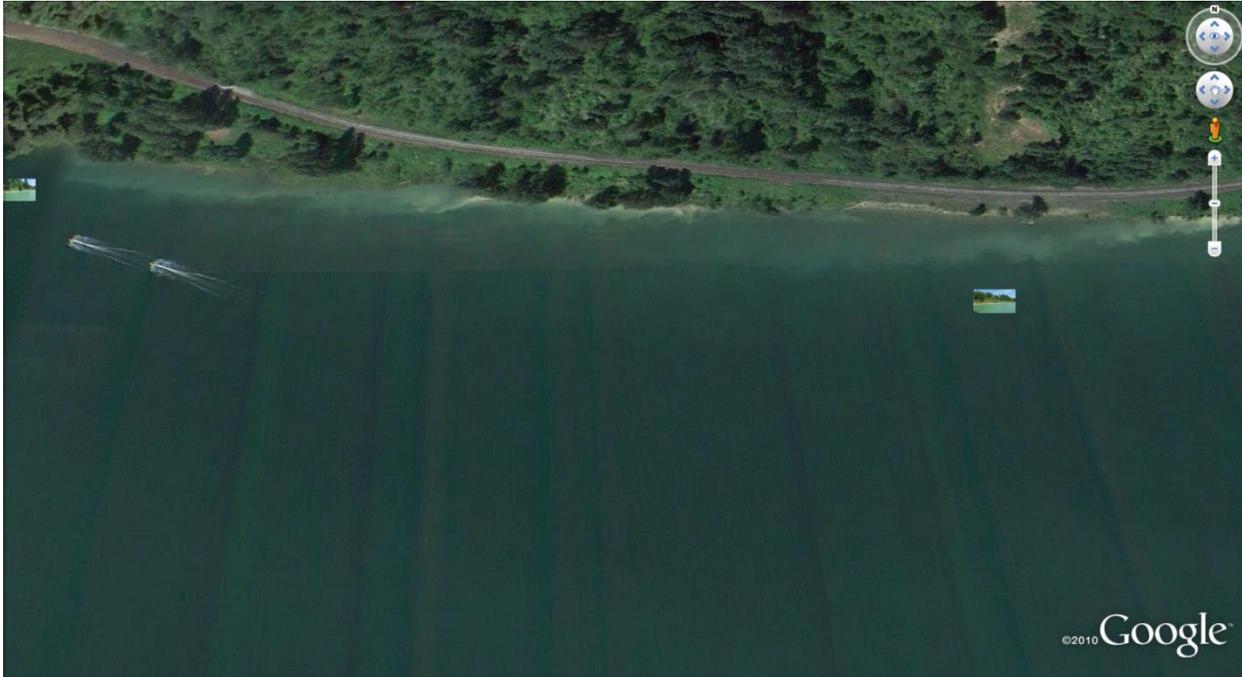
The bank erosion inventory showed localized erosion problems with evidence of increased turbidity following boat wake action. The localized turbidity problem is not representative of the AU (Figure 182).

Figure 182. Turbidity effects of boat wakes on Pend Oreille River.

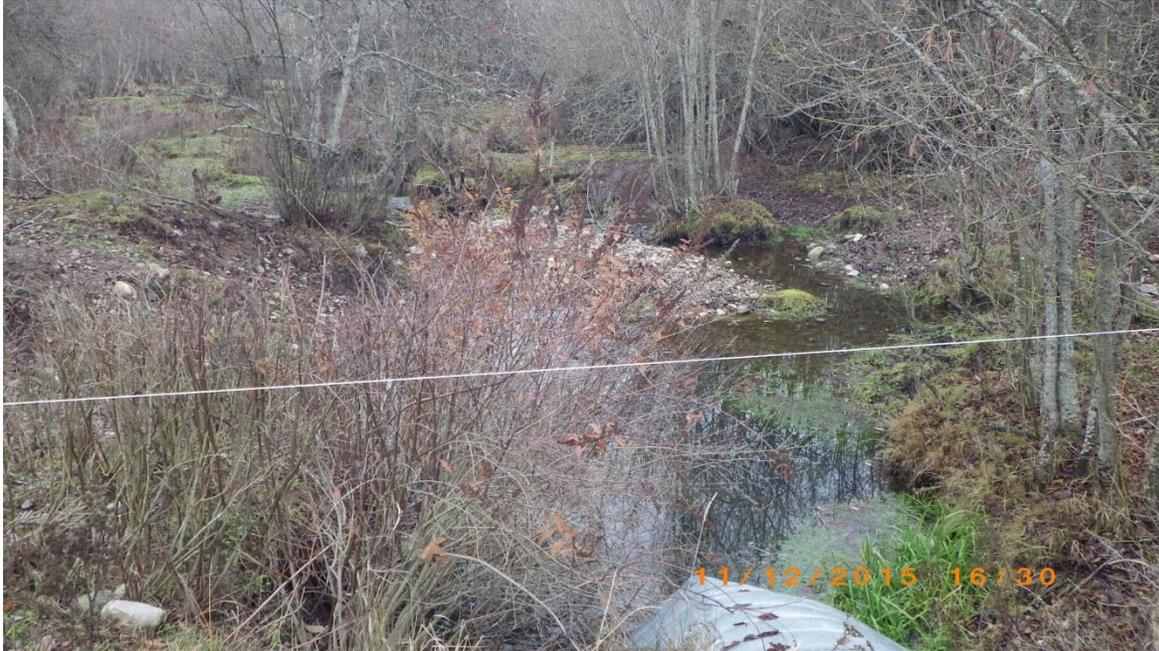
In 2015, DEQ conducted a survey of 12 stream crossing conditions within the Cocolalla Lake watershed (Table 67). Eight of the crossings had erosion issues. One crossing over Westmond Creek had severe erosion at the outlet of the culvert, which was exacerbated by cattle grazing (Figure 196). Three crossings had road fill erosion into the creek at the crossing (Figure 197 and Figure 198). A bridge at the outlet of Cocolalla Lake was undersized with two overflow culverts that were rusted out (Figure 199 and Figure 200).

Figure 196. Erosion at outlet of upper Cocolalla Creek crossing.

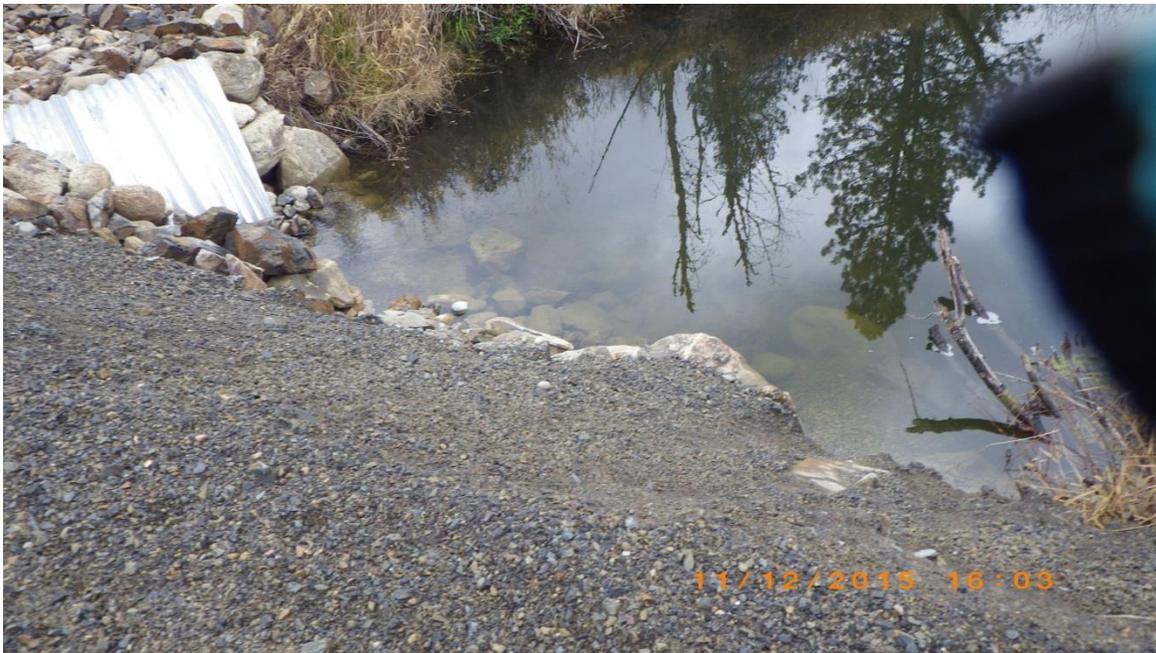
Figure 197. Road fill erosion into upper Cocolalla Creek.

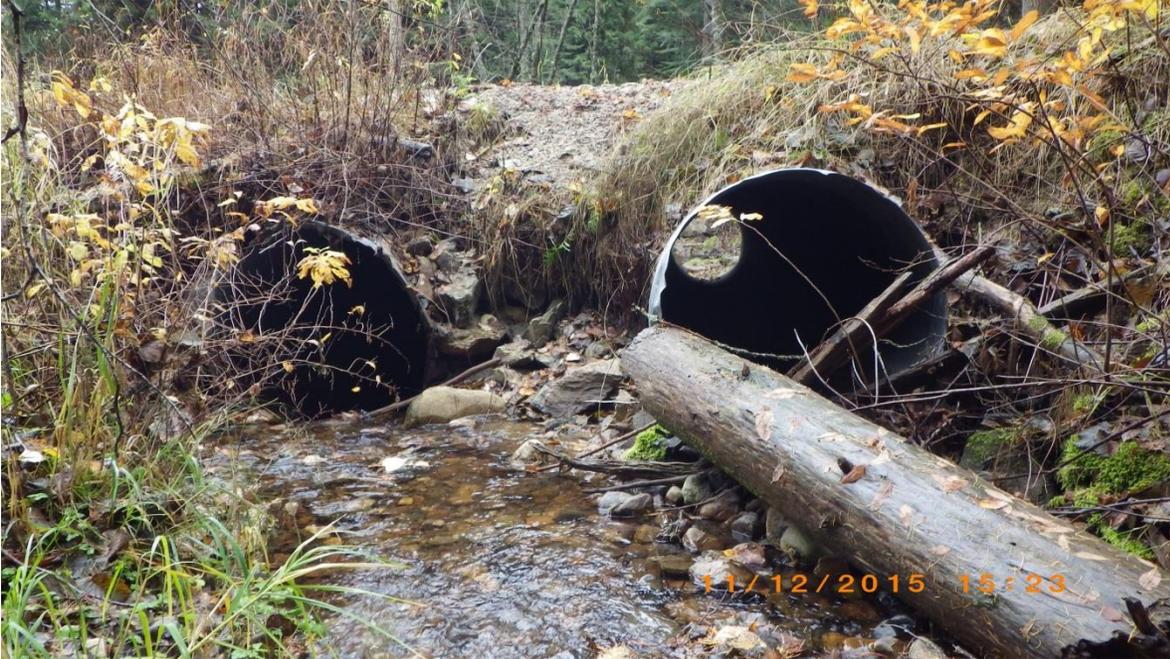
Figure 198. Road fill erosion into Fish Creek.

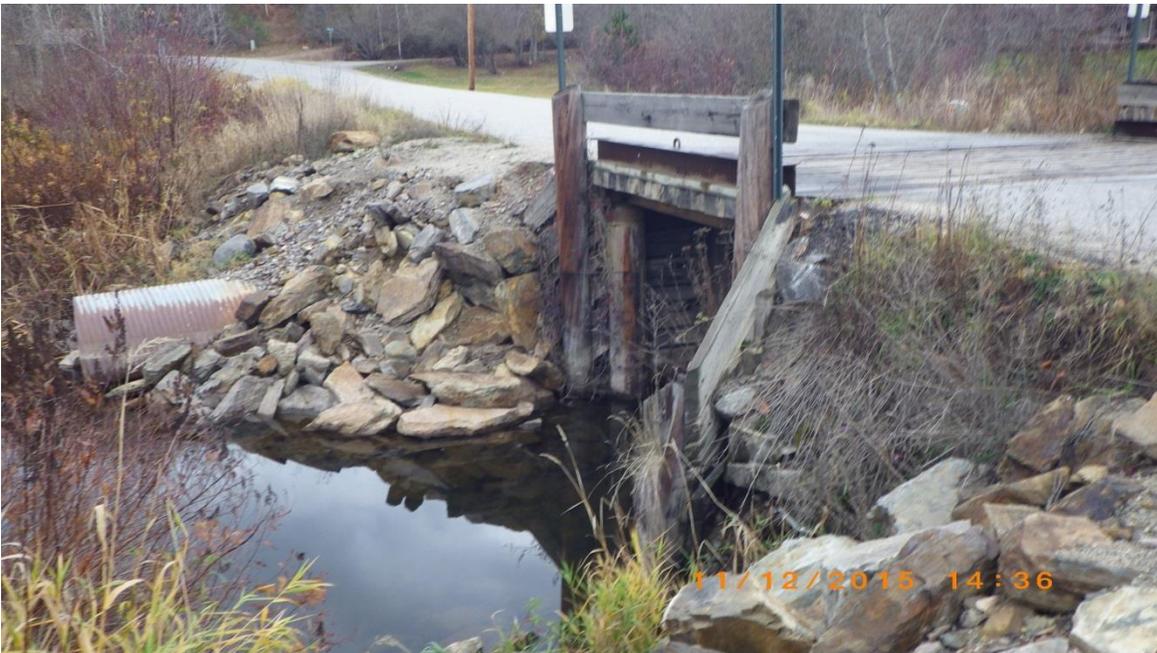
Figure 199. Undersized bridge at outlet of Cocolalla Lake.
